Compliance Inspection Form

Existing Subsurface Sewage Treatment Systems (SSTS)

Property address: 21775 OLINDA LN N, CITY OF SCANDIA
Reason for inspection: PROPERTY TRANSFER

Brief system description: 2) 1000-GALLON SEPTIC TANKS, 1000 LIFT AND PRESSURIZED MOUND

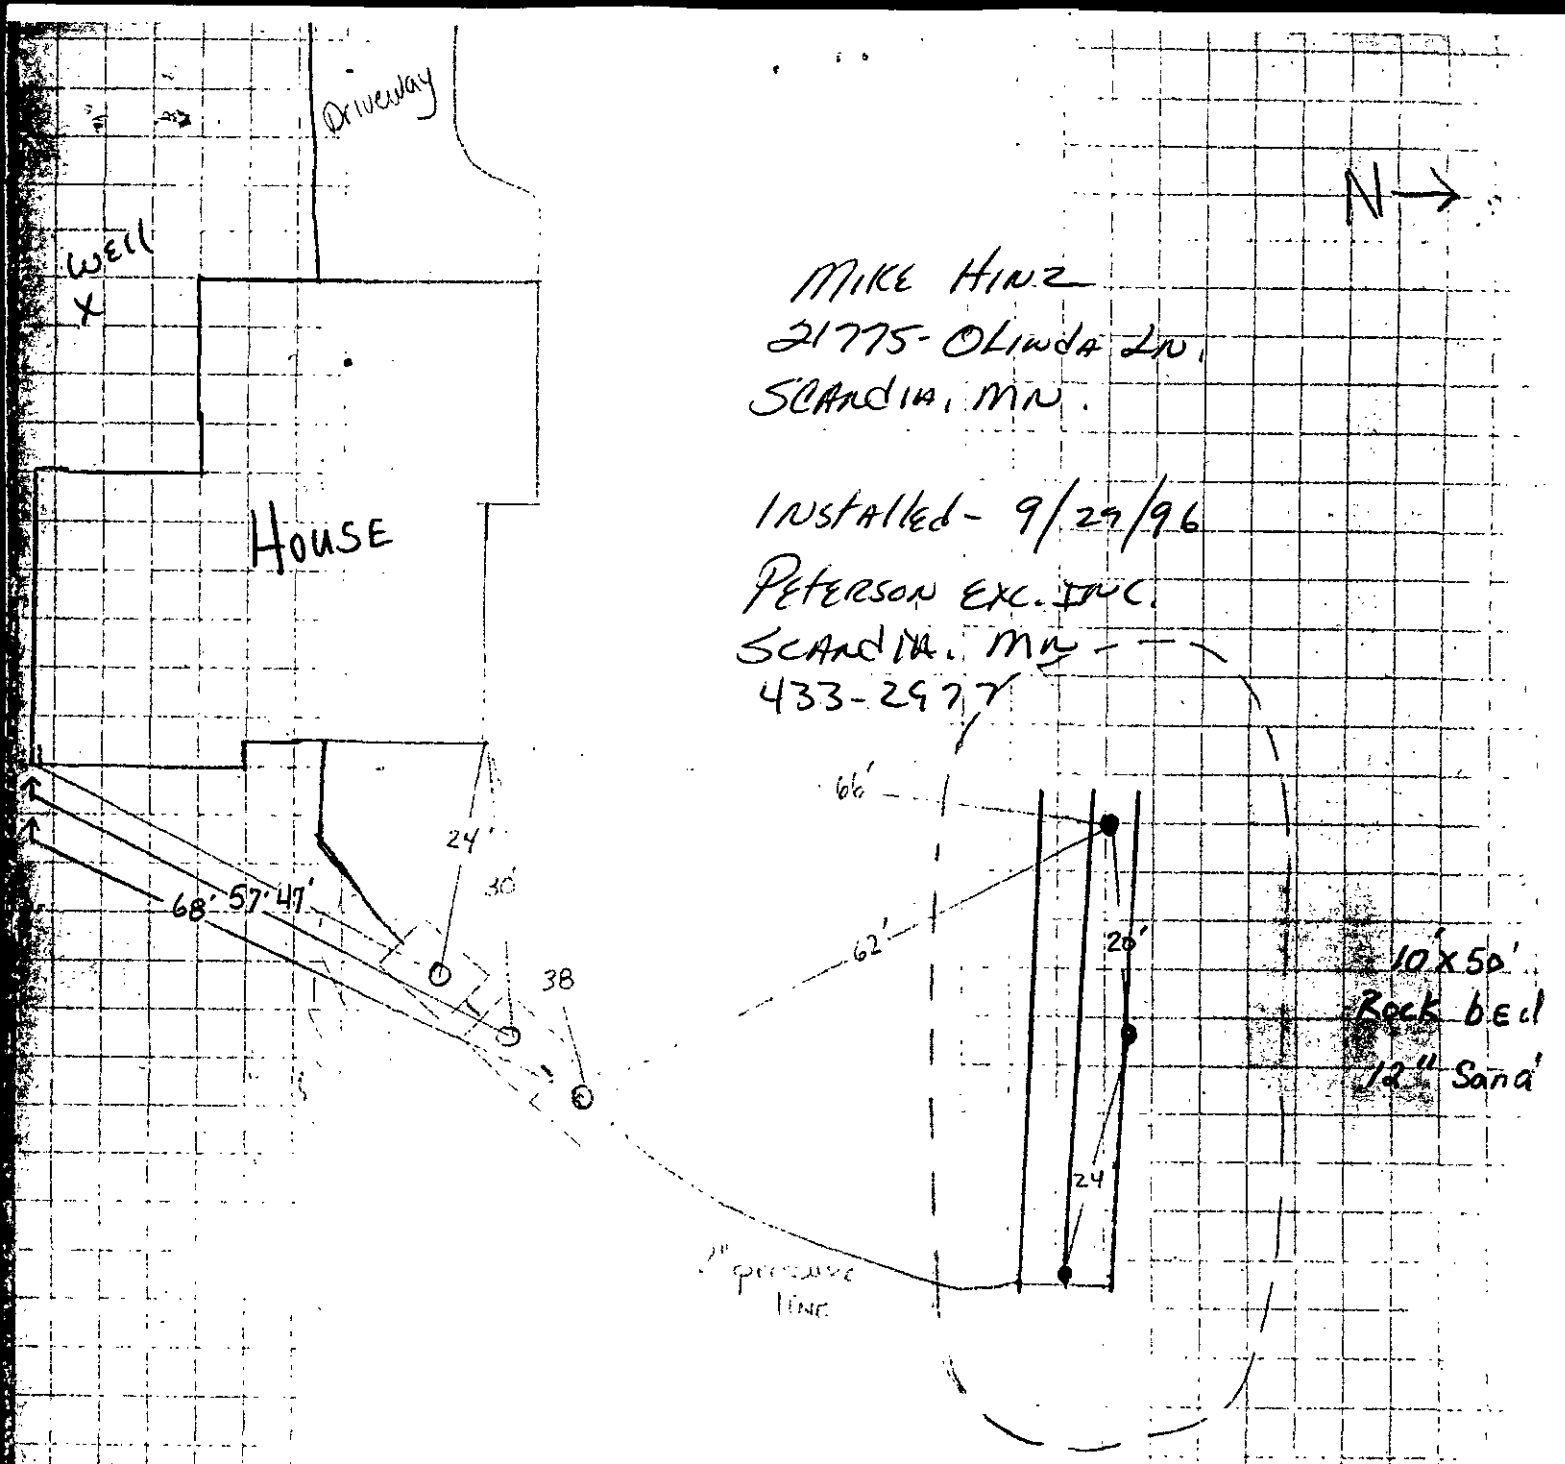
MIKE HINZ
21775 - OLINDA LN.
SCANDIA, MN.

INSTALLED - 9/29/96
PETERSON EXC. INC.
SCANDIA, MN -
433-2977
