Midwest Sewer Services

SUBSURFACE SEWAGE TREATMENT SYSTEM (SSTS) COMPLIANCE REPORT

Date: February 25, 2021 **Time:** 1:15 PM **Owner:** Pat O'Reilly
Inspection Address: 1691 Oldridge Ave N, West Lakeland, MN **Site Conditions:** 6" Snow 12" Frost

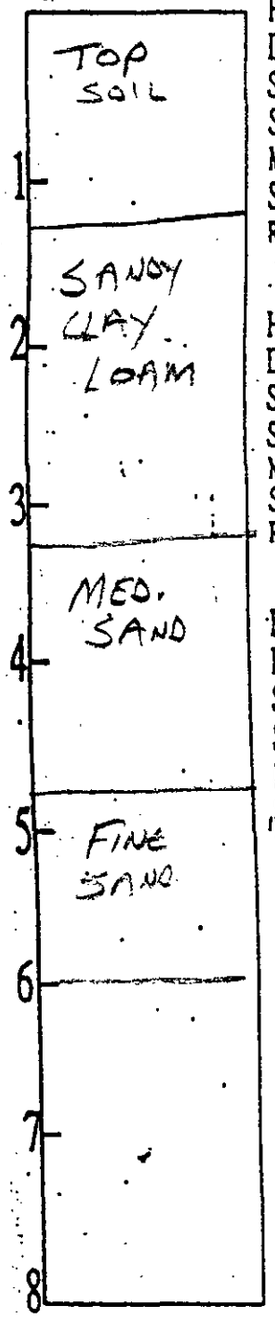
#3

Horizon: A
Depth: 14"
Soil Texture: _____
Soil Color: 10YR3/2
Mottling: Yes __ No X Clay films: Yes __ No X
Soil Stucture: _____
Roots: Yes __ No X Carbonates: Yes __ No X

Horizon: B
Depth: 38"
Soil Texture: _____
Soil Color: 10YR5/3
Mottling: Yes __ No X Clay films: Yes X No __
Soil Stucture: _____
Roots: Yes __ No X Carbonates: Yes __ No X

Horizon: C
Depth: 58"
Soil Texture: _____
Soil Color: 10YR 6/6
Mottling: Yes __ No X Clay films: Yes __ No X
Soil Stucture: _____
Roots: Yes __ No X Carbonates: Yes __ No X

Horizon: D
Depth: 72"
Soil Texture: _____
Soil Color: 10YR 6/4
Mottling: Yes __ No X Clay films: Yes __ No X
Soil Stucture: _____
Roots: Yes __ No X Carbonates: Yes __ No X

End of boring at 6 feet.
Standing water table: NONE
Present at ____ feet of depth,
____ hours after boring.
Not present in boring hole ____.

Mottled Soil: NONE
Observed at ____ feet of depth.
Not observed in boring hole ____.
Observations and comments:

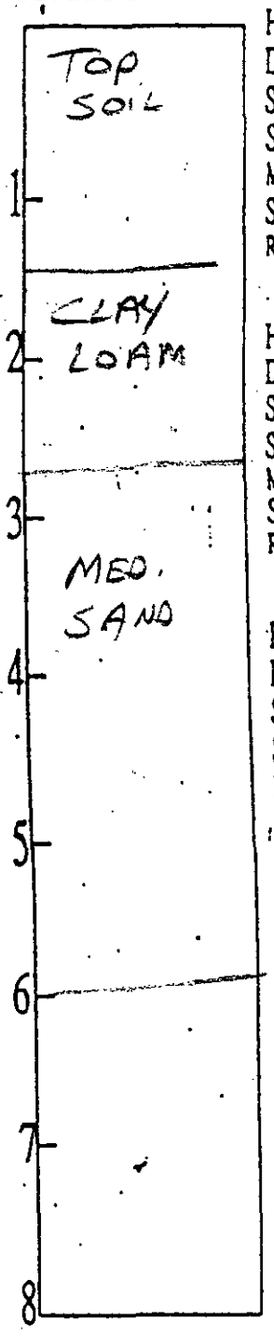
#4

Horizon: A
Depth: 17"
Soil Texture: _____
Soil Color: 10YR3/2
Mottling: Yes __ No X Clay films: Yes __ No X
Soil Stucture: _____
Roots: Yes __ No X Carbonates: Yes __ No X

Horizon: B
Depth: 32"
Soil Texture: _____
Soil Color: 10YR 6/4
Mottling: Yes __ No X Clay films: Yes X No __
Soil Stucture: _____
Roots: Yes __ No X Carbonates: Yes __ No X

Horizon: C
Depth: 72"
Soil Texture: _____
Soil Color: 10YR 5/3
Mottling: Yes __ No X Clay films: Yes __ No X
Soil Stucture: _____
Roots: Yes __ No X Carbonates: Yes __ No X

End of boring at 6 feet.
Standing water table: NONE
Present at ____ feet of depth,
____ hours after boring.
Not present in boring hole ____.

Mottled Soil: NONE
Observed at ____ feet of depth.
Not observed in boring hole ____.
Observations and comments:
