Midwest Sewer Services

SUBSURFACE SEWAGE TREATMENT SYSTEM (SSTS) COMPLIANCE REPORT

Date: March 9, 2021 **Time:** 11:00 AM **Owner:** Paul Clark

Inspection Address: 23249 St Croix Trl N, Scandia, MN **Site Conditions:** 0" Snow 2" Frost

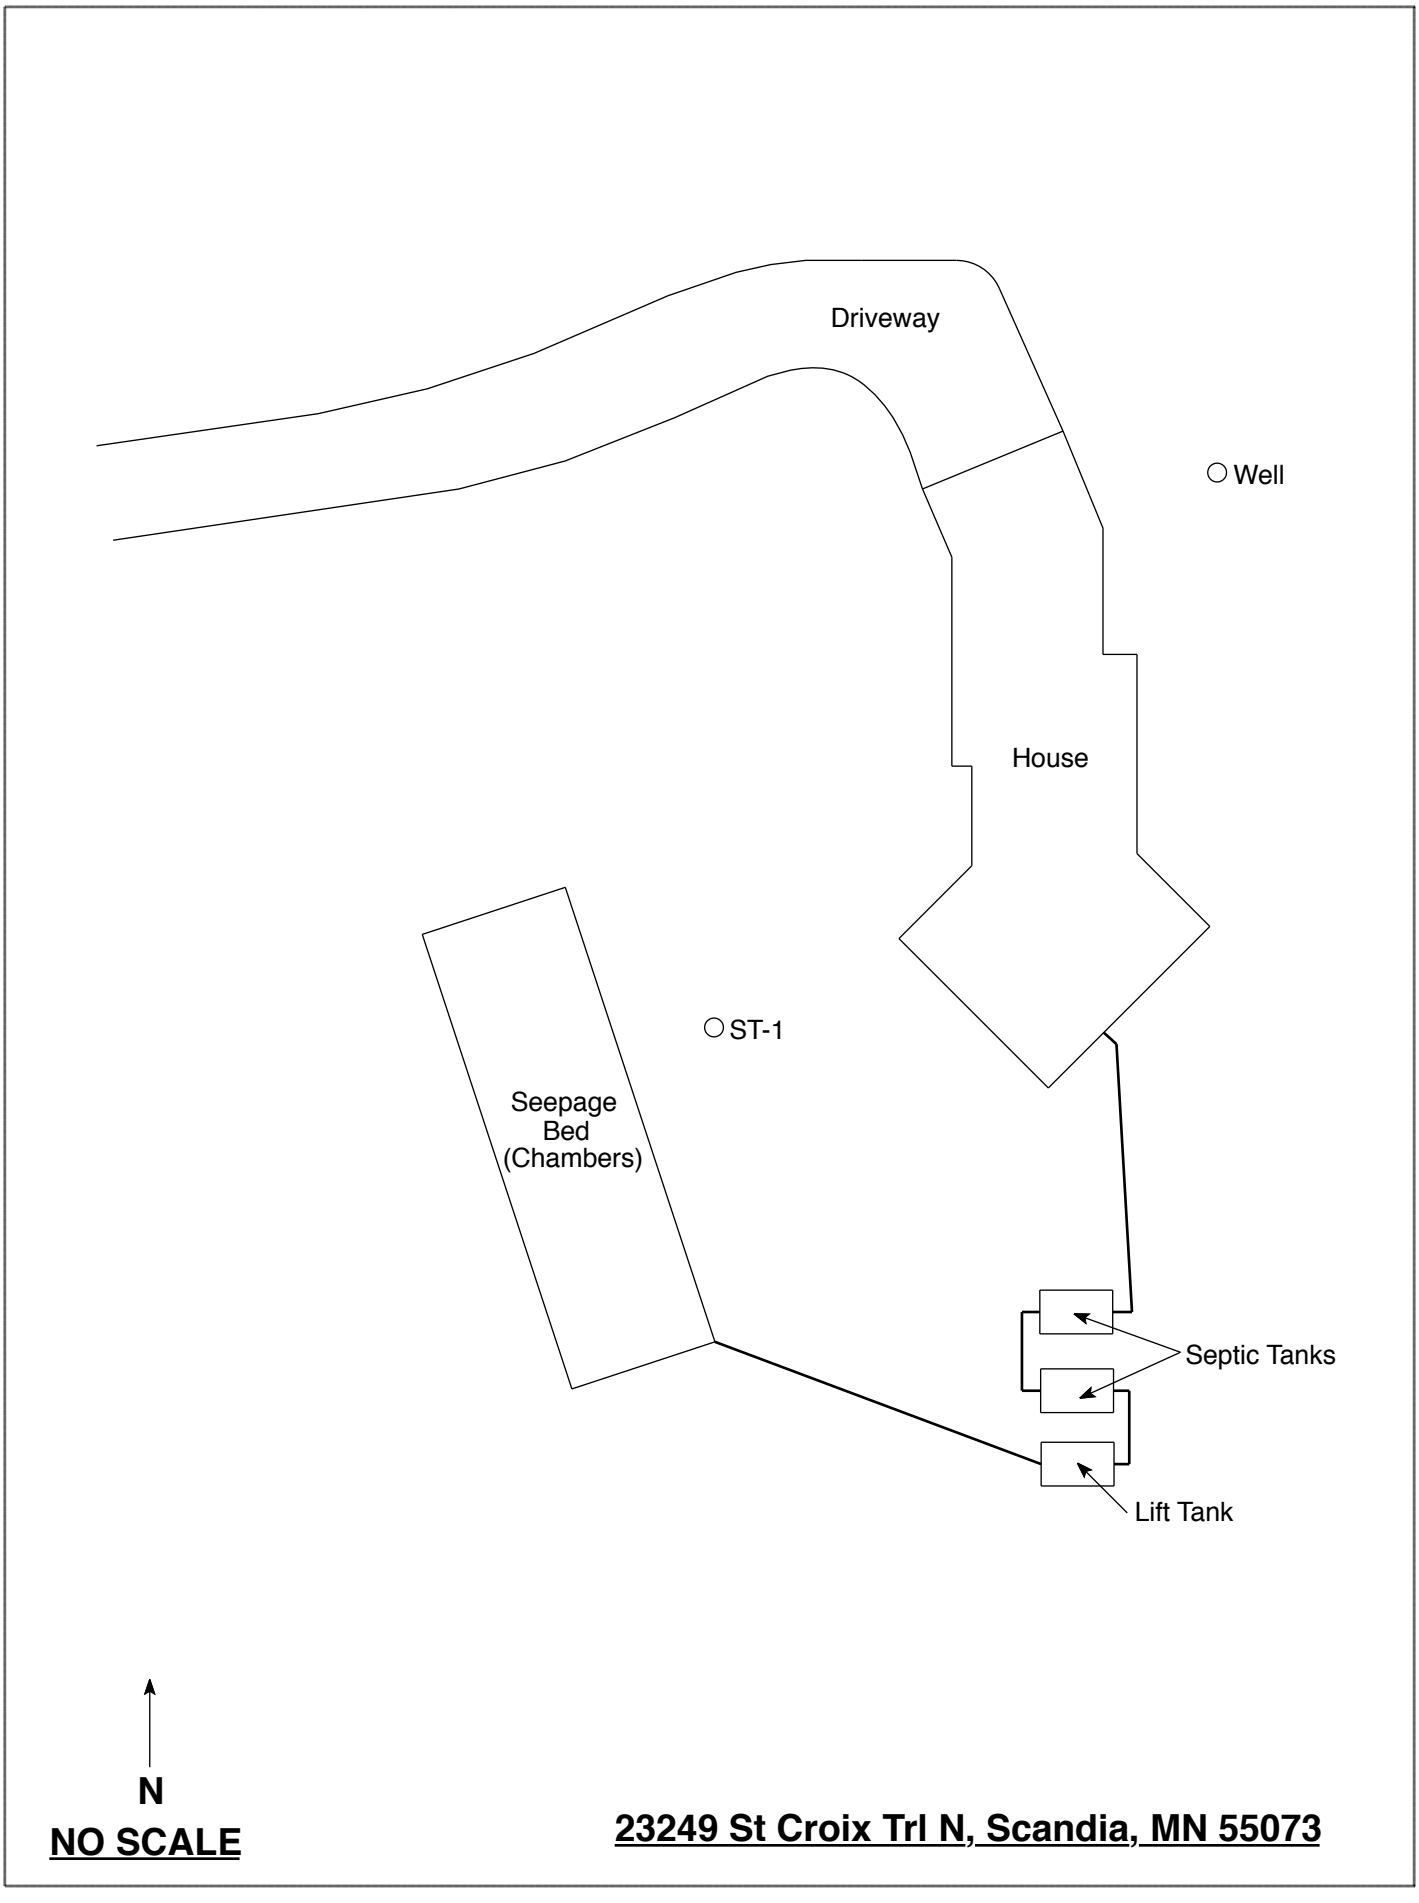
Driveway
Well
House
ST-1
Seepage
Bed
(Chambers)
Septic Tanks
Lift Tank
N
NO SCALE
23249 St Croix Trl N, Scandia, MN 55073
