Midwest Sewer Services

SUBSURFACE SEWAGE TREATMENT SYSTEM (SSTS) COMPLIANCE REPORT

Inspection Address: 2545 Overlook Ave N, West Lakeland, MN 55082

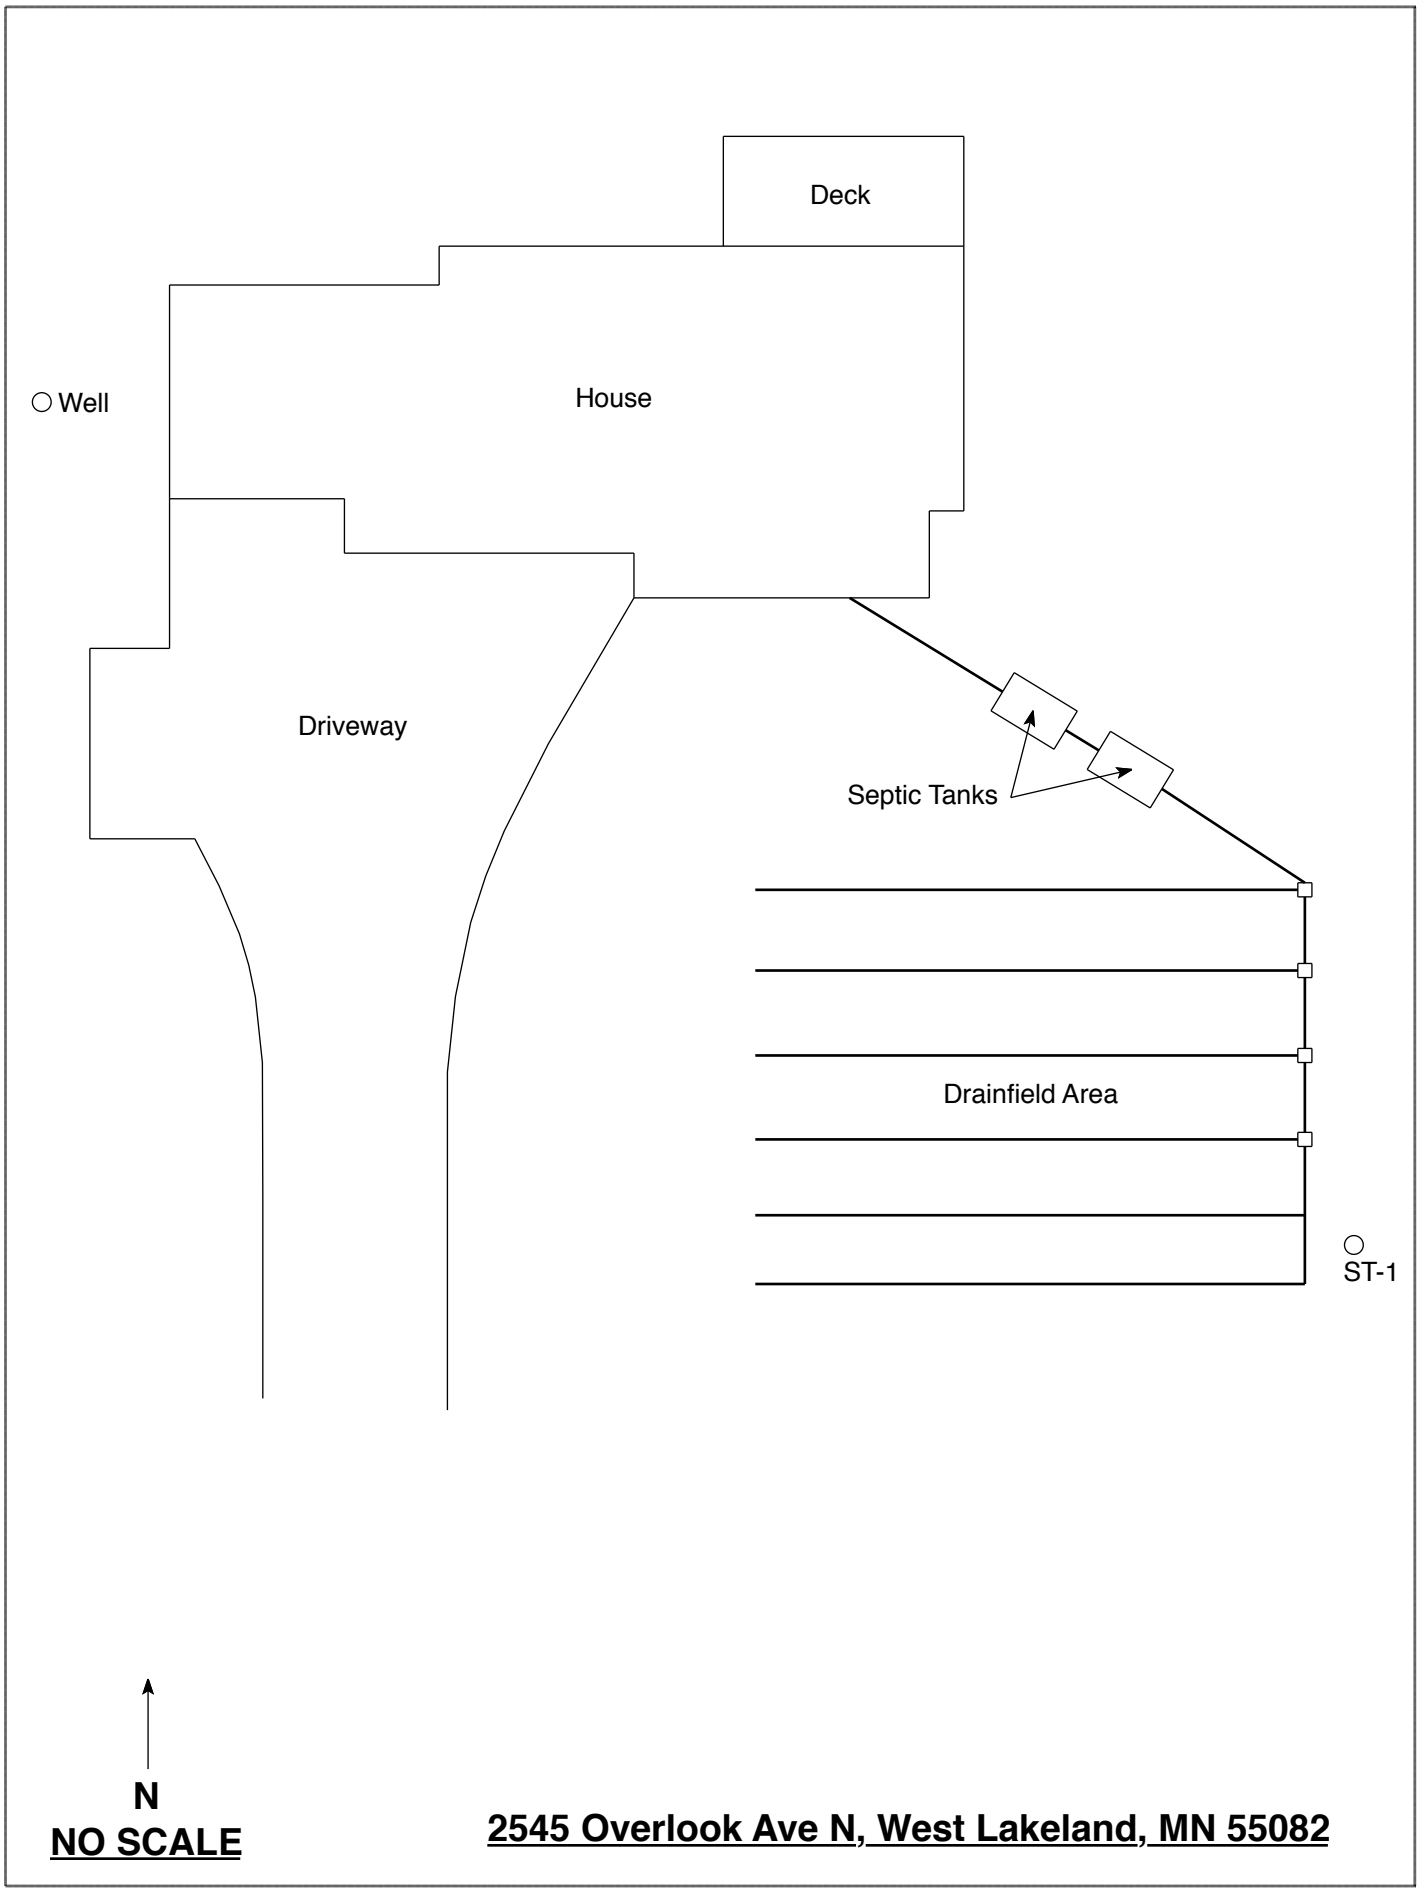
Deck
Well
House
Driveway
Septic Tanks
Drainfield Area
ST-1
N
NO SCALE
2545 Overlook Ave N, West Lakeland, MN 55082
