Midwest Sewer Services

SUBSURFACE SEWAGE TREATMENT SYSTEM (SSTS) COMPLIANCE REPORT

Inspection Address: 16901 Northridge Ave N, May Twp, MN 55047

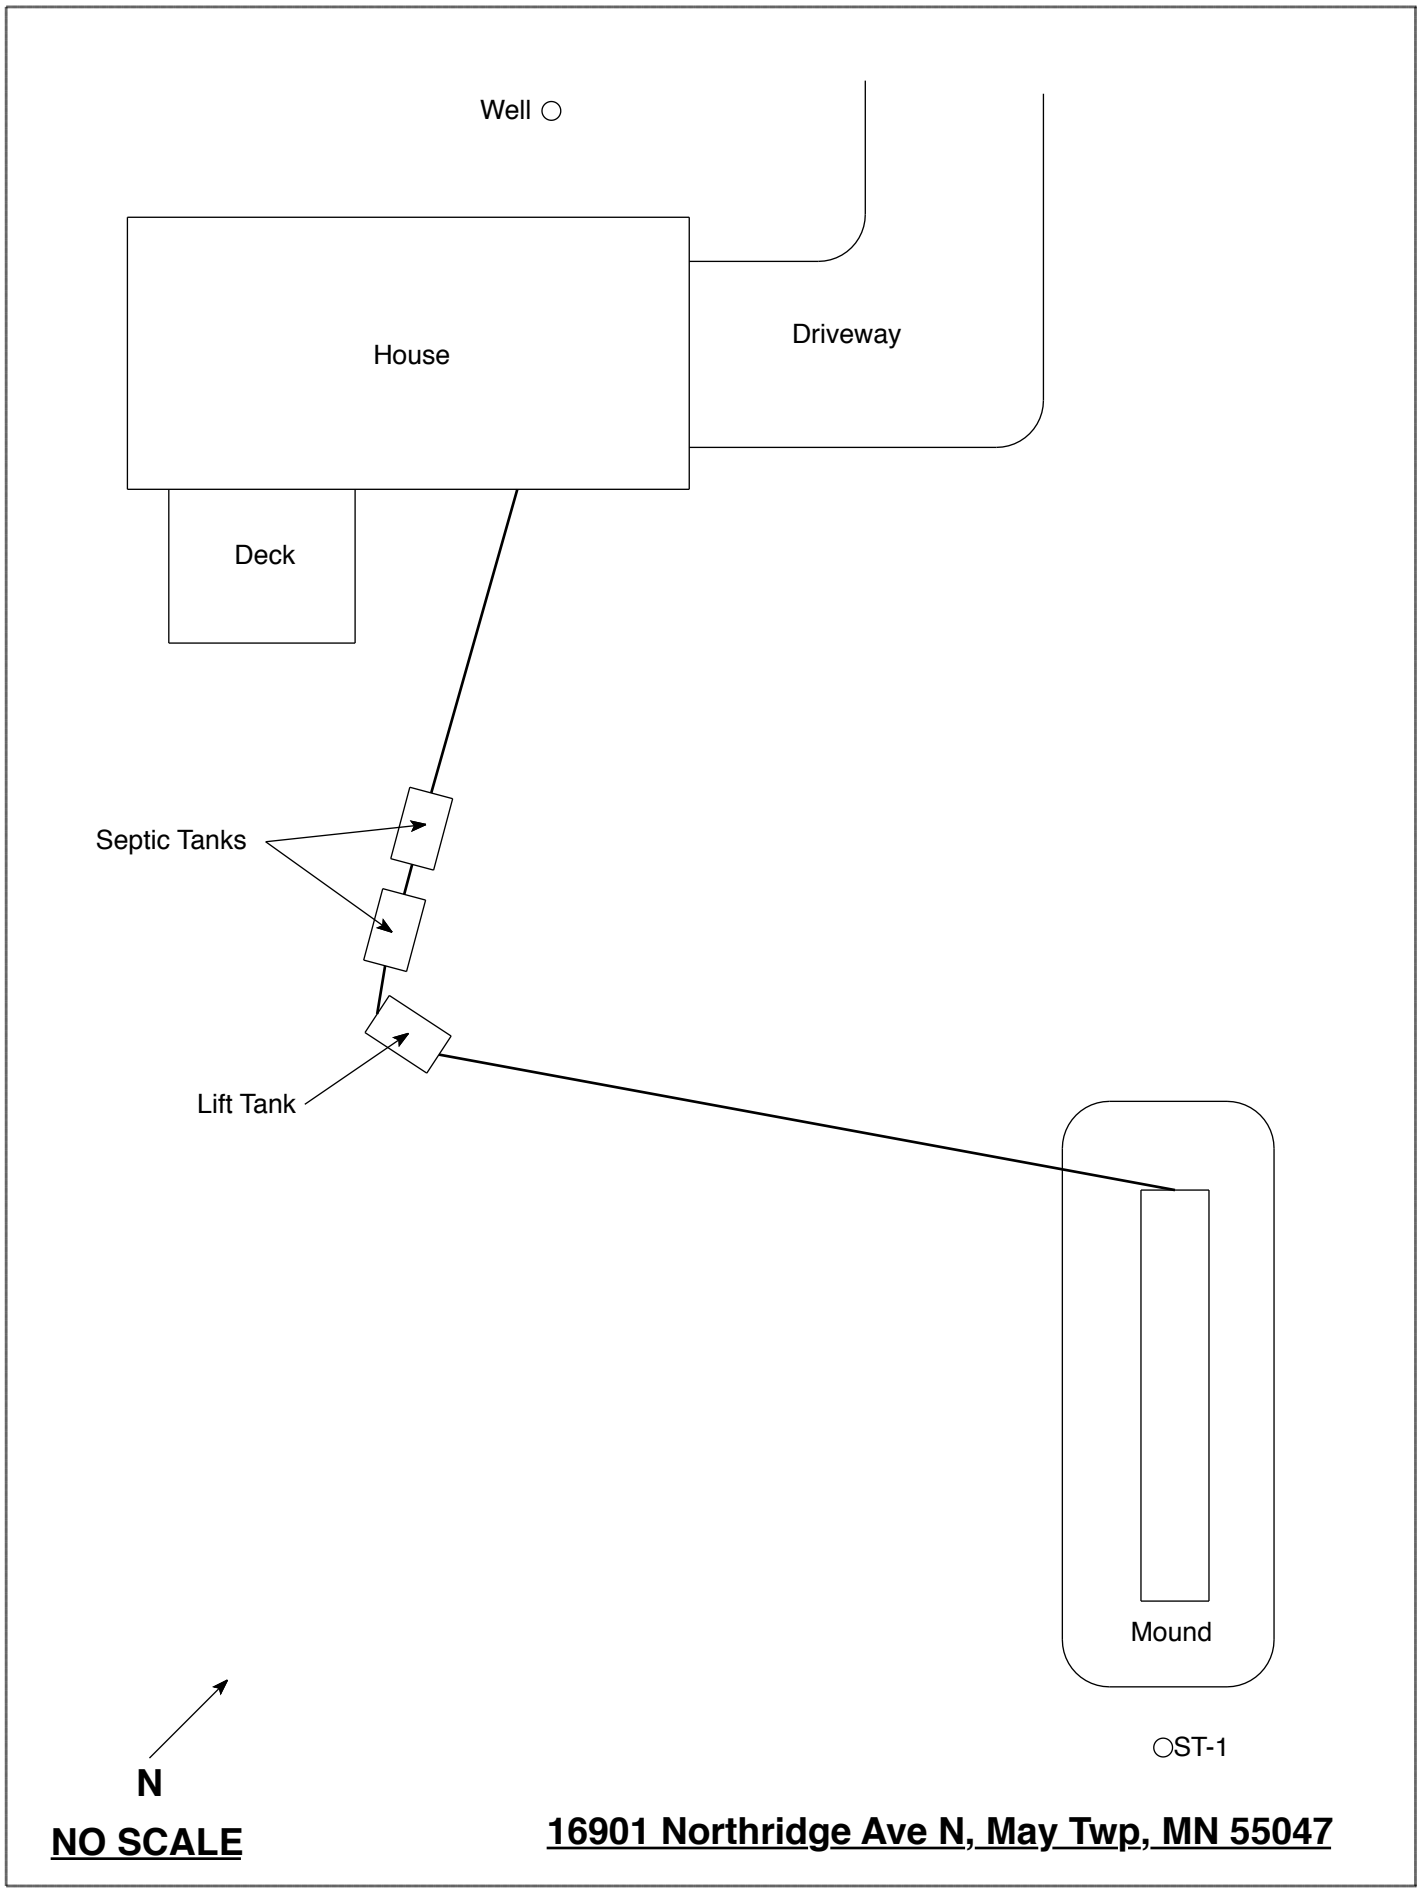
Well ○
House
Driveway
Deck
Septic Tanks
Lift Tank
Mound
○ST-1
N
NO SCALE
16901 Northridge Ave N, May Twp, MN 55047
