ZIERKE SOIL TESTING

Compliance inspection report form

Existing Subsurface Sewage Treatment System (SSTS)

Property address: 7200 Manning Ave N Stillwater, MN 55082

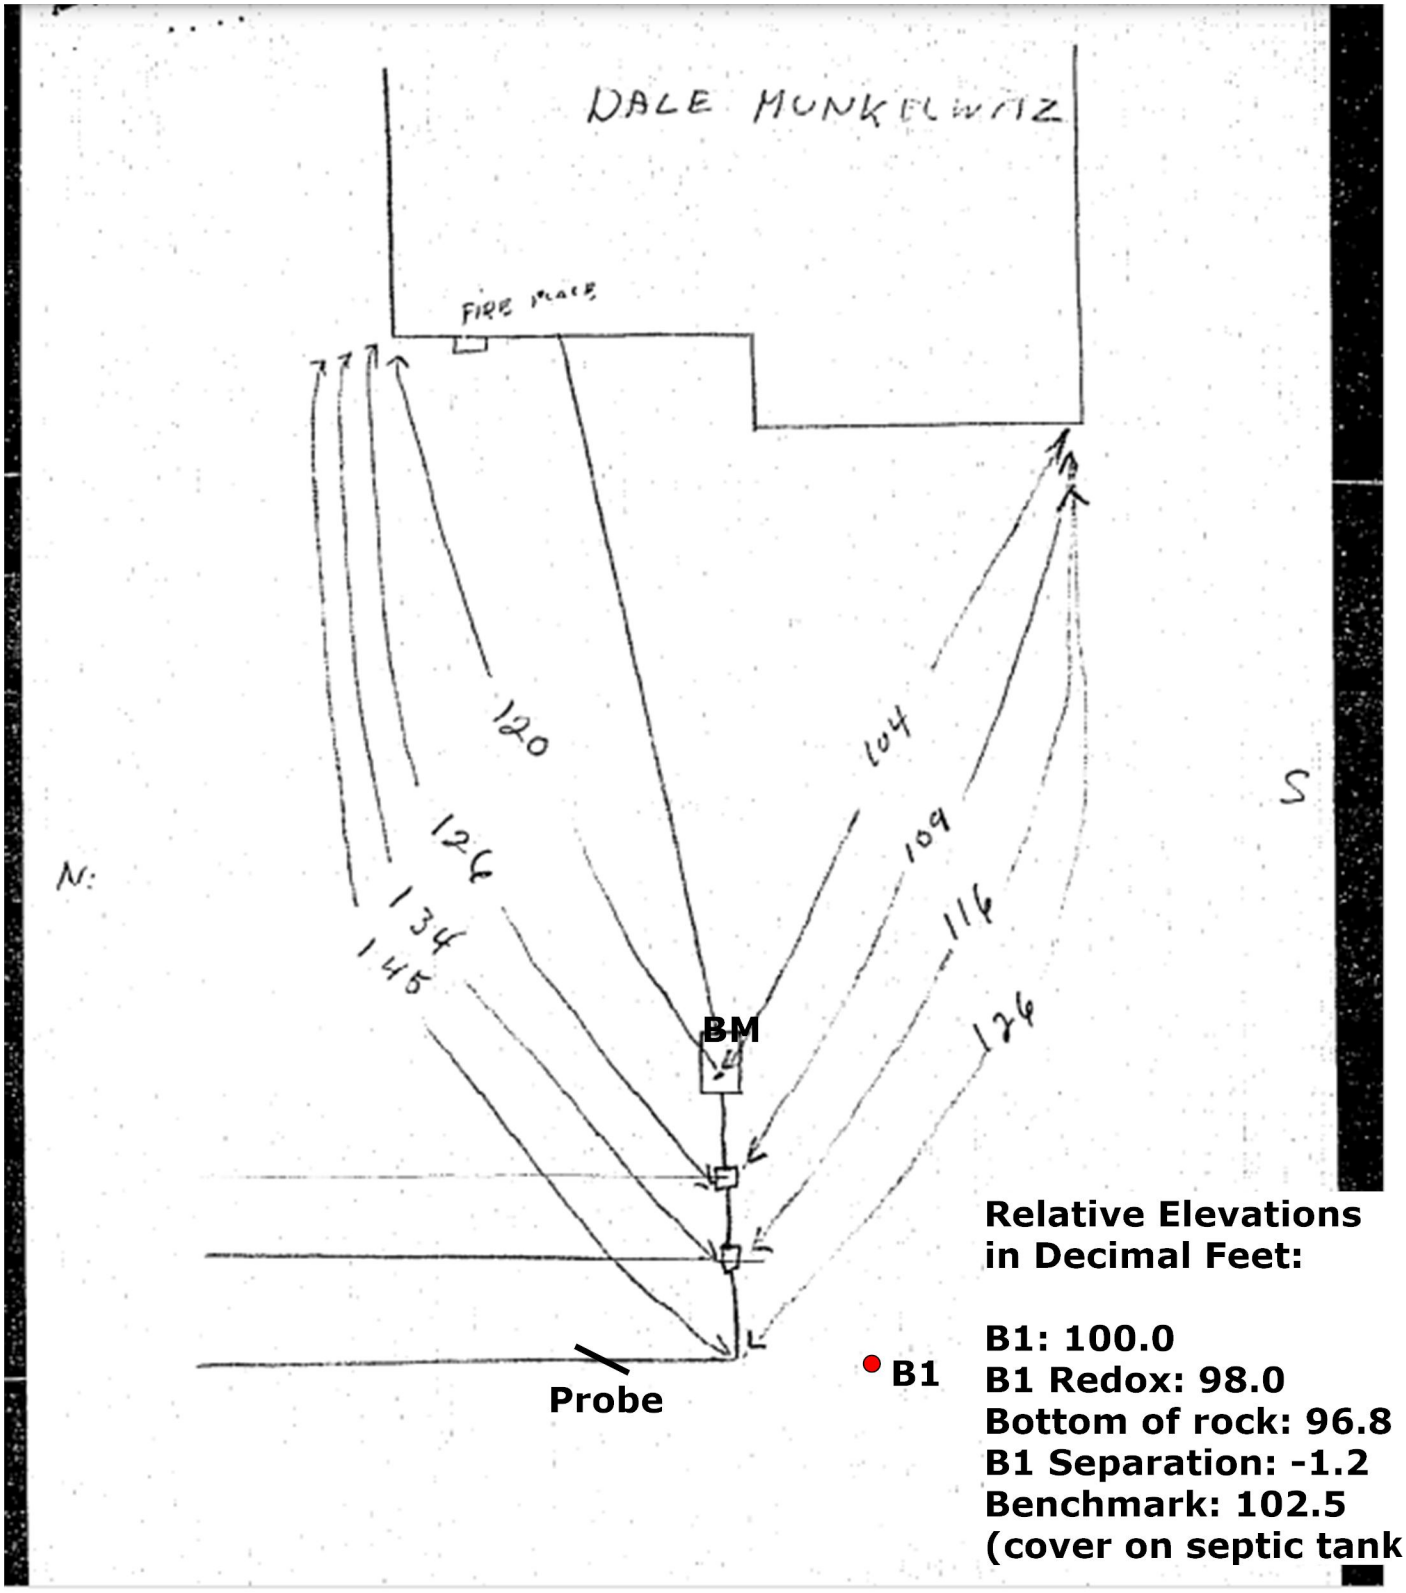
Relative Elevations in Decimal Feet:

Based off of these criteria, your system is non-compliant due to a lack of vertical separation between the bottom of your drain field and indicators of seasonally wet soil (redoximorphic features). Therefore, this system is considered "failing to protect groundwater" and is not considered an imminent threat to public health. I am required to provide copies of this report to you and to Washington County. You should contact them as to the next steps that will be required to bring the system into compliance.

A. Bottom of distribution media	96.8'
B. Periodically saturated soil/bedrock	98.0'
C. System separation	-1.2'
D. Required compliance separation*	3.0'

B1: 100.0
B1 Redox: 98.0
Bottom of rock: 96.8
B1 Separation: -1.2
Benchmark: 102.5
(cover on septic tank)
