Compliance inspection report form

Existing Subsurface Sewage Treatment System (SSTS)

Property address: 20120 Ingersoll Ave N Forest Lake, MN 55025

20120 INGERSOLL AVE N
FOREST LAKE, MN 55025
6/28/22

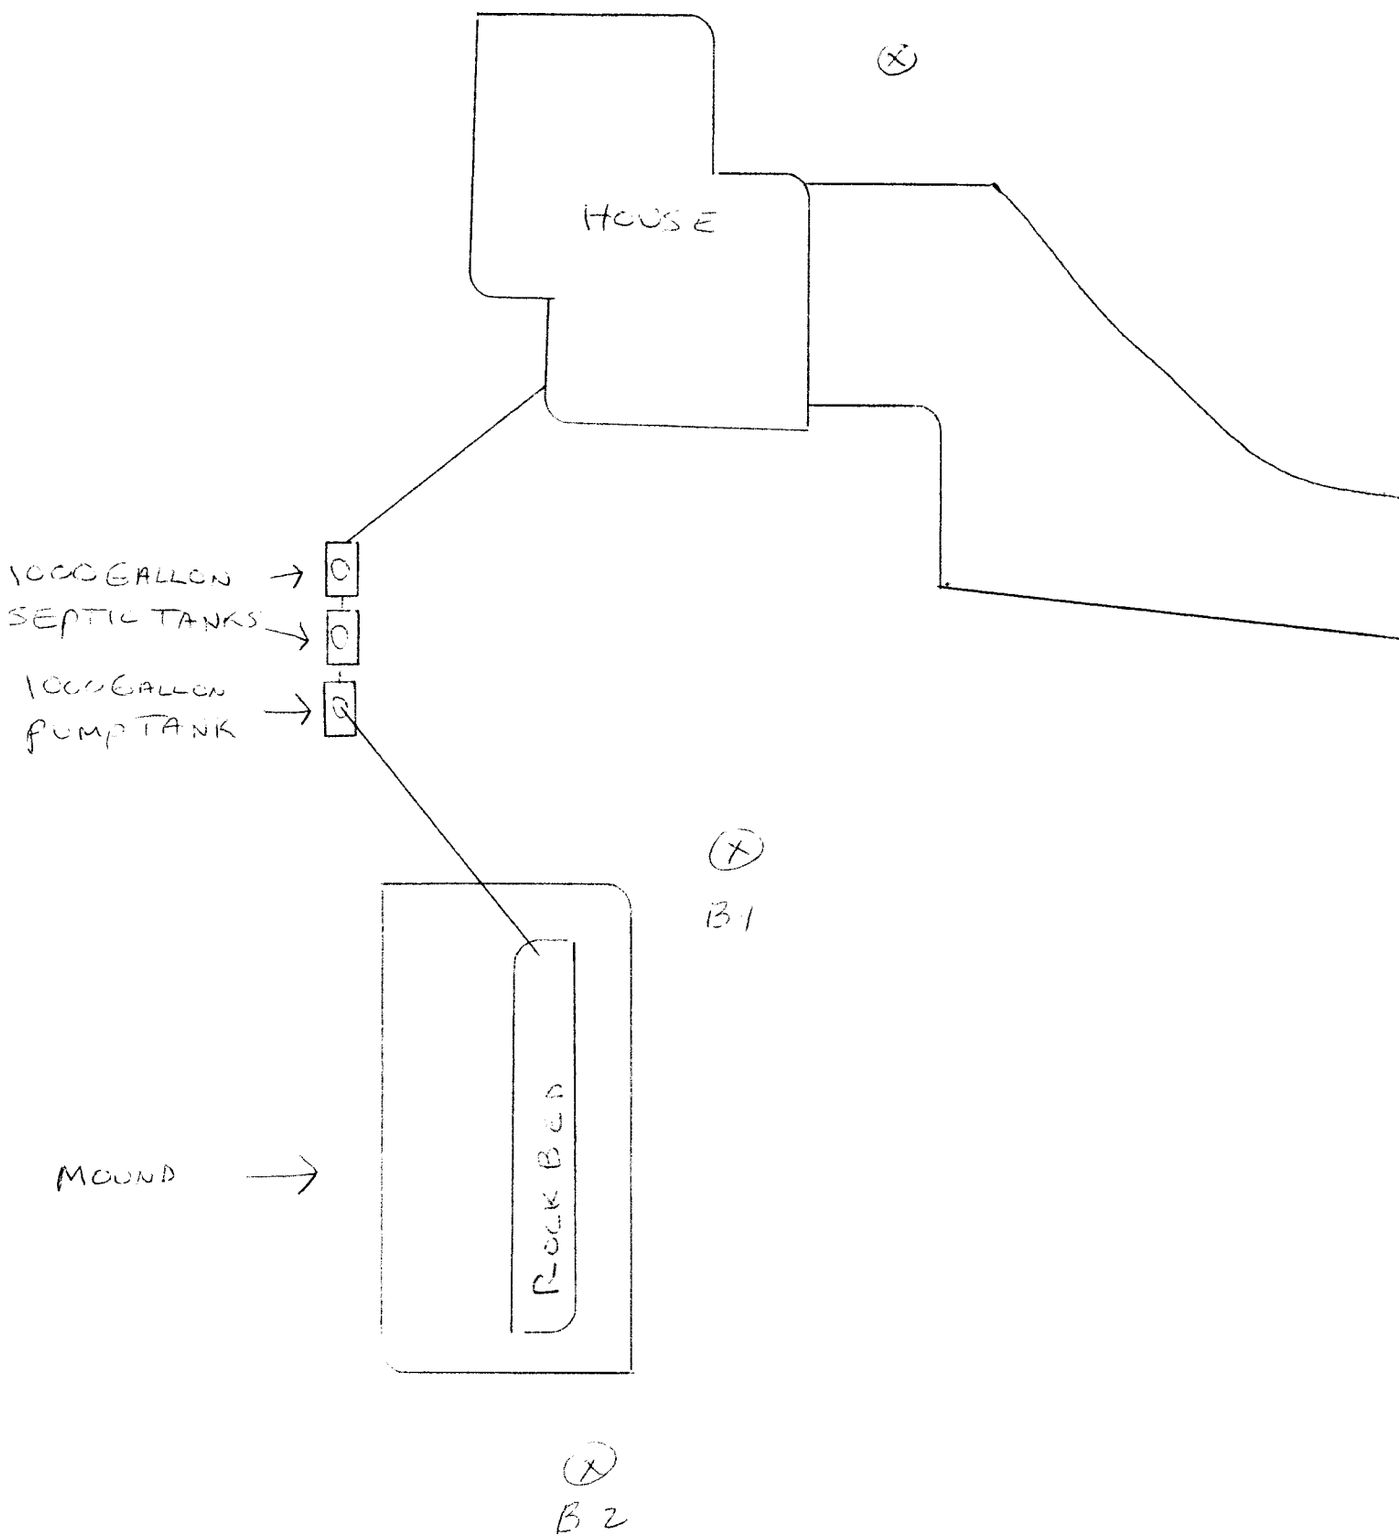
Brief system description: Two 1000 gallon precast septic tanks and a 1000 gallon pump tank lifting to a mound drainfield.

A. Bottom of distribution media	101.3
B. Periodically saturated soil/bedrock	98.1
C. System separation	3.2
D. Required compliance separation*	3.0
