Compliance inspection report form

Existing Subsurface Sewage Treatment System (SSTS)

Property address: 9861 51st St N, Lake Elmo

Brief system description: Septic tank, lift tank and mound

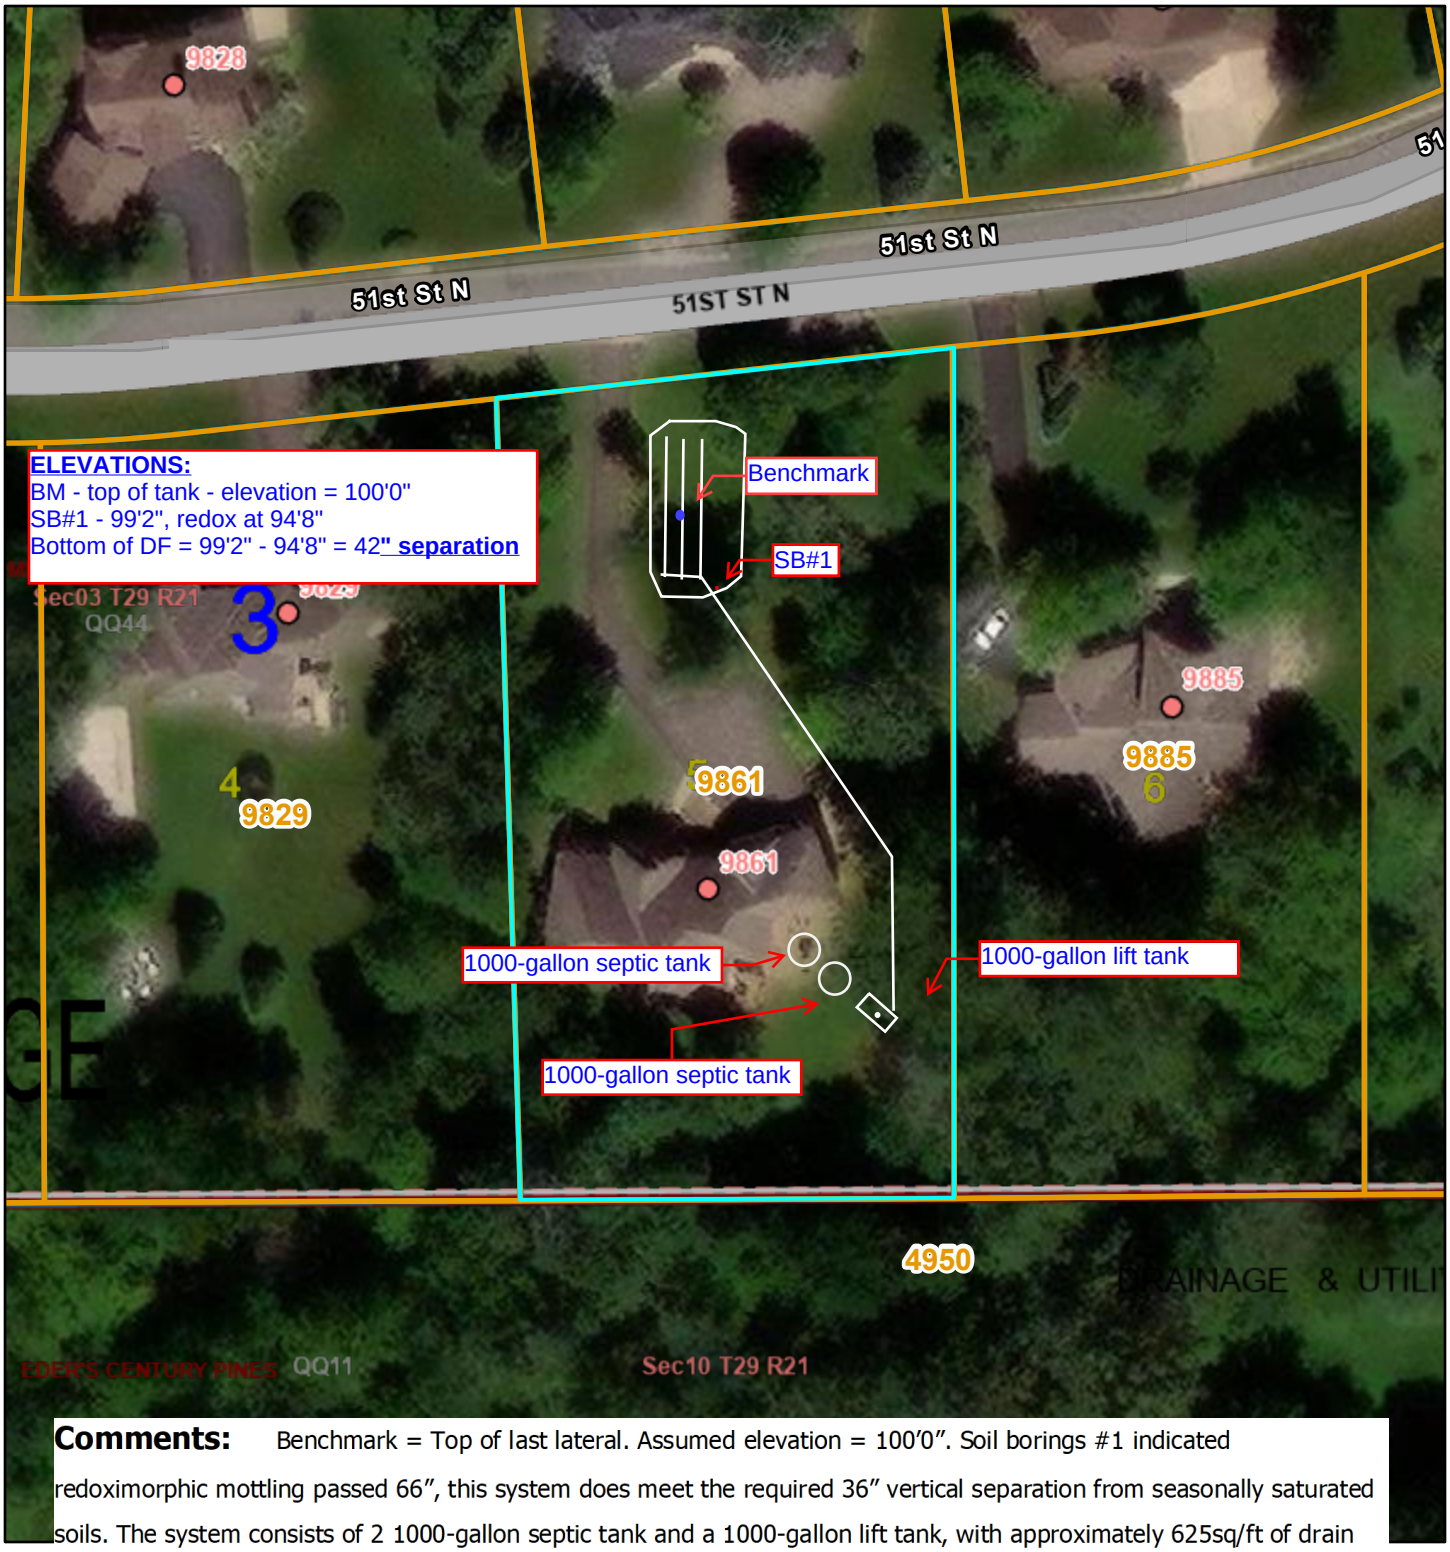
ArcGIS Web AppBuilder

Comments: Benchmark = Top of last lateral. Assumed elevation = 100'0". Soil borings #1 indicated redoximorphic mottling passed 66", this system does meet the required 36" vertical separation from seasonally saturated soils. The system consists of 2 1000-gallon septic tank and a 1000-gallon lift tank, with approximately 625sq/ft of drain field with 6" of rock under the distribution media. The tanks were pumped at the time of the inspection, the baffles are intact and the tank is water tight. This system is classified as compliant. This inspection is not a warranty or guarantee, either written or implied, of future or long-term hydraulic functionality/performance, but rather a determination if the systems use is/may cause pollution and/or adverse harm to the environment, groundwater or public health and safety at the time of this inspection. No guarantee can be made on future hydraulic performance, or the performance of system components (pumps, controls, etc.). Changes in use can cause any system, failing or compliant, to become hydraulically overloaded and ultimately fail. Owner/buyer assumes full responsibility for the long-term performance of this system as well as any future upgrade, repairs or replacement costs. Liability is limited to the cost of this inspection.
