# ZIERKE SOIL TESTING

# Compliance inspection report form

## Existing Subsurface Sewage Treatment System (SSTS)

Property address: 6730 165th St N Hugo, MN 55038

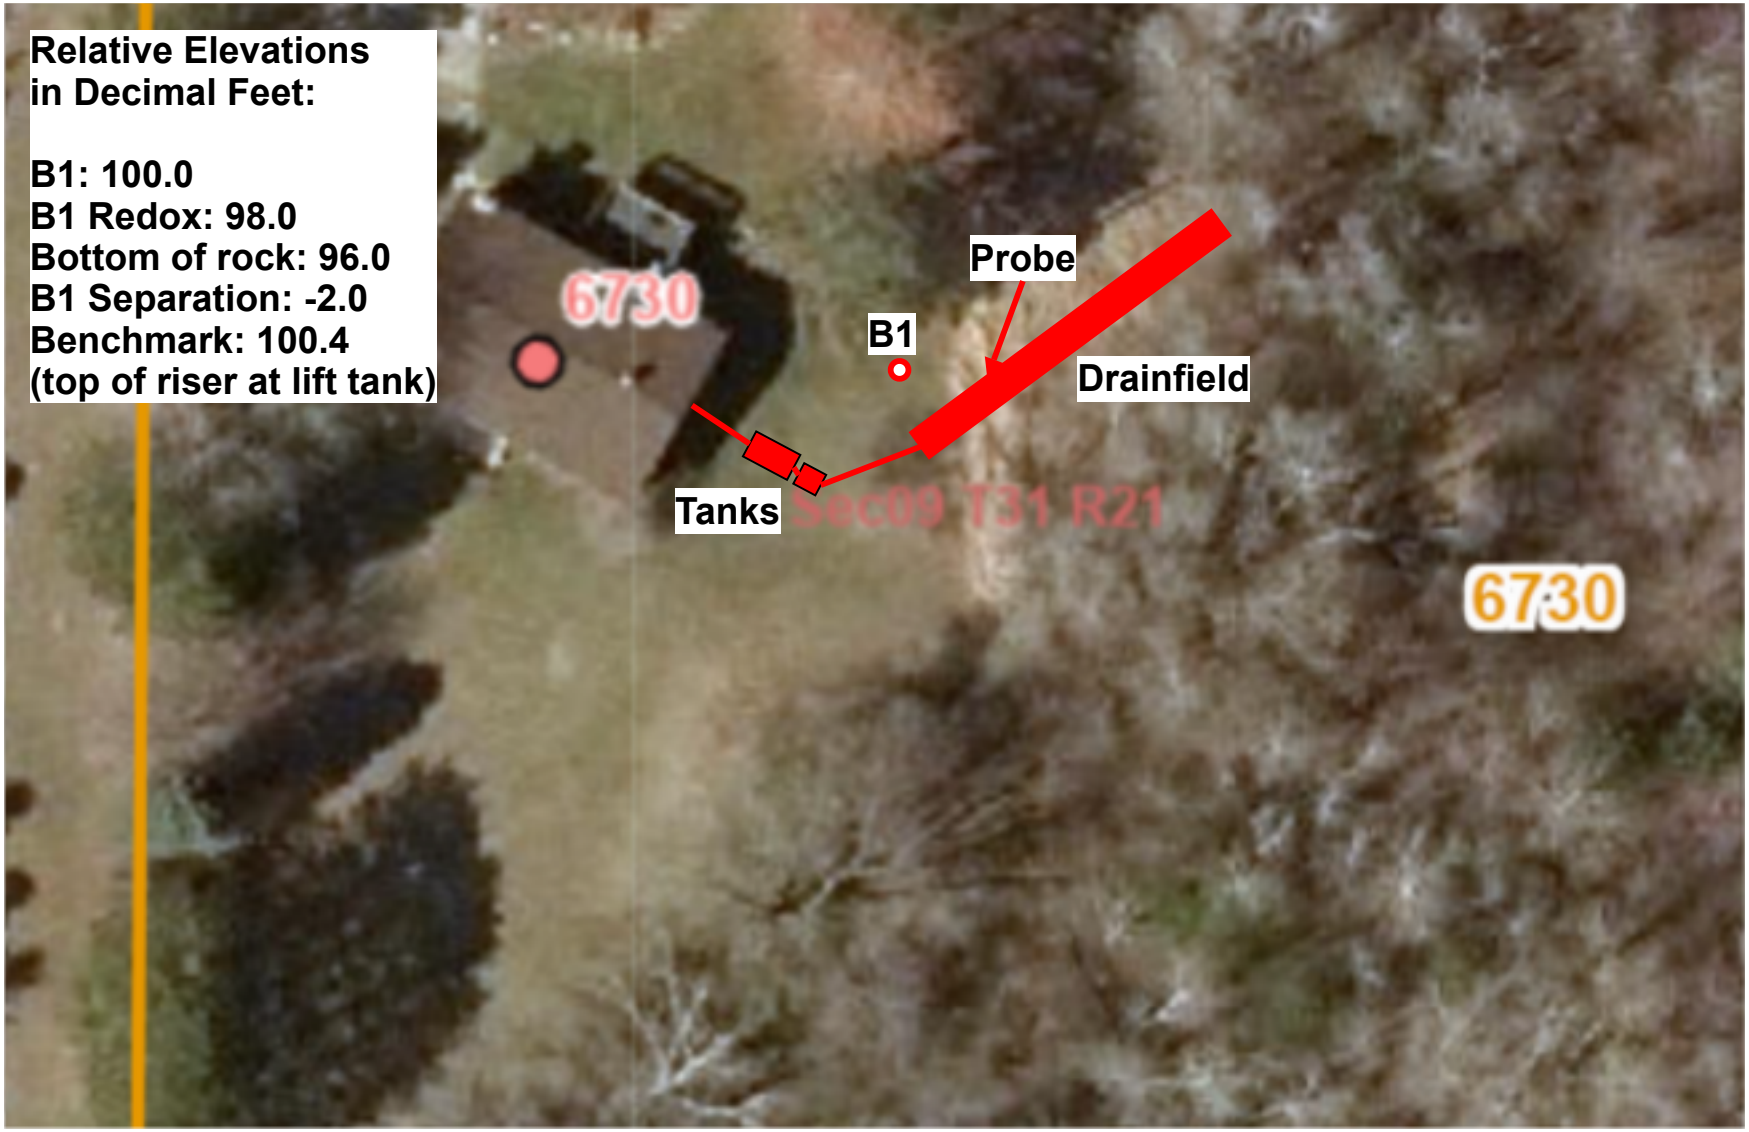
See attached elevations and boring.

Relative Elevations
in Decimal Feet:
B1: 100.0
B1 Redox: 98.0
Bottom of rock: 96.0
B1 Separation: -2.0
Benchmark: 100.4
(top of riser at lift tank)
6730
Probe
B1
Drainfield
Tanks
Sec09 T31 R21
6730
