SUBSURFACE SEWAGE TREATMENT SYSTEM (SSTS) COMPLIANCE REPORT

Date: May 30, 2023 **Time:** 2:30 PM **Owner:** Rod Johnson

Inspection Address: 14174 65th St S, Denmark Twp, MN 55033

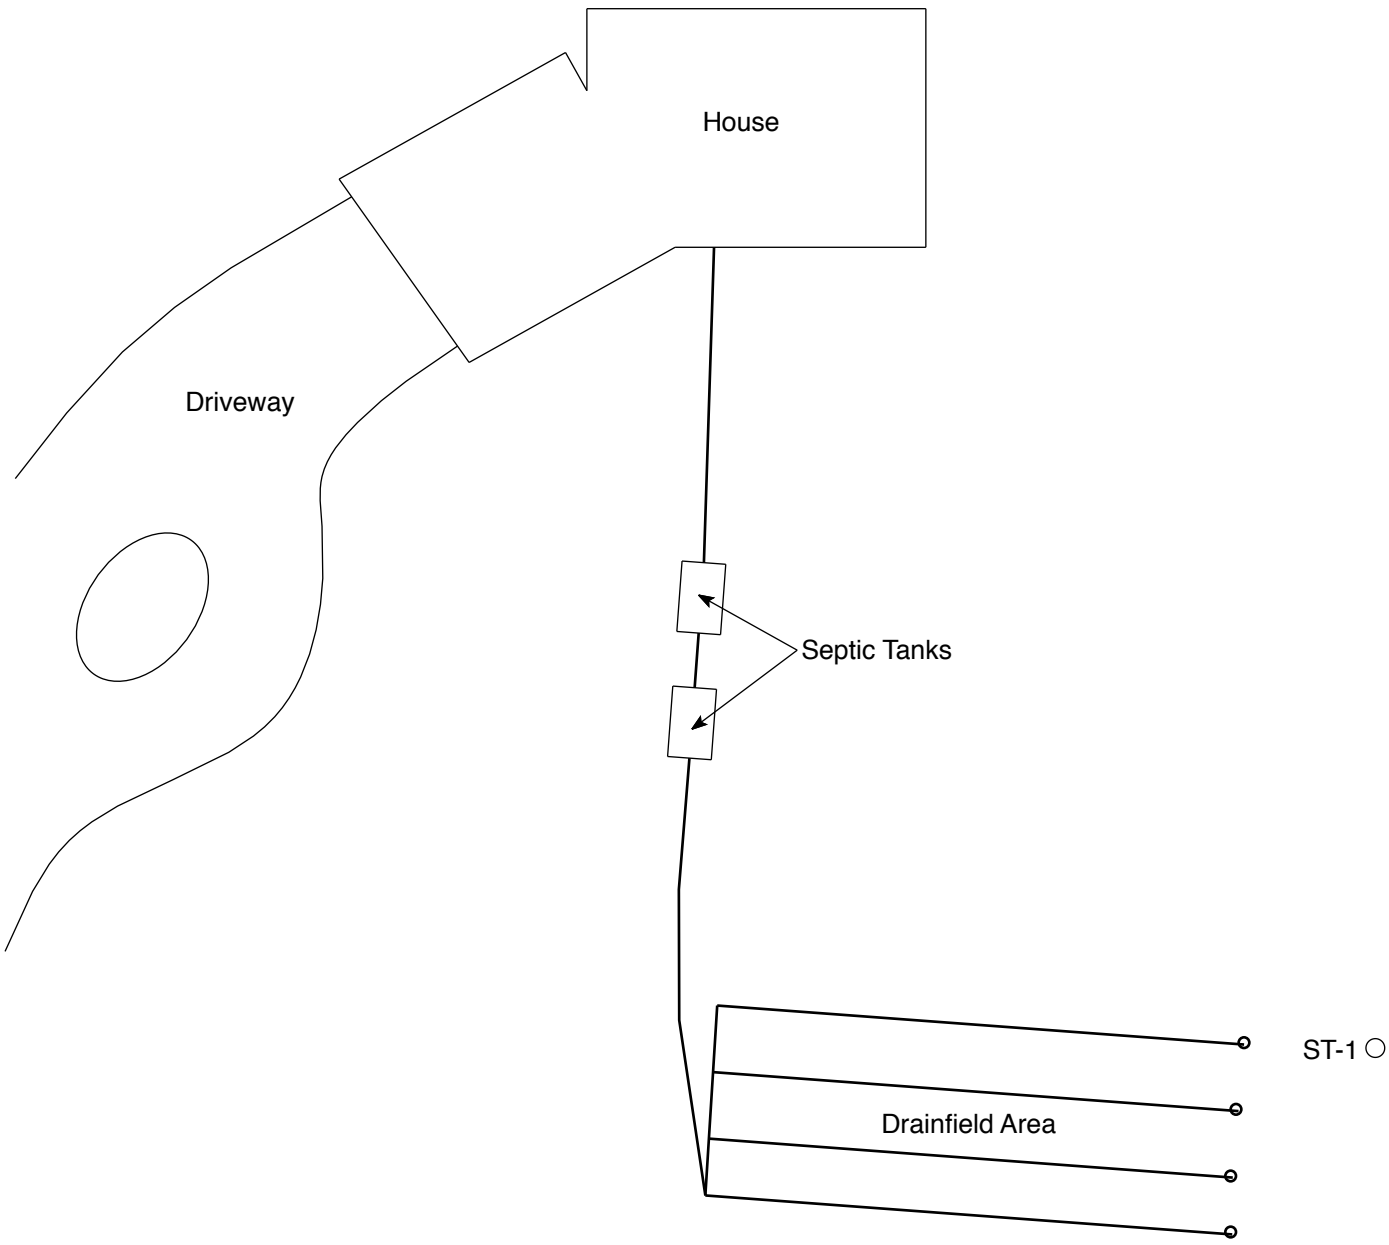
14174 65th St S, Denmark Twp, MN 55033

NO SCALE
