Compliance inspection report form

Existing Subsurface Sewage Treatment System (SSTS)

Property address: 4370 Stillwater Blvd N Lake Elmo, MN 55042

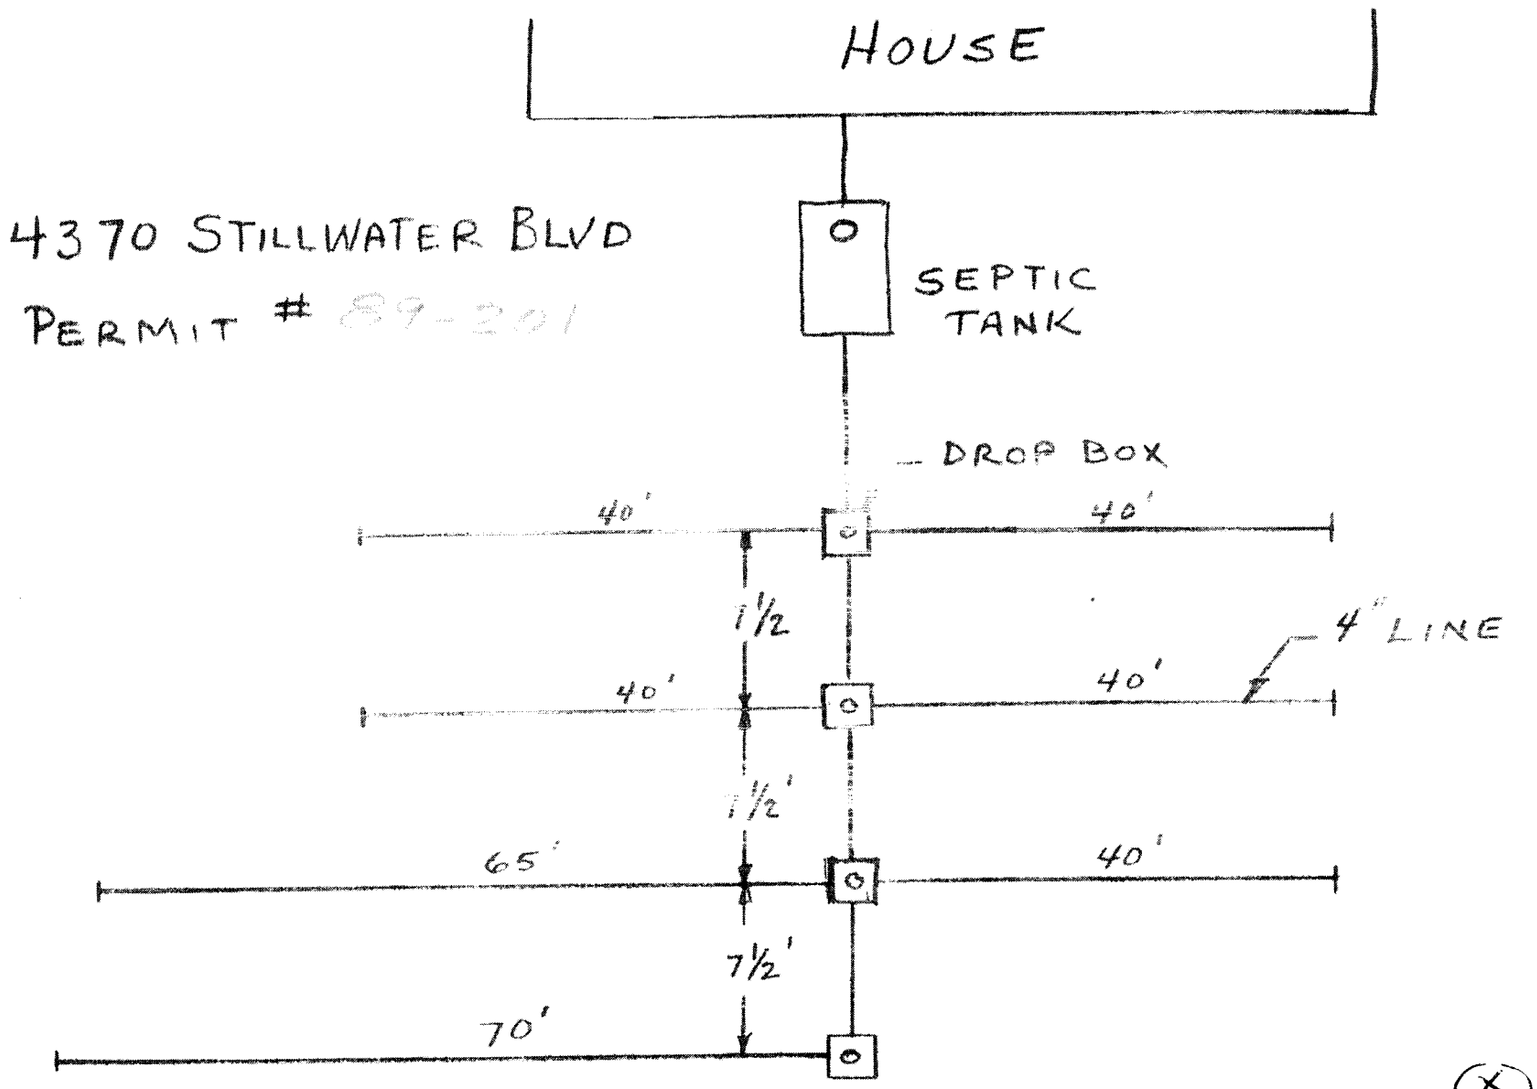
HOUSE
4370 STILLWATER BLVD
PERMIT # 89-201
SEPTIC TANK
DROP BOX
40'
40'
1½
4" LINE
40'
40'
1½'
65'
40'
7½'
70'

(X)
B-1
6-29-23
