Midwest Sewer Services

SUBSURFACE SEWAGE TREATMENT SYSTEM (SSTS) COMPLIANCE REPORT

Date: July 12, 2023 **Time:** 12:45 PM **Owner:** Estate of Donald & Carol Magnuson

Inspection Address: 13655 Greenwood Trl N, West Lakeland, MN 55082

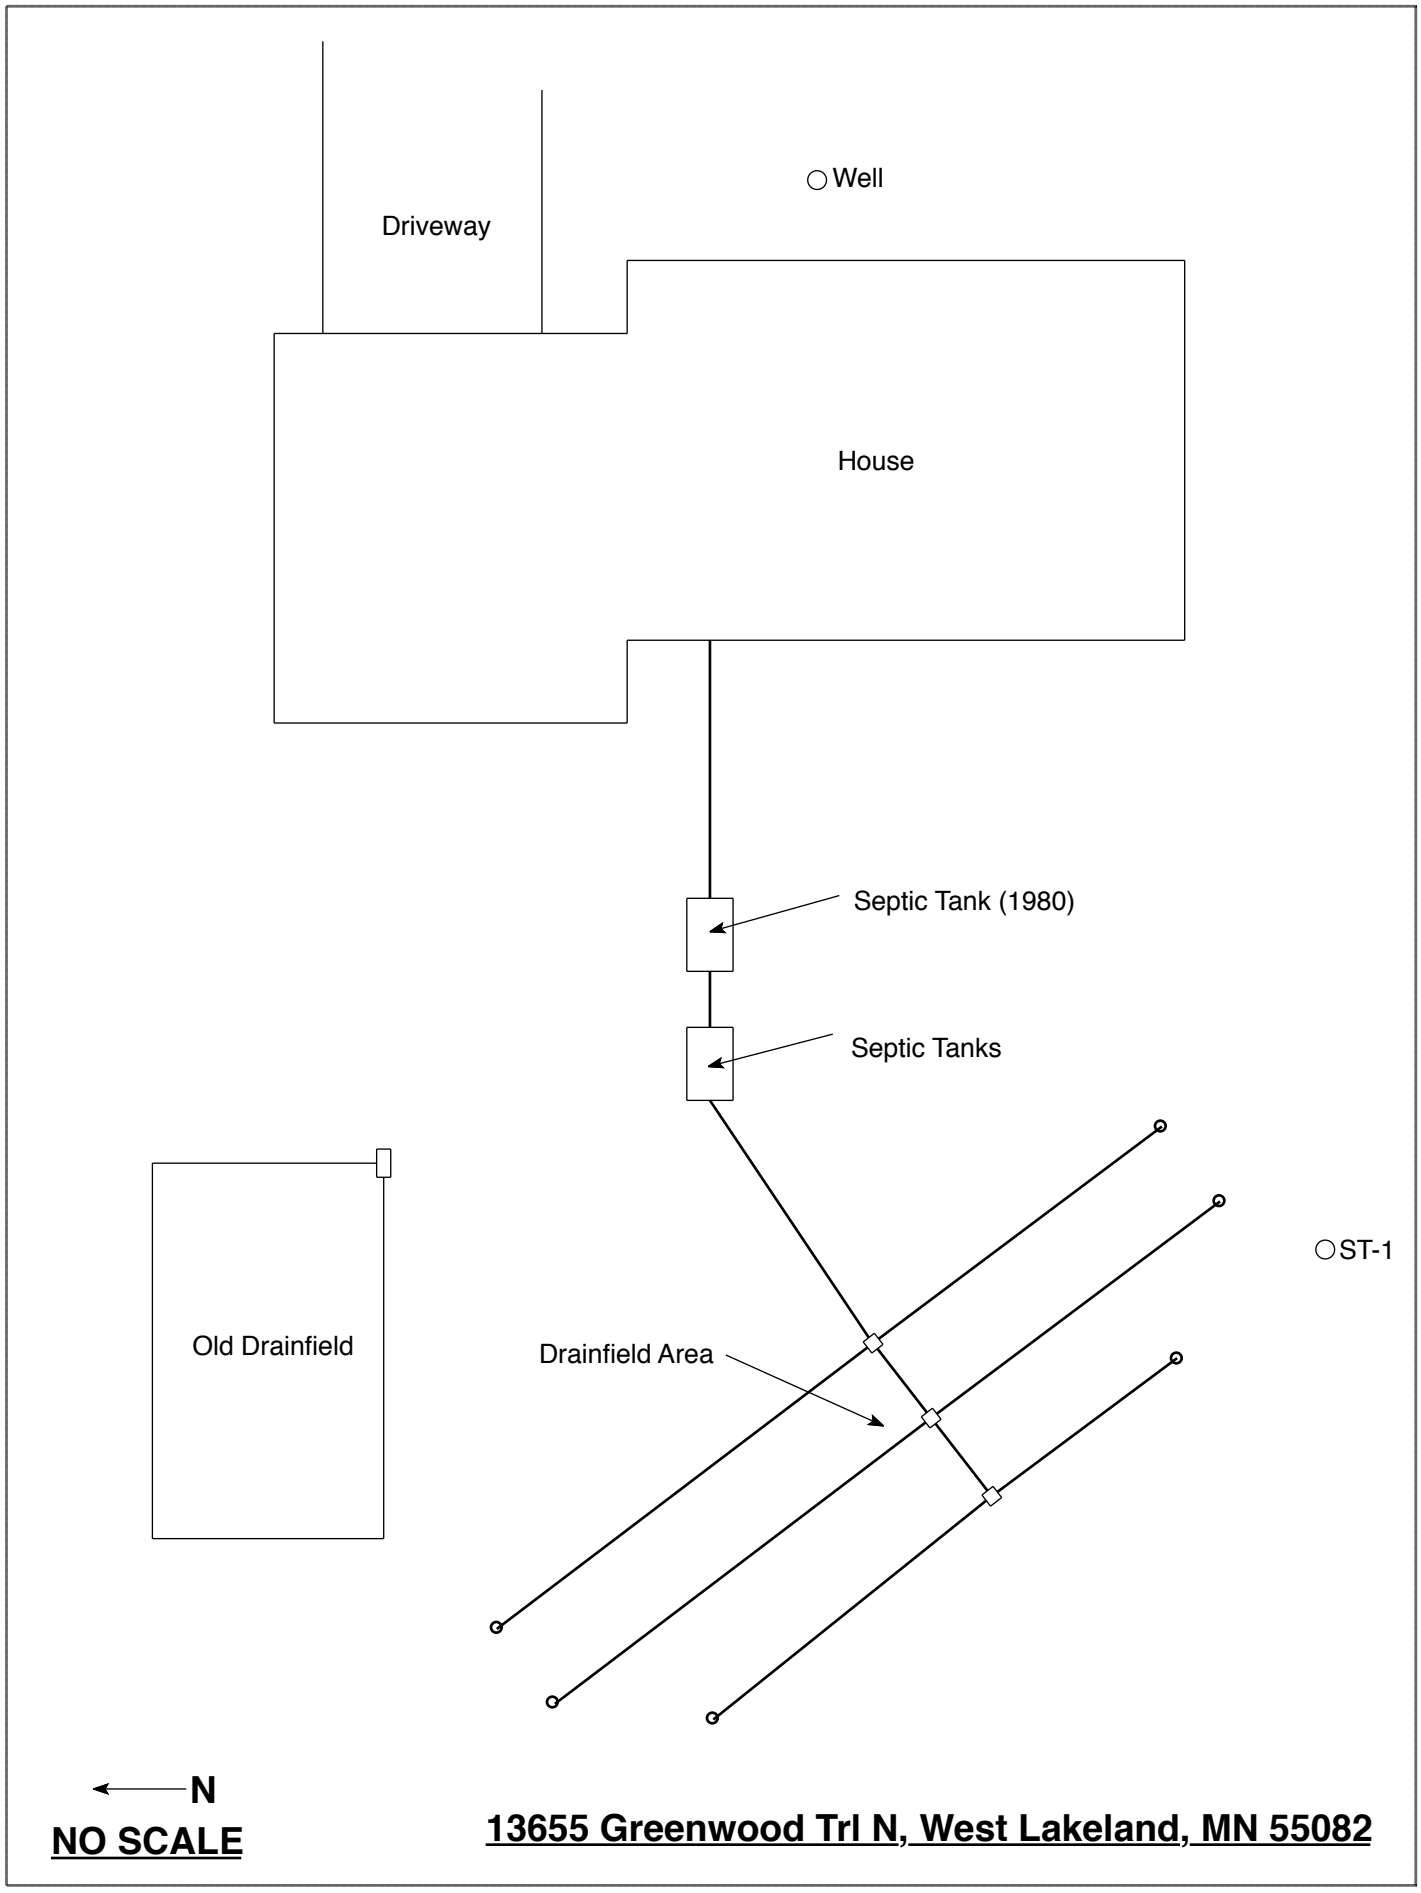
Well
Driveway
House
Septic Tank (1980)
Septic Tanks
Old Drainfield
Drainfield Area
ST-1
N
NO SCALE
13655 Greenwood Trl N, West Lakeland, MN 55082
