ZIERKE SOIL TESTING

Compliance inspection report form

Existing Subsurface Sewage Treatment System (SSTS)

Property address: 11691 Lansing Ave N Stillwater, MN 55082

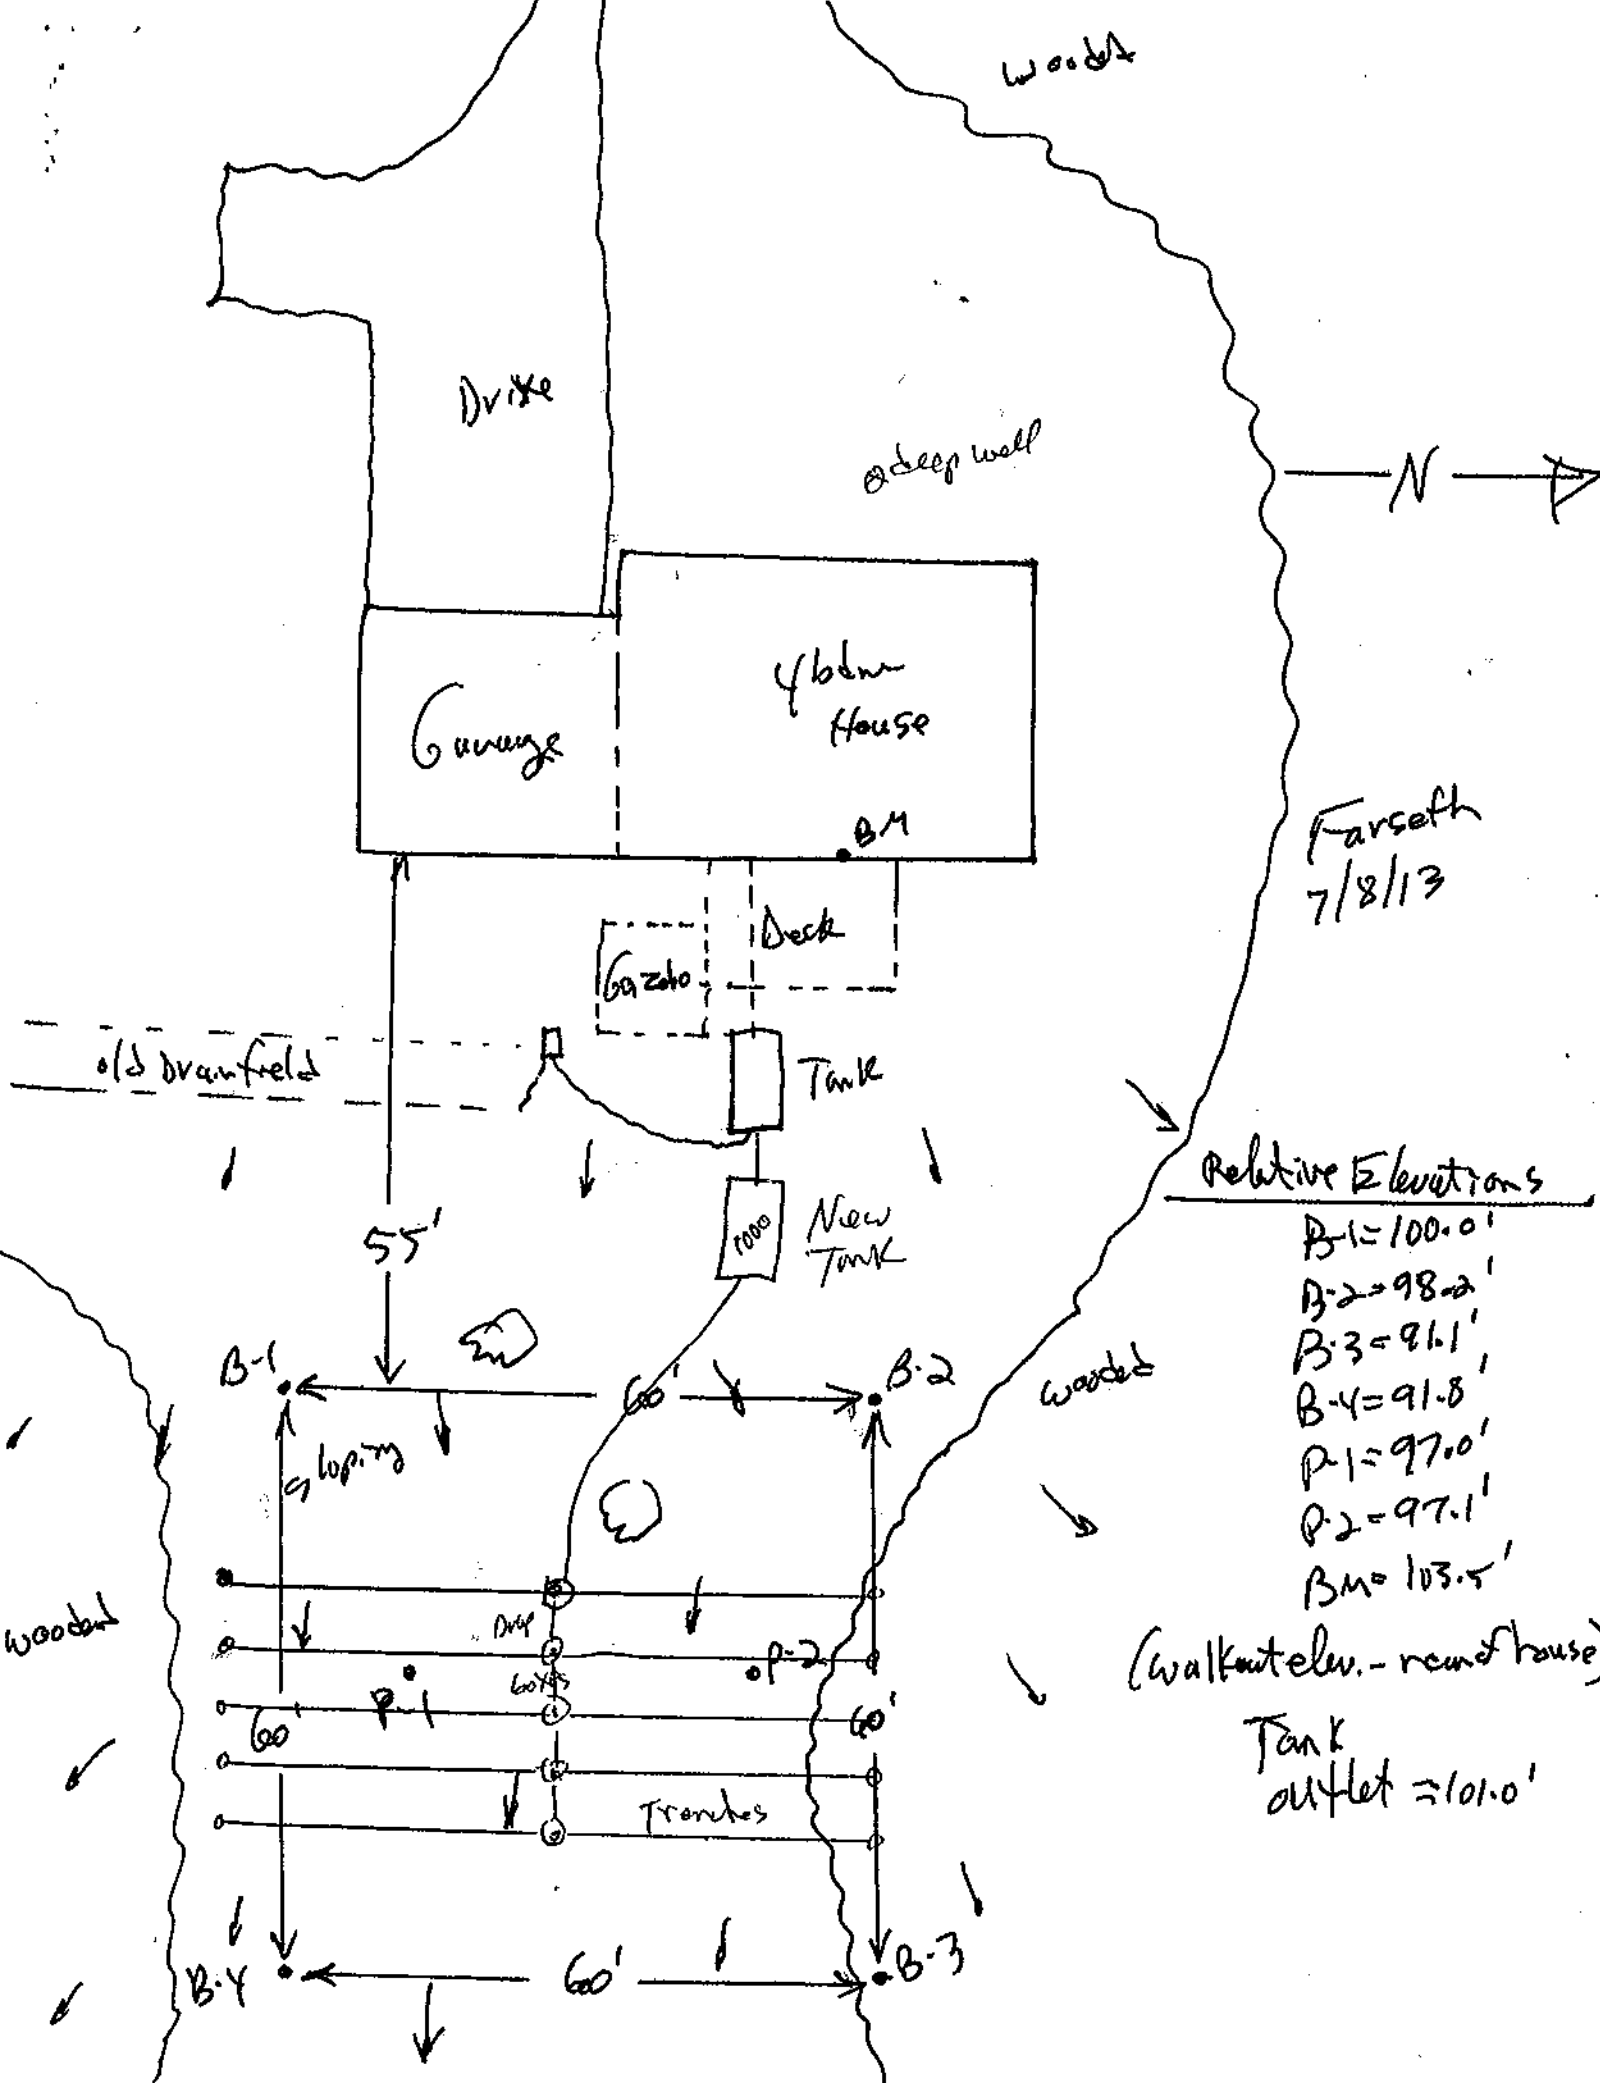
Woods
Drive
deep well
N
Garage
Ybelw House
BM
Farseth
7/8/13
Deck
6x20+6
old Drainfield
Tank
1000
New Tank
55'
B-1
60'
B-2
Grading
Relative Elevations
B-1 = 100.0'
B-2 = 98.2'
B-3 = 91.1'
B-4 = 91.8'
P-1 = 97.0'
P-2 = 97.1'
BM = 103.5'
(walkout elev. - rear of house)
Tank outlet = 101.0'
wooded
wooded
Drop
P-1
P-2
60'
60'
Trenches
B-4
60'
B-3

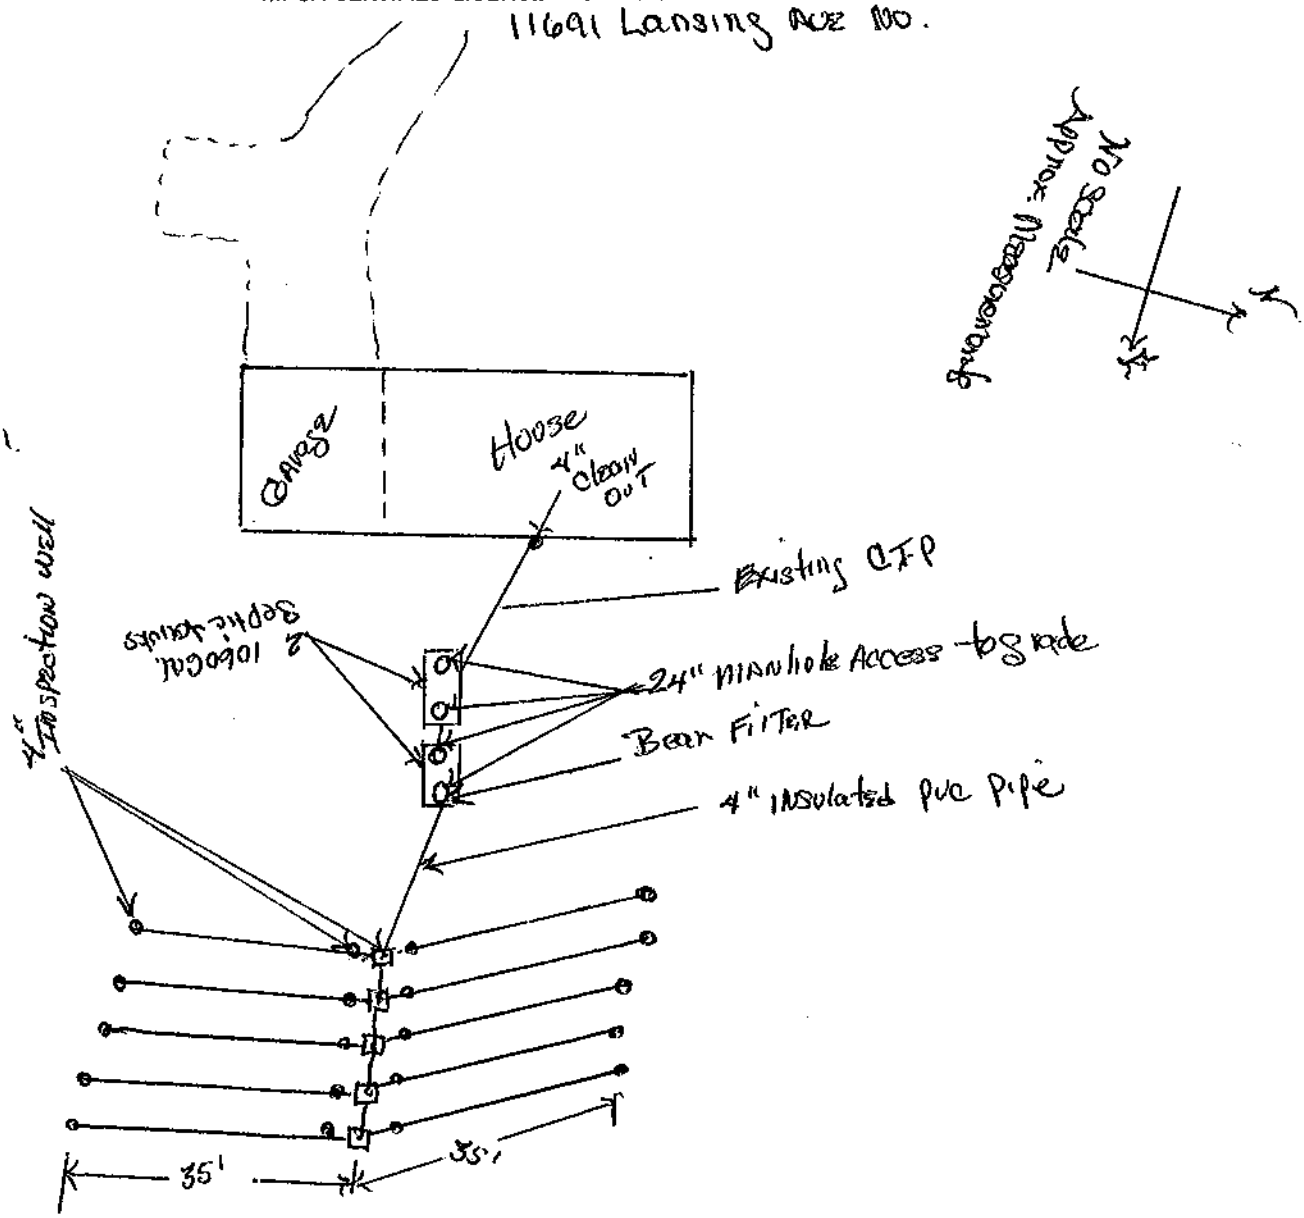
Installed 8-13-11
C&B Excavating & Sewer Inc
-two 1060 Gal. Septic tanks in Series
1. Bear Filter IN Outlet OF 2ND tank
30' Insulated pvc
Chambers (Hi-cap) drop boxes/Inspection wells
