SUBSURFACE SEWAGE TREATMENT SYSTEM (SSTS) COMPLIANCE REPORT

Date: March 12, 2024 **Time:** 1:45 PM **Owner:** Charity Olson & Josh Olson

Inspection Address: 2100 Paris Ave N, West Lakeland, MN 55082

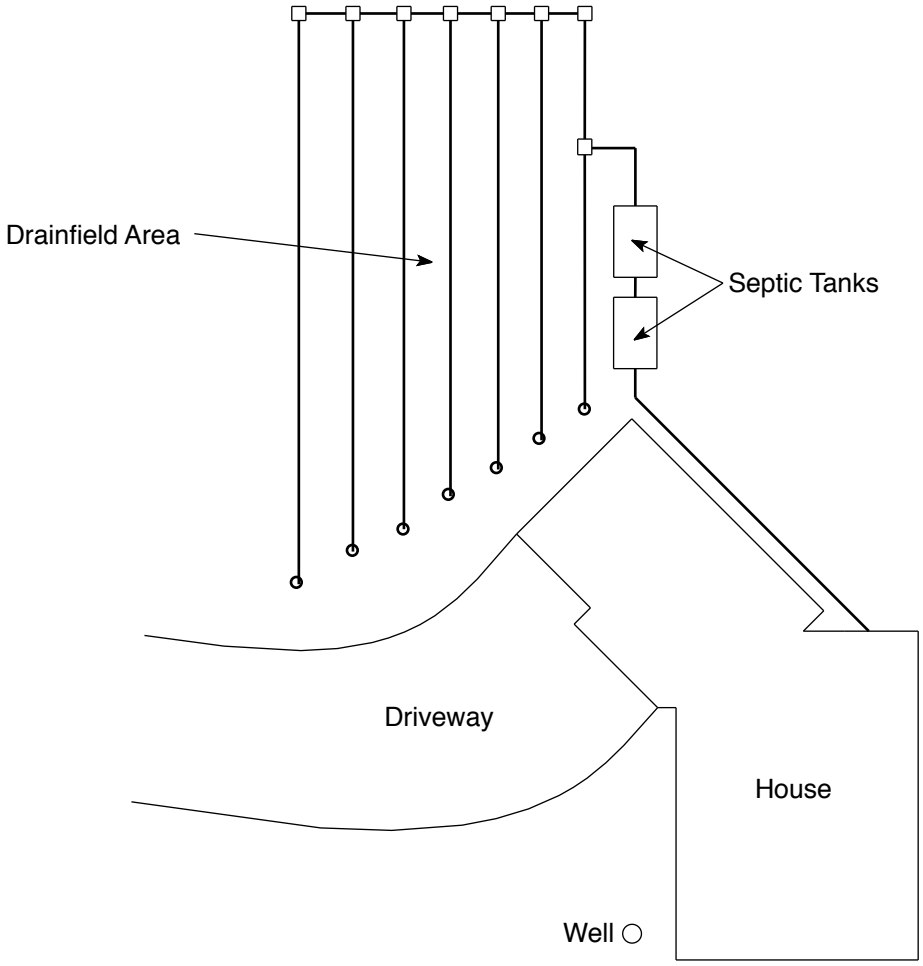
2100 Paris Ave N, West Lakeland, MN 55082
