Compliance inspection report form

Existing Subsurface Sewage Treatment System (SSTS)

Property address: 12744 150th St N May Twp, MN 55047

System status on date (mm/dd/yyyy): 4/25/2024

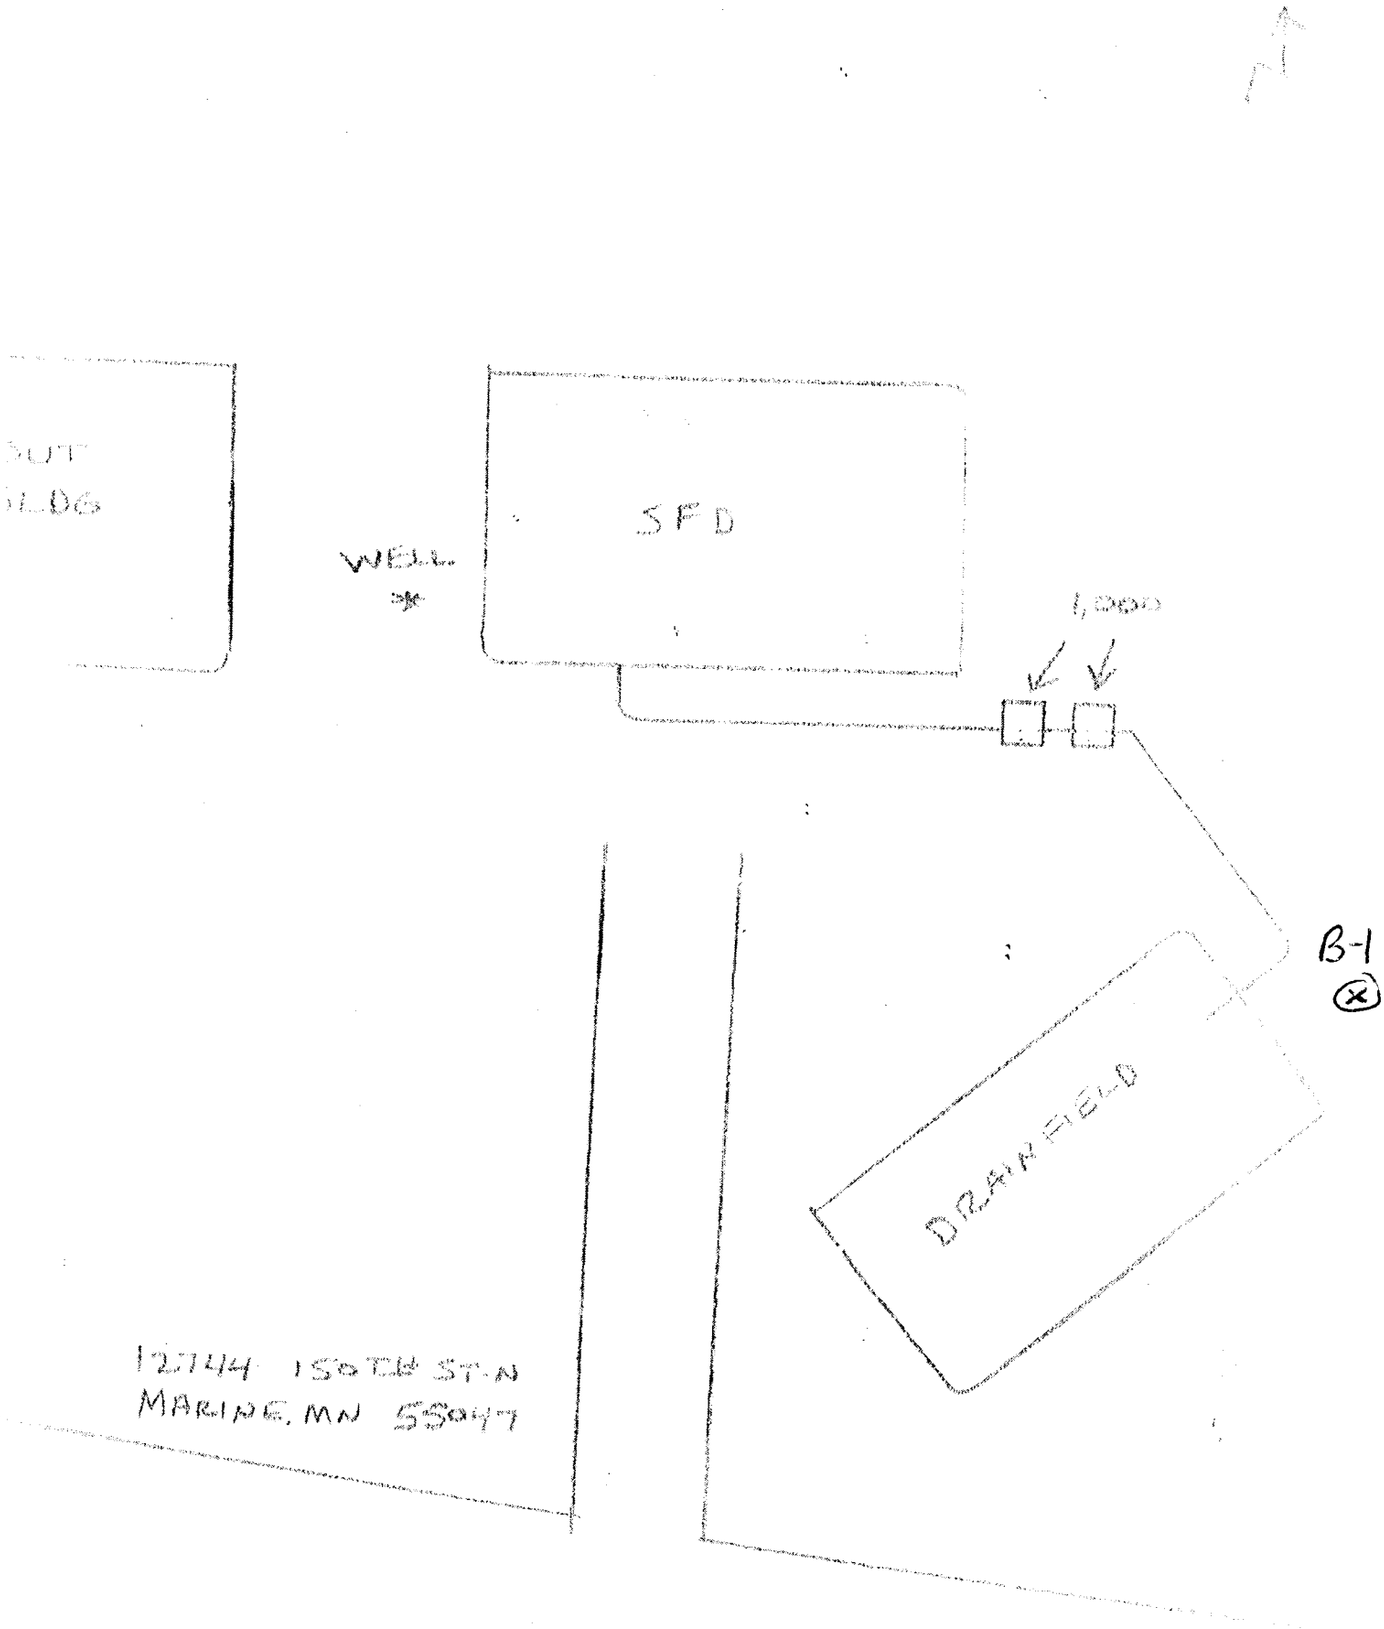
N
SFD
WELL
1,000
B-1
DRAIN FIELD
12744 150TH ST N
MARINE, MN 55047
