Midwest Sewer Services

SUBSURFACE SEWAGE TREATMENT SYSTEM (SSTS) COMPLIANCE REPORT

Inspection Address: 12665 10th St S, Afton, MN 55001

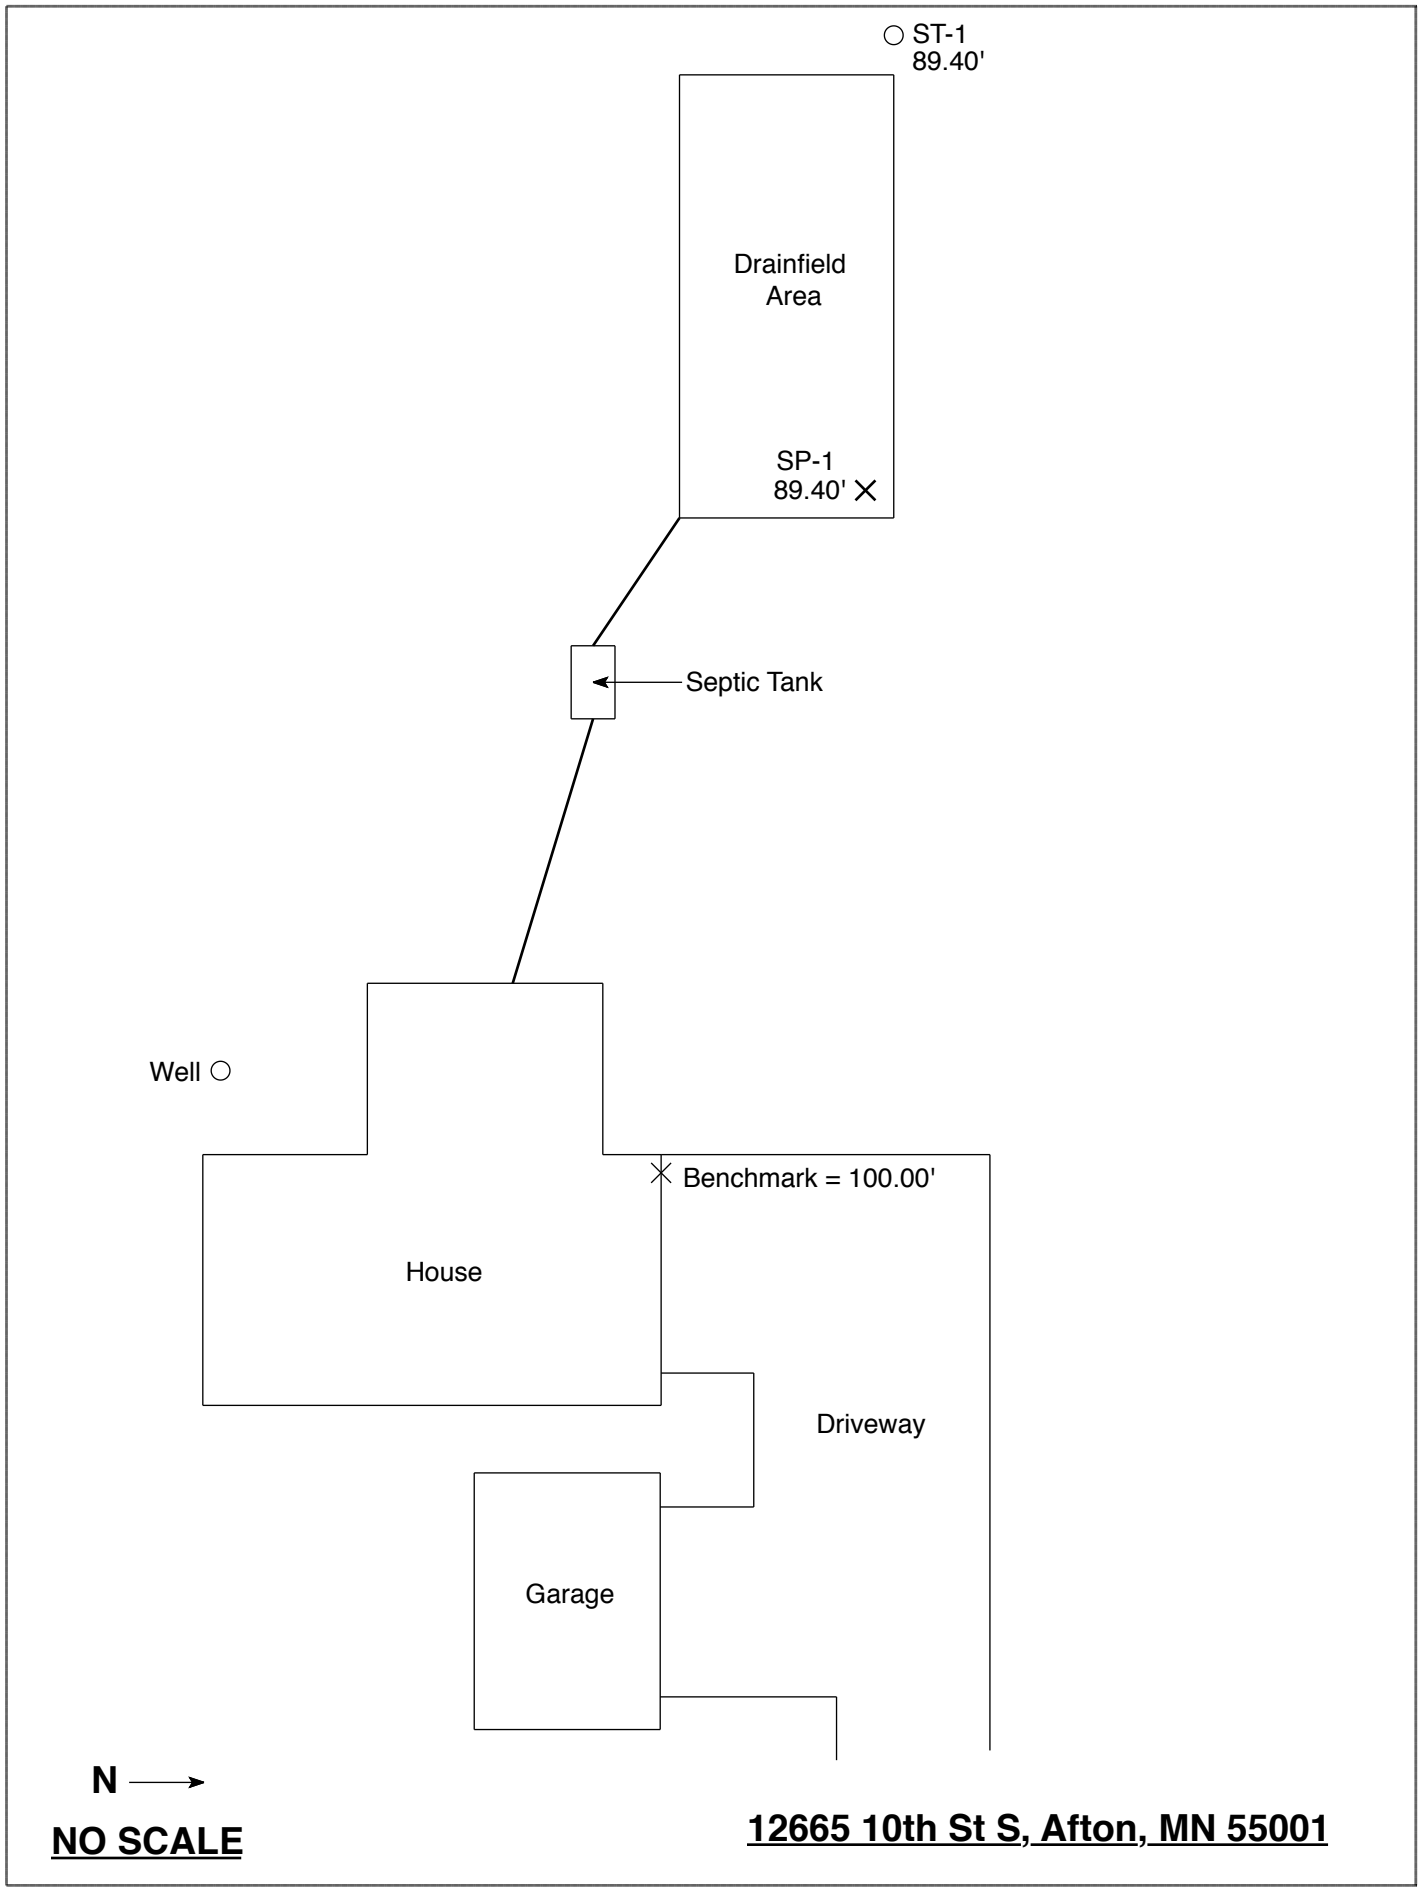
ST-1
89.40'
Drainfield
Area
SP-1
89.40'
Septic Tank
Well
Benchmark = 100.00'
House
Driveway
Garage
N
NO SCALE
12665 10th St S, Afton, MN 55001
