ZIERKE SOIL TESTING

Compliance inspection report form

Existing Subsurface Sewage Treatment System (SSTS)

Property address: 5730 Roscoe Rd Oakdale, MN 55128

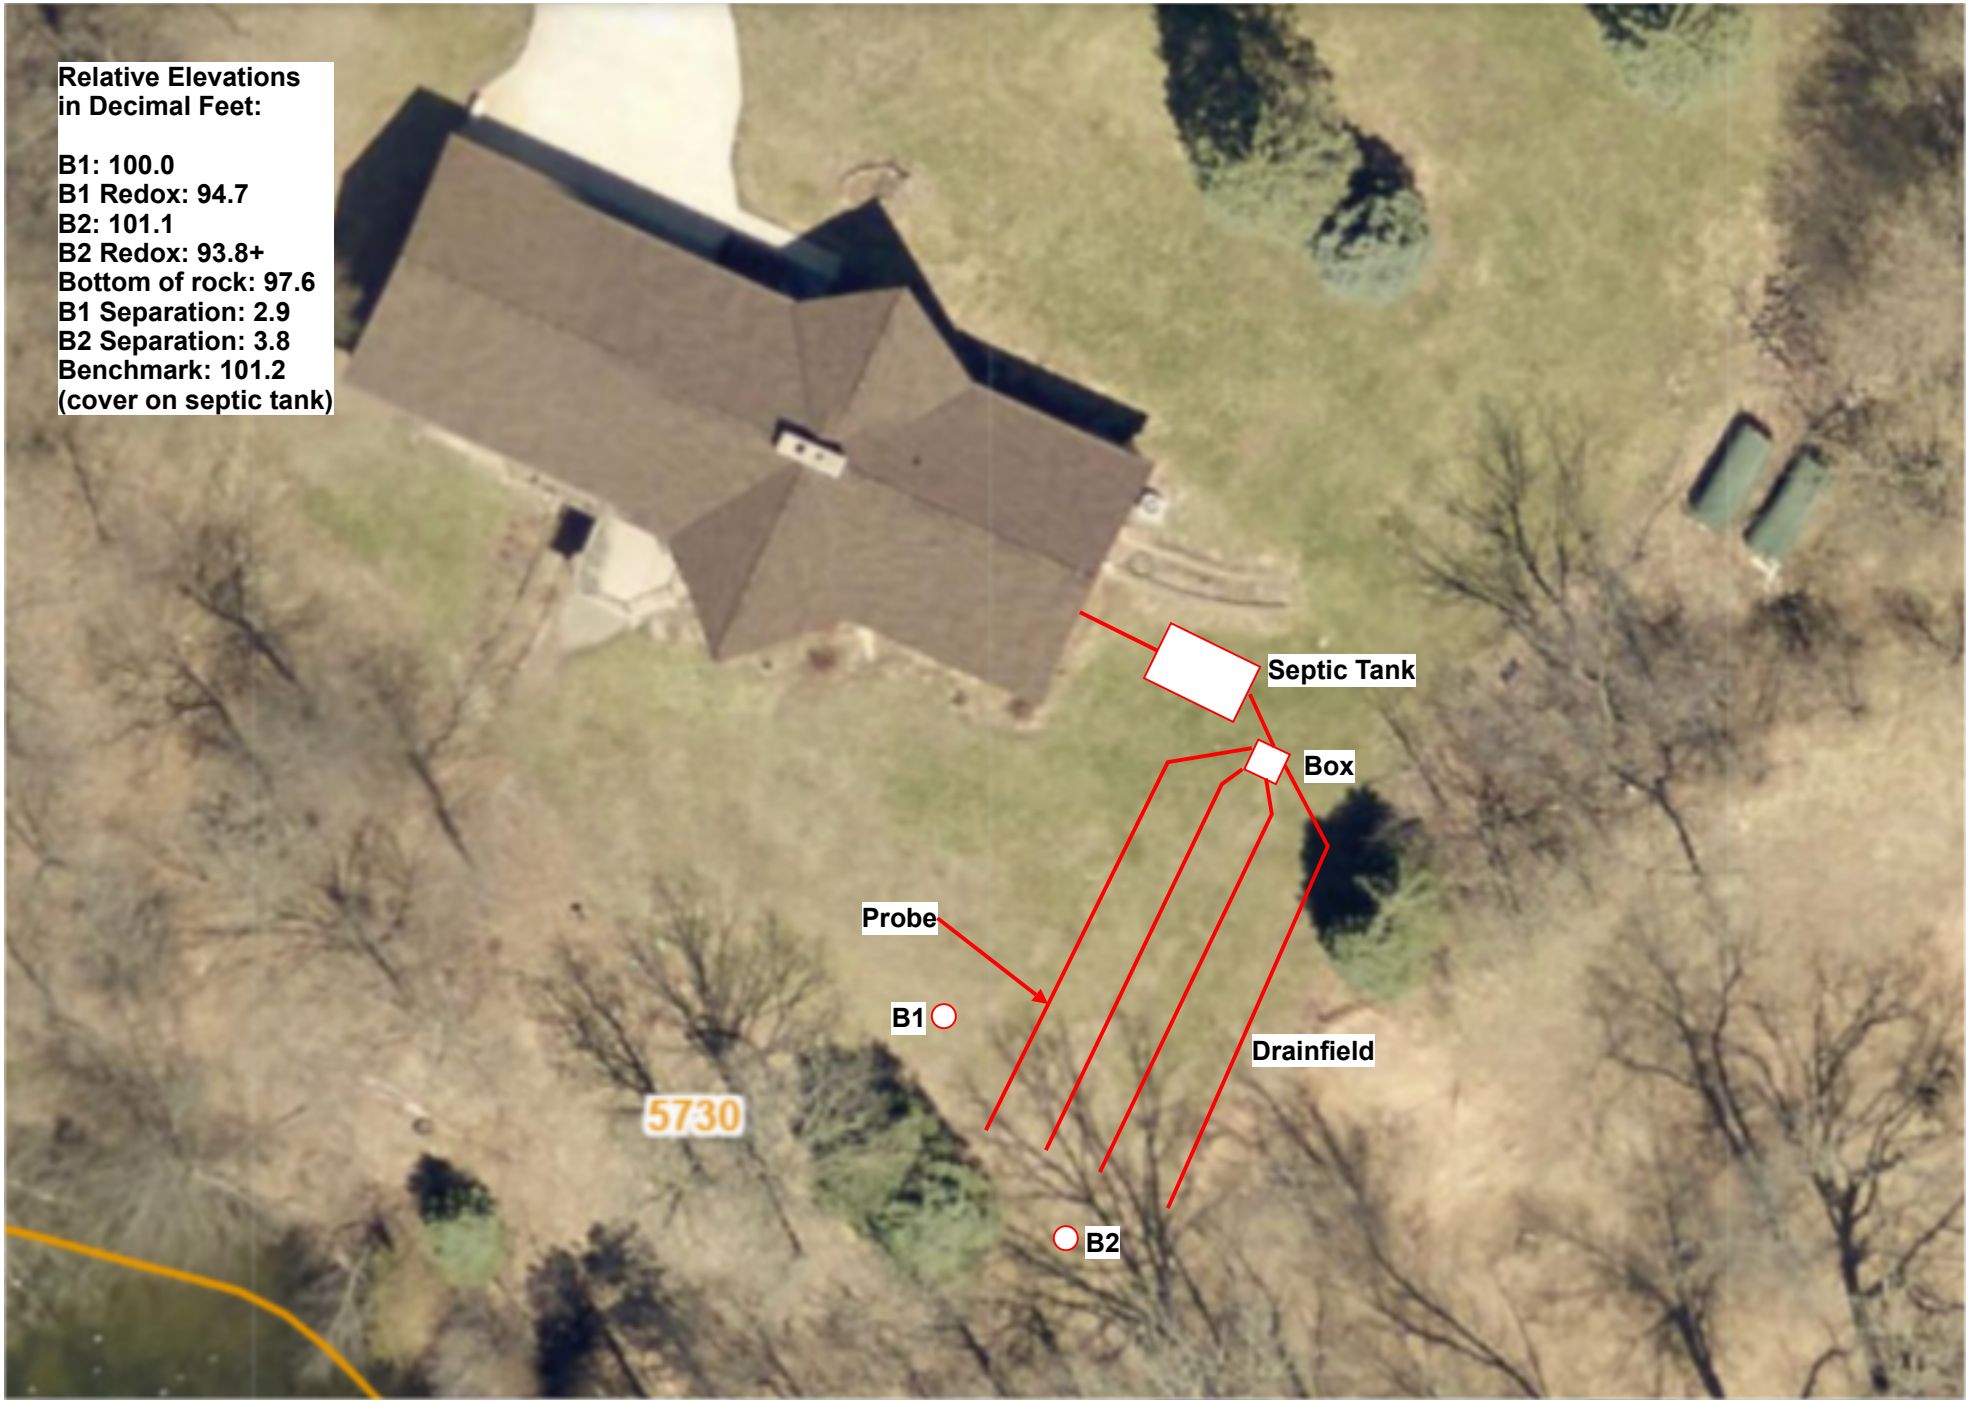
A. Bottom of distribution media	97.6'
B. Periodically saturated soil/bedrock	94.7'-93.8'
C. System separation	2.9'-3.8'
D. Required compliance separation*	3.0'

Relative Elevations
in Decimal Feet:
B1: 100.0
B1 Redox: 94.7
B2: 101.1
B2 Redox: 93.8+
Bottom of rock: 97.6
B1 Separation: 2.9
B2 Separation: 3.8
Benchmark: 101.2
(cover on septic tank)
Septic Tank
Box
Probe
B1
Drainfield
5730
B2
