**SUBSURFACE SEWAGE TREATMENT SYSTEM (SSTS) COMPLIANCE REPORT**

**Date:** September 4, 2024 **Time:** 12:15 PM **Owner:** Pam Helgeson

**Inspection Address:** 7656 128th St N, Hugo, MN 55110

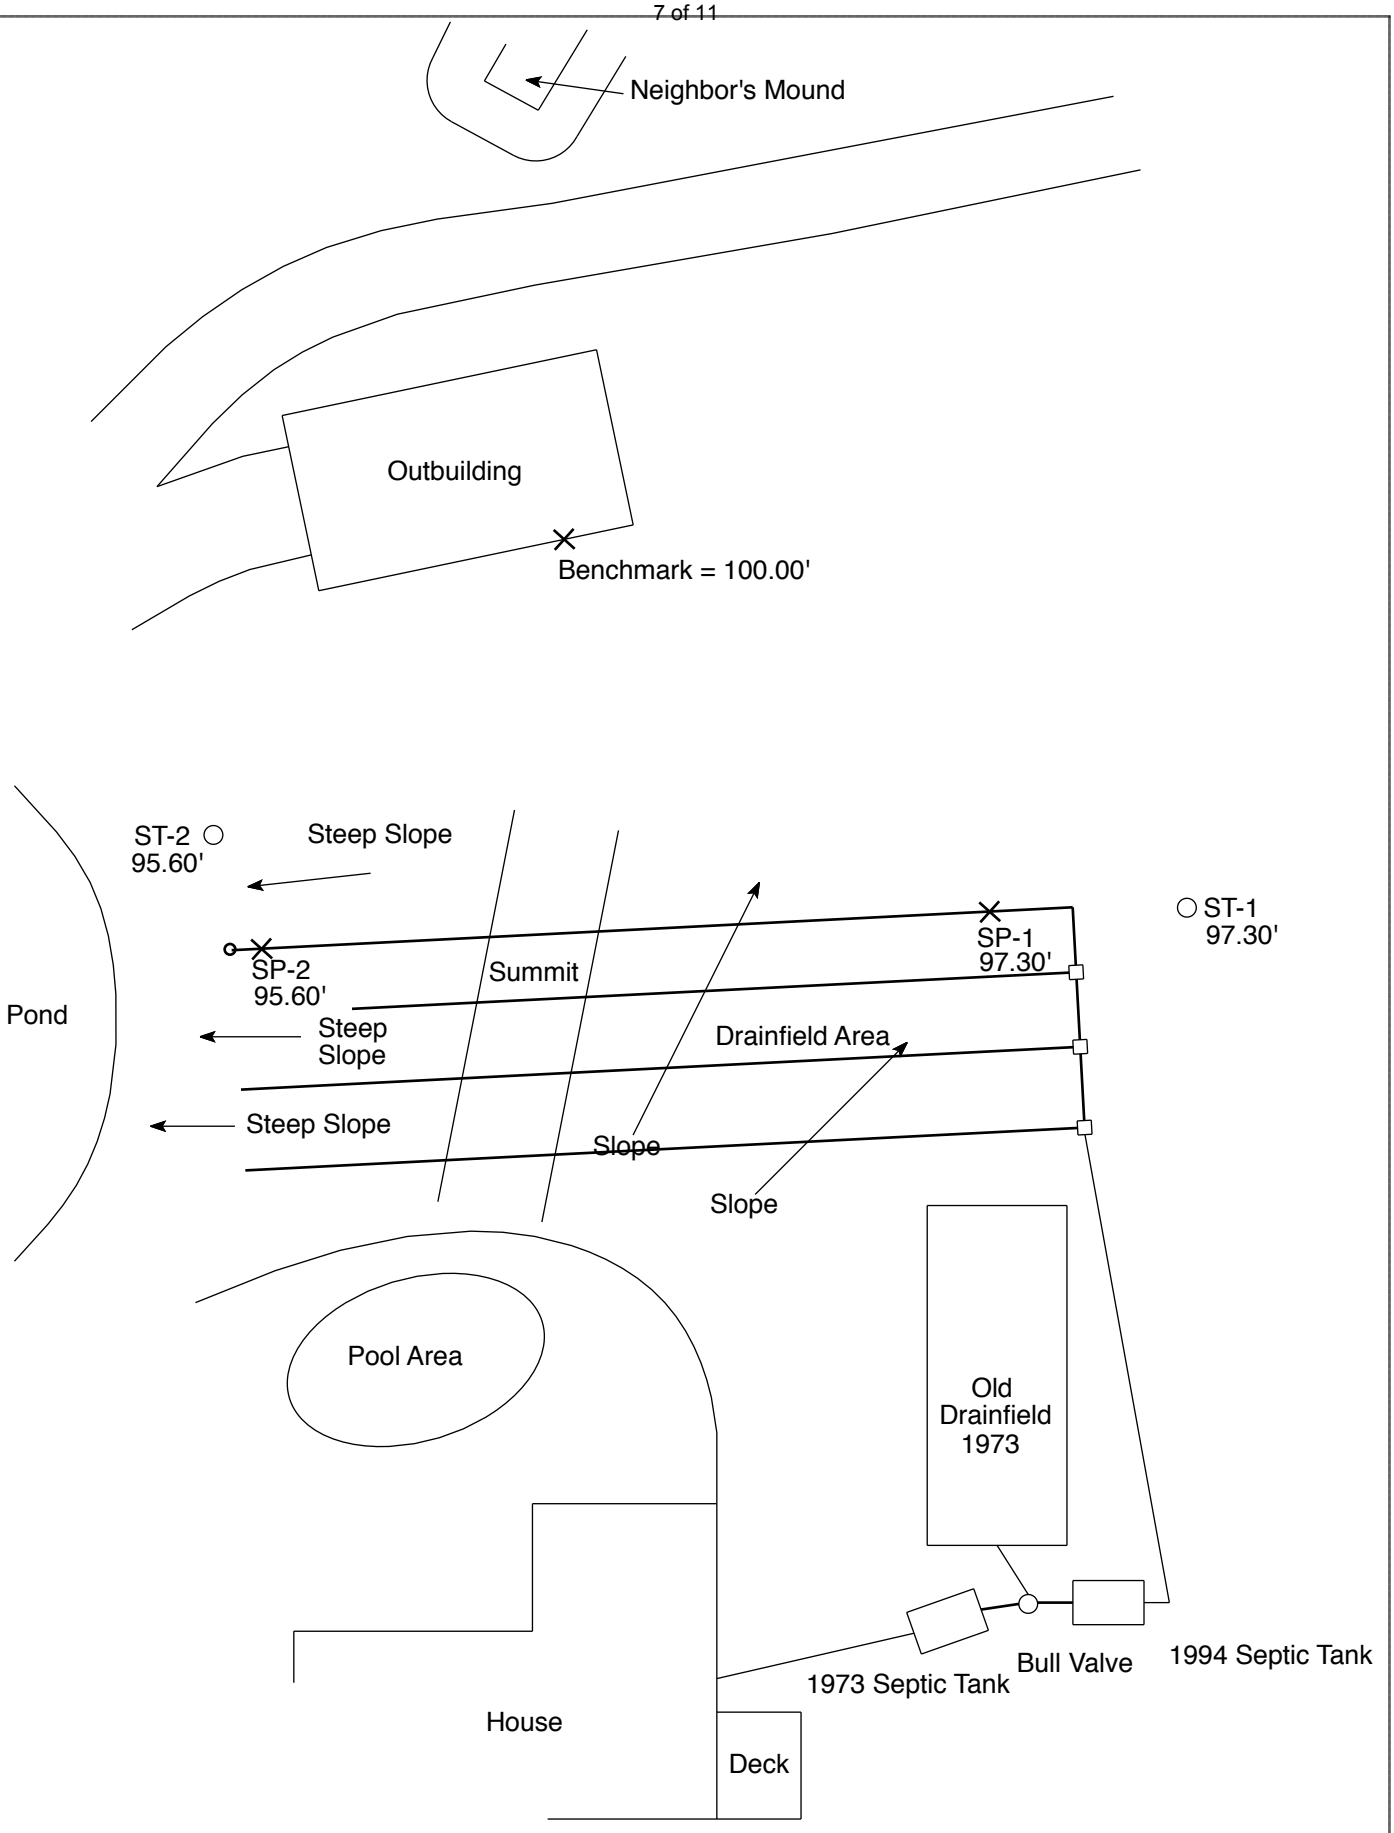
**7656 128th St N, Hugo, MN 55110**

A "bull valve" allows the flow to be directed to one or both of the drainfields. I believe the valve is currently set to allow flow to the 1994 drainfield. The 1973 drainfield would not have the required three-foot separation.

My inspection indicates that this system is presently "non-compliant" in accordance with MPCA rules 7080.1500 Subp.4(B)(D) because of the lack of the required three foot separation between the bottom of the drainfield and seasonally saturated soils.
