Midwest Sewer Services

SUBSURFACE SEWAGE TREATMENT SYSTEM (SSTS) COMPLIANCE REPORT

Inspection Address: 39 Oakridge Dr, Newport, MN 55055

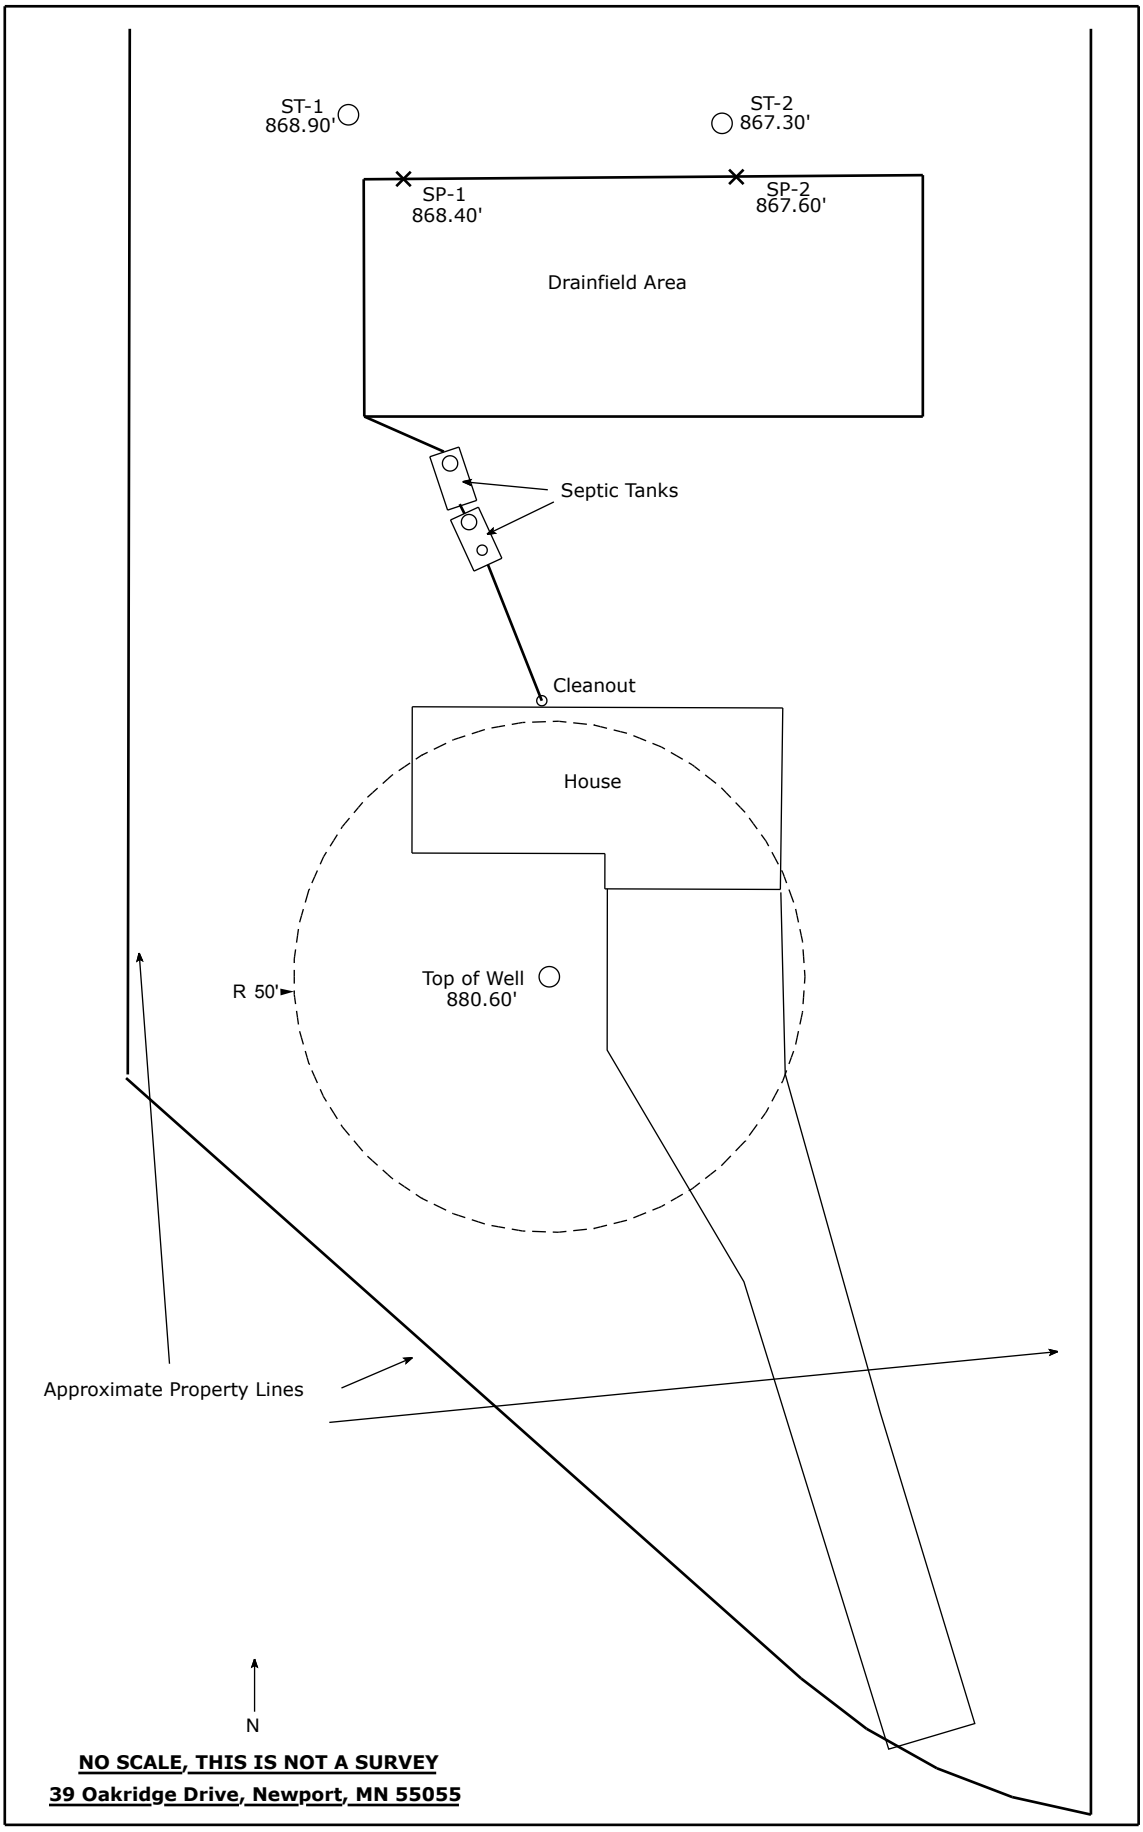
My inspection indicates that this system is presently "non-compliant" in accordance with MPCA rules 7080.1500 Subp.4(B)(E) because of the lack of the required two foot separation between the bottom of the drainfield and seasonally saturated soils.

ST-1
868.90'
ST-2
867.30'
SP-1
868.40'
SP-2
867.60'
Drainfield Area
Septic Tanks
Cleanout
House
Top of Well
880.60'
R 50'
Approximate Property Lines
N
NO SCALE, THIS IS NOT A SURVEY
39 Oakridge Drive, Newport, MN 55055
