SUBSURFACE SEWAGE TREATMENT SYSTEM COMPLIANCE REPORT

Date: October 19, 2016 **Time:** 10:30 AM **Owner:** Mary Blickenderfer

Inspection Address: 125 Lakeland Shores Rd N, Lakeland Shores, MN 55043

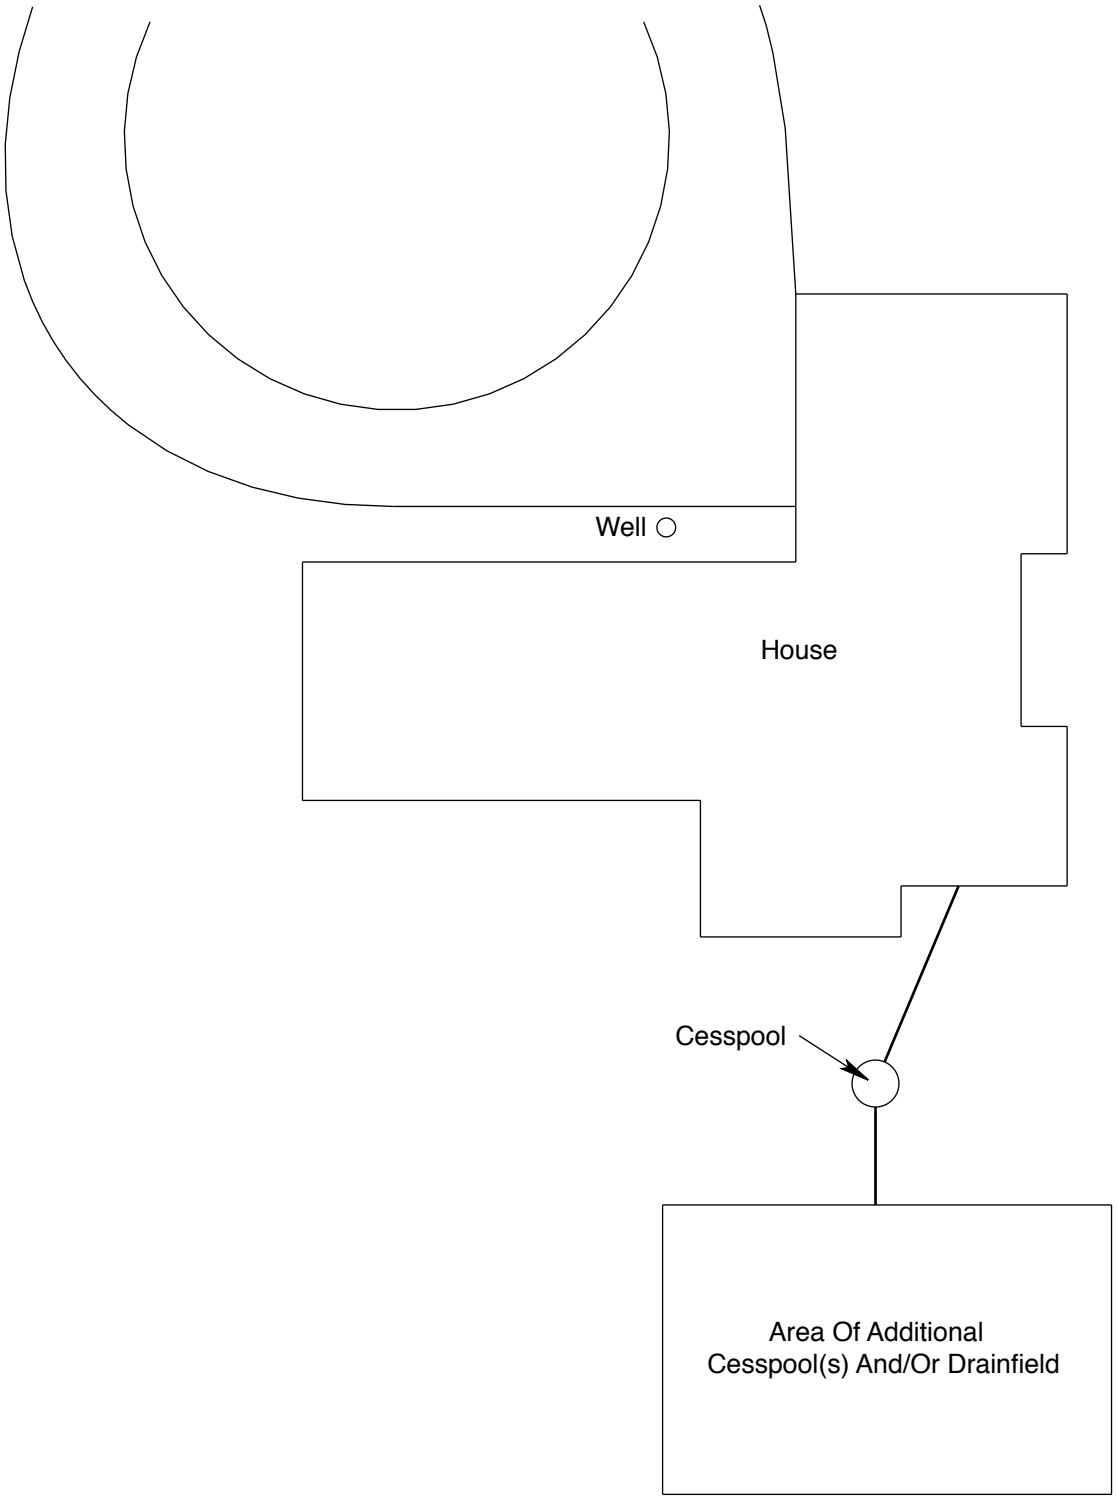
125 Lakeland Shores Rd N, Lakeland Shores, MN 55043

I have performed an "MPCA Compliance Inspection" on this septic system. I contacted Washington County and was advised that there are no records for this system. This very old system (installed in approximately 1959) consists of cesspool. Additional cesspool(s) and/or a drainfield may exist beyond the first cesspool. This house is presently vacant.
