SUBSURFACE SEWAGE TREATMENT SYSTEM COMPLIANCE REPORT

Date: December 12, 2016 **Time:** 10:00 AM **Owner:** Jeremy Schwieger

Inspection Address: 9440 239th St N, Forest Lake, MN 55025

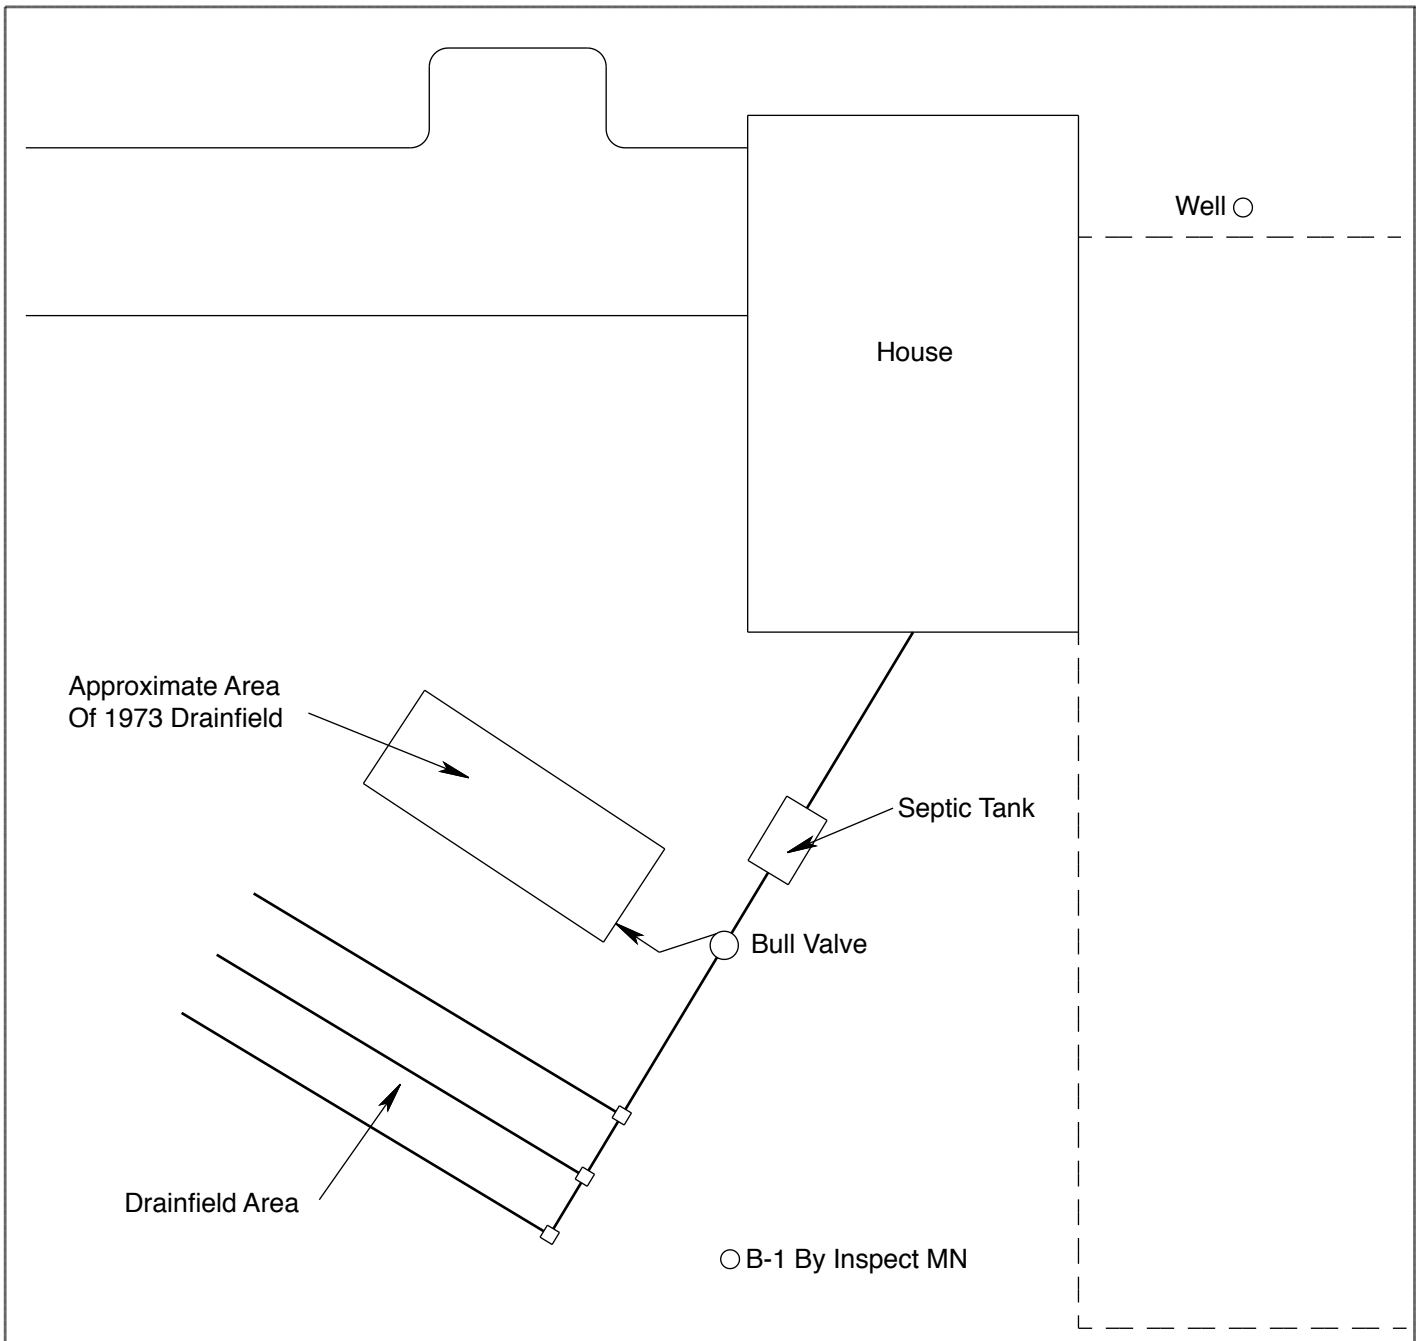
9440 239th St N, Forest Lake, MN 55025

I have performed an "MPCA Compliance Inspection" on this septic system, and have reviewed the original design/permit records, along with a previous compliance inspection from 2014, which were on file at Washington County. This very old system consists of a pre-cast septic tank, a "bull valve", and two separate rock trench drainfields (one drainfield was installed in 1973 and the other was installed 1987). The 1973 drainfield should be disconnected if the system is to remain in place.
