SUBSURFACE SEWAGE TREATMENT SYSTEM COMPLIANCE REPORT

Date: February 9, 2017 **Time:** 10:00 AM **Owner:** Judy Soukup

Inspection Address: 2856 Inwood Ave N, Lake Elmo, MN **Site Conditions:** 4" Snow 9" Frost

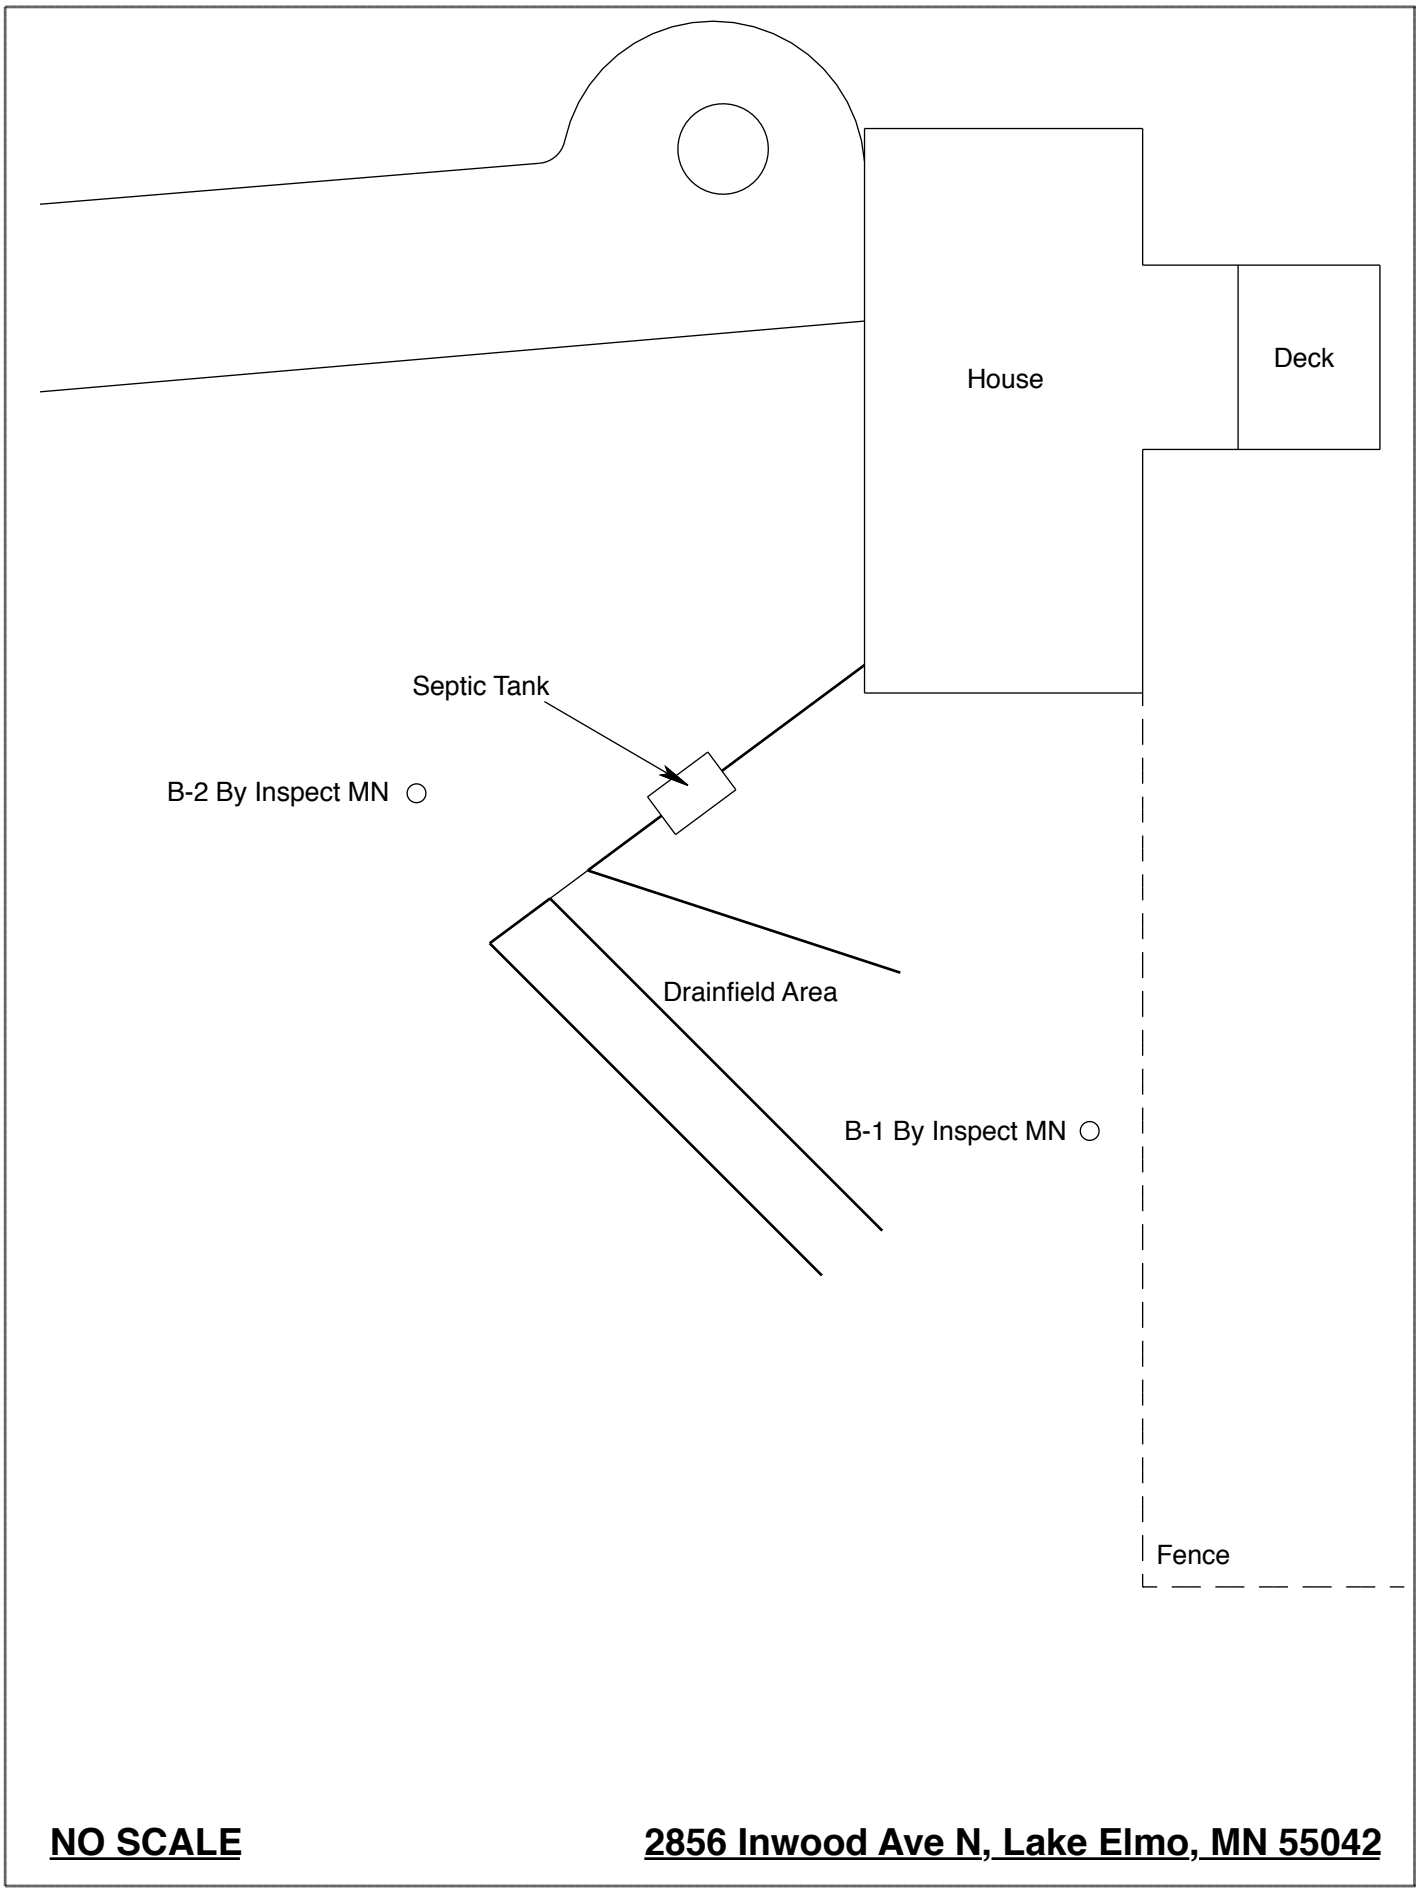
2856 Inwood Ave N, Lake Elmo, MN 55042

NO SCALE
