Inspect Minnesota & Midwest Soil Testing

SUBSURFACE SEWAGE TREATMENT SYSTEM (SSTS) COMPLIANCE REPORT

Inspection Address: 203 Quehl Ave N, Lakeland, MN 55043

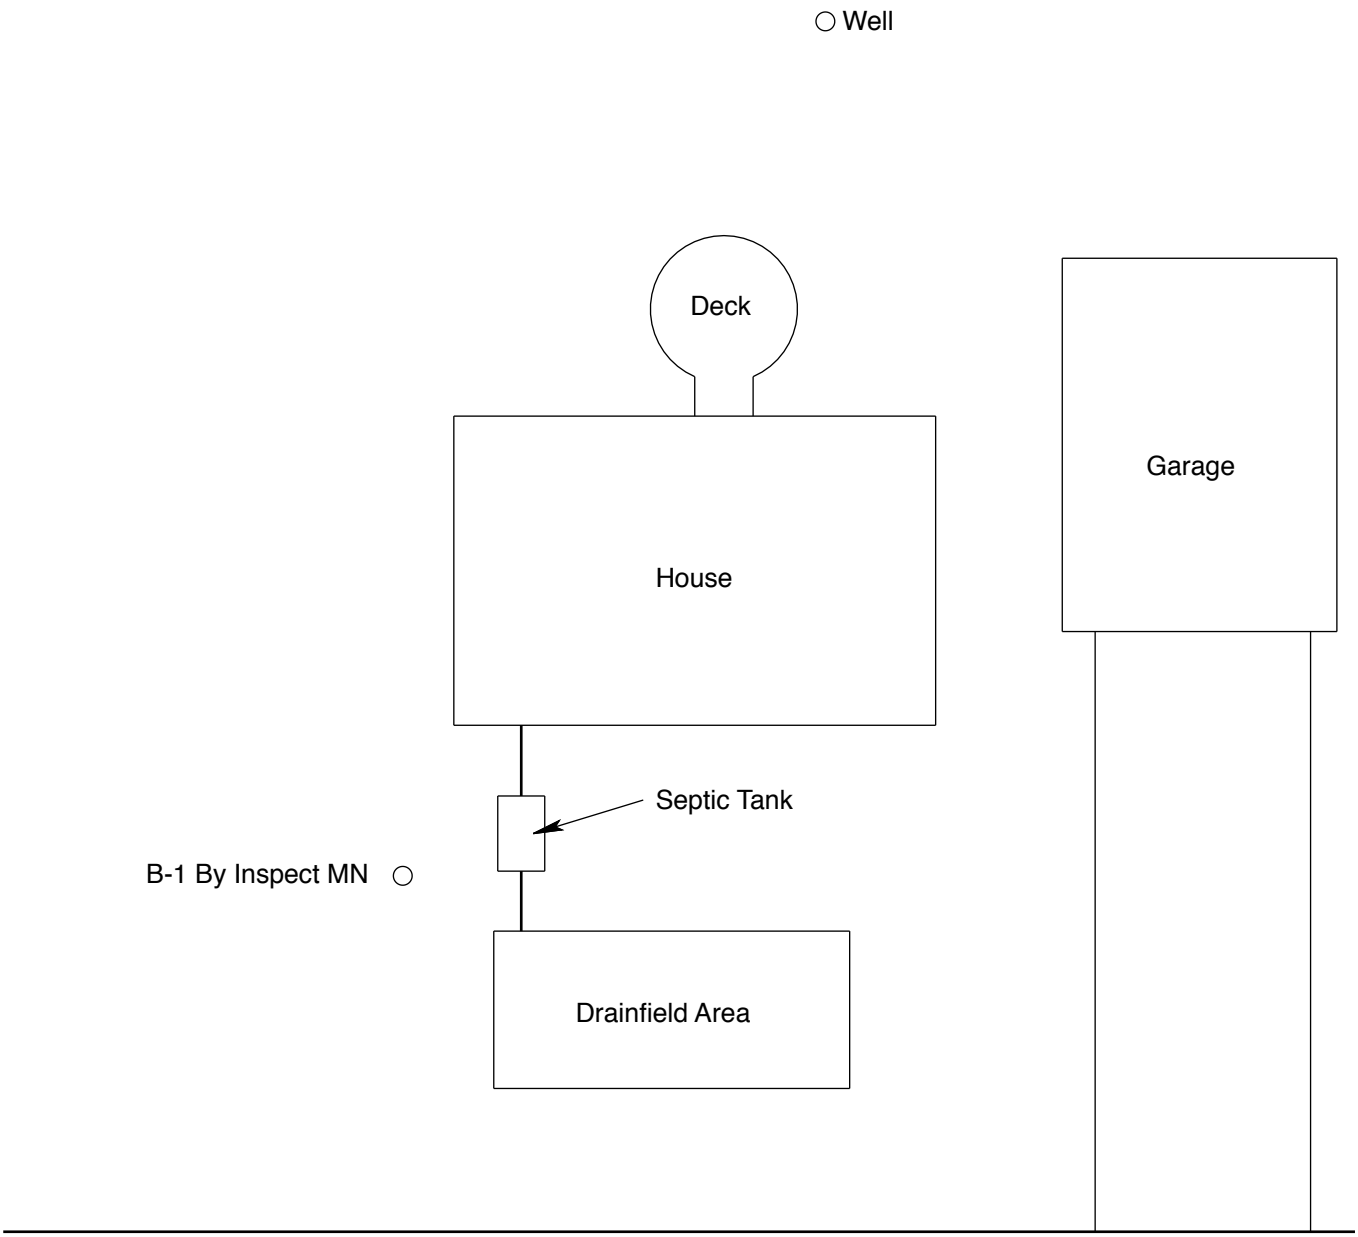
203 Quehl Ave N, Lakeland, MN 55043

Brief system description: A pre-cast septic tank and a rock trench drainfield.
