Compliance Inspection Form

Existing Subsurface Sewage Treatment Systems (SSTS)

Property address: 14676 197th St Ct N Marine on St Croix, MN 55047
Reason for inspection: Sale

Brief system description: 1500 gallon septic tank, 1000 gallon septic tank, 1000 gallon lift station, mound dispersal system

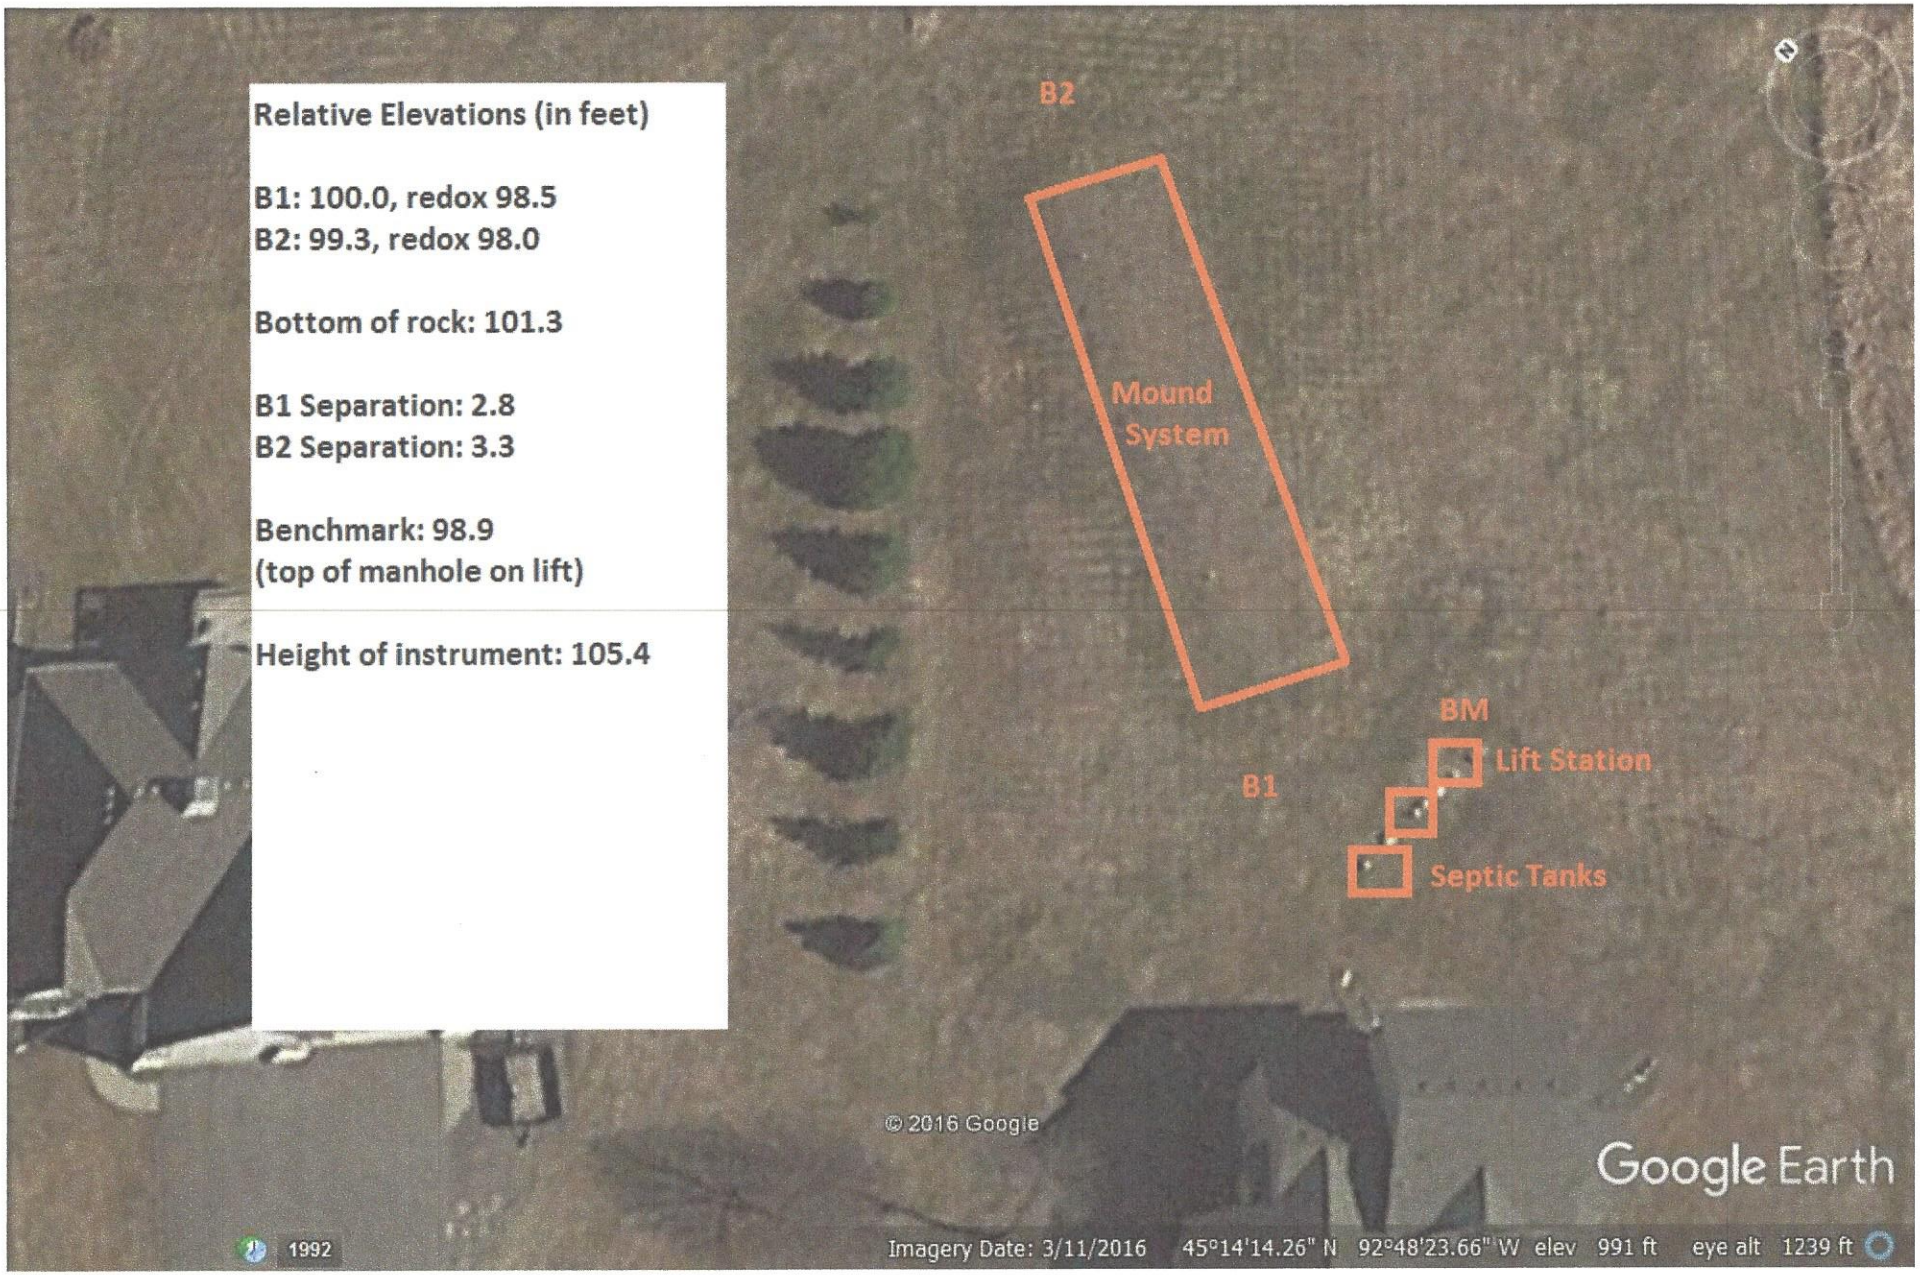
A. Bottom of distribution media	101.3
B. Periodically saturated soil/bedrock	98.5
C. System separation	2.8
D. Required compliance separation*	3.0 (2.55 with allowance)

Relative Elevations (in feet)
B1: 100.0, redox 98.5
B2: 99.3, redox 98.0
Bottom of rock: 101.3
B1 Separation: 2.8
B2 Separation: 3.3
Benchmark: 98.9
(top of manhole on lift)
Height of instrument: 105.4
B2
Mound System
BM
Lift Station
B1
Septic Tanks
© 2016 Google
Google Earth
1992
Imagery Date: 3/11/2016 45°14'14.26" N 92°48'23.66" W elev 991 ft eye alt 1239 ft
