SUBSURFACE SEWAGE TREATMENT SYSTEM (SSTS) COMPLIANCE REPORT

Date: July 24, 2017 **Time:** 9:30 AM **Owner:** Richard Polta

Inspection Address: 10421 Grey Cloud Trl S, Cottage Grove, MN 55016

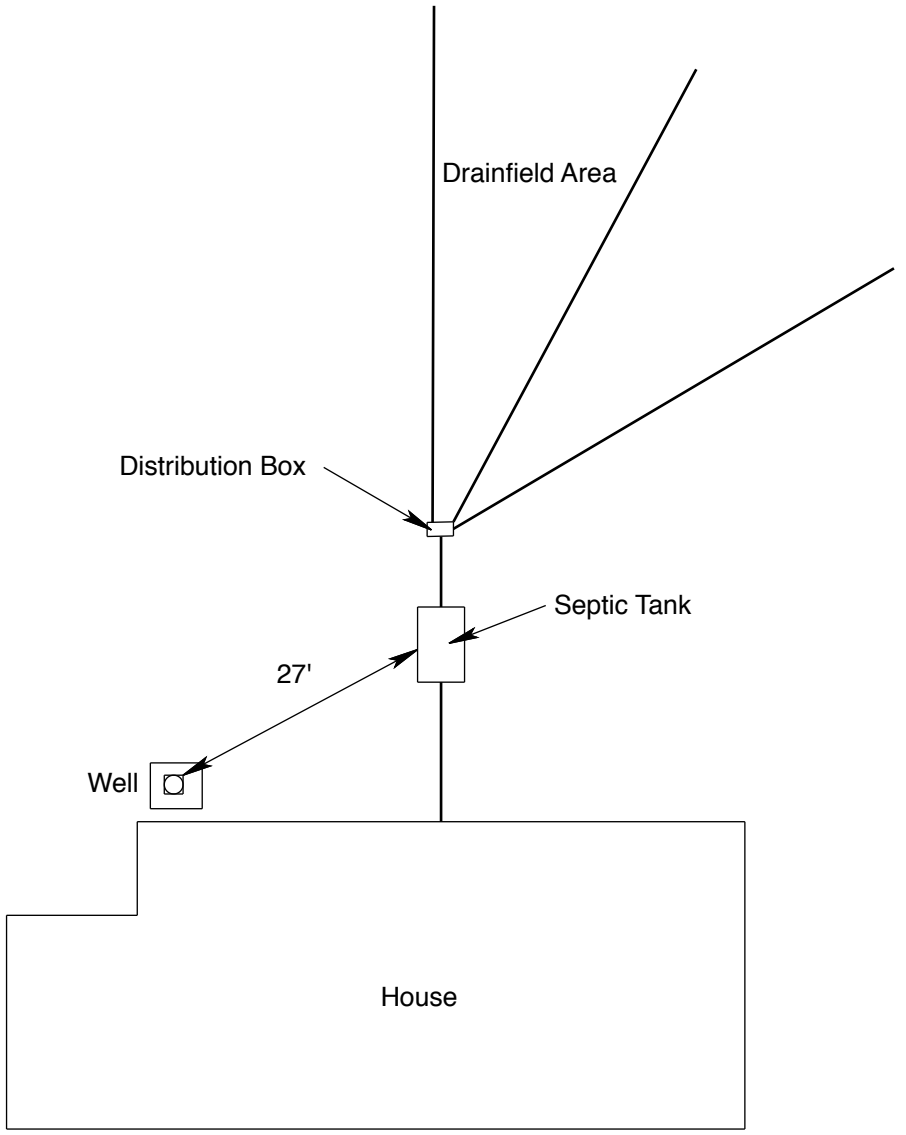
10421 Grey Cloud Trl S, Cottage Grove, MN 55016

Although not compliance criteria, it should be noted the septic tank does not meet the 50 foot set-back to the deep well.

○ B-1 By Inspect MN
