Inspect Minnesota & Midwest Soil Testing

SUBSURFACE SEWAGE TREATMENT SYSTEM (SSTS) COMPLIANCE REPORT

Inspection Address: 4210 Penfield Ave S, Afton, MN 55001

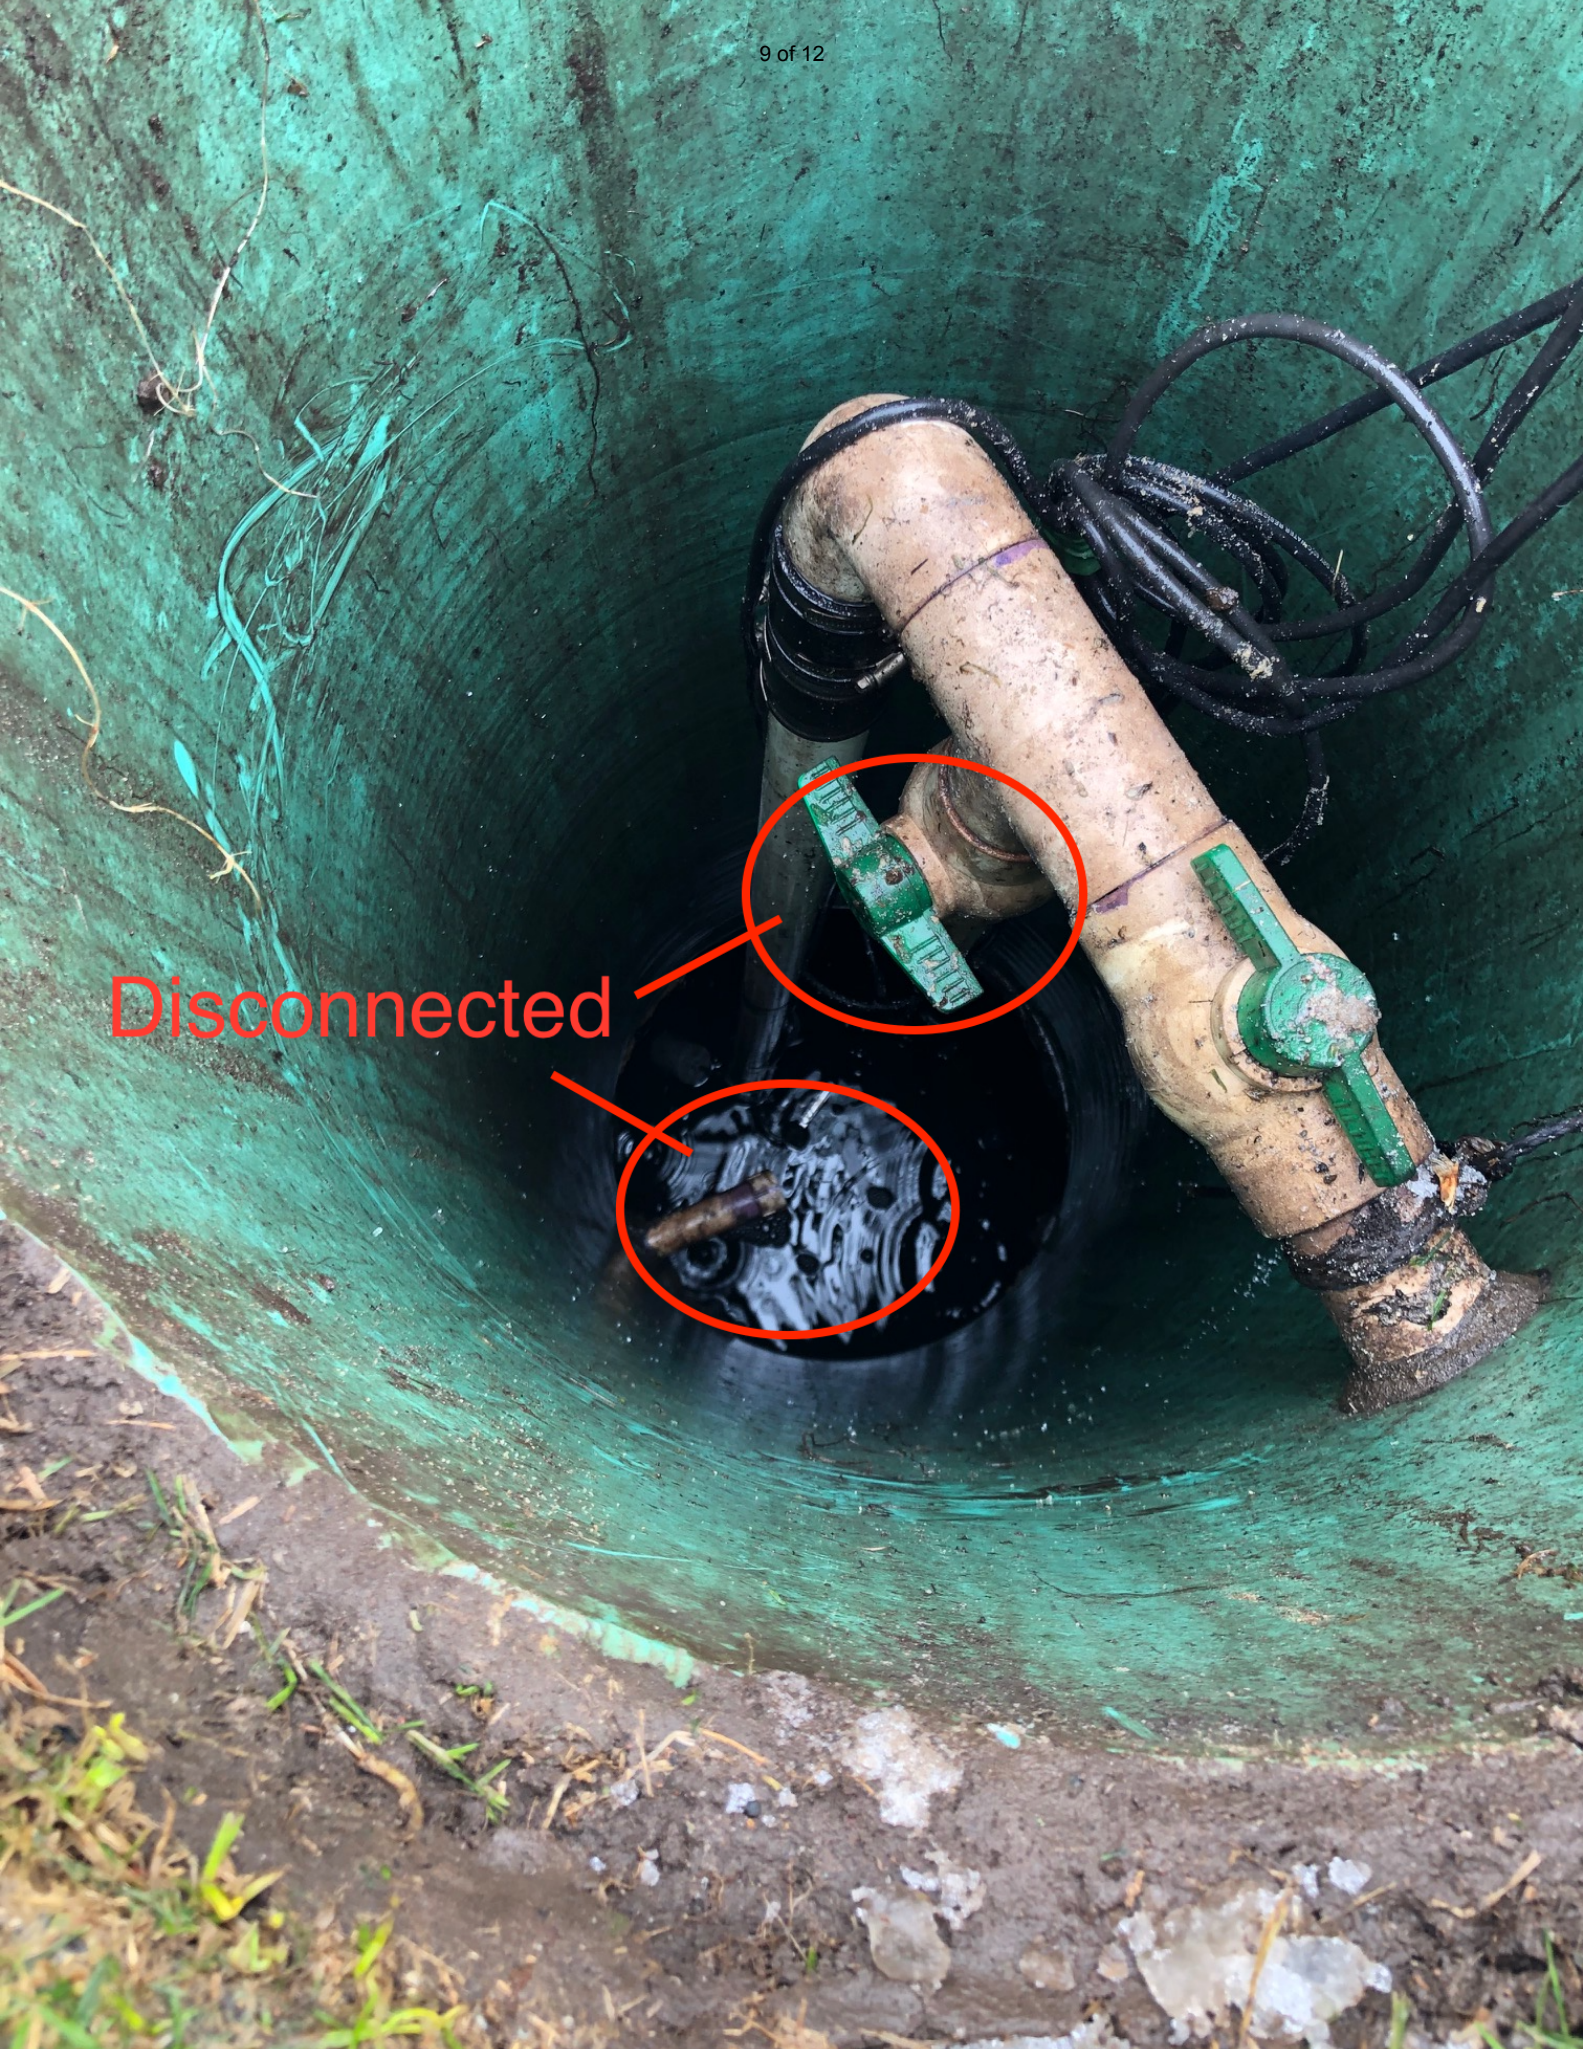
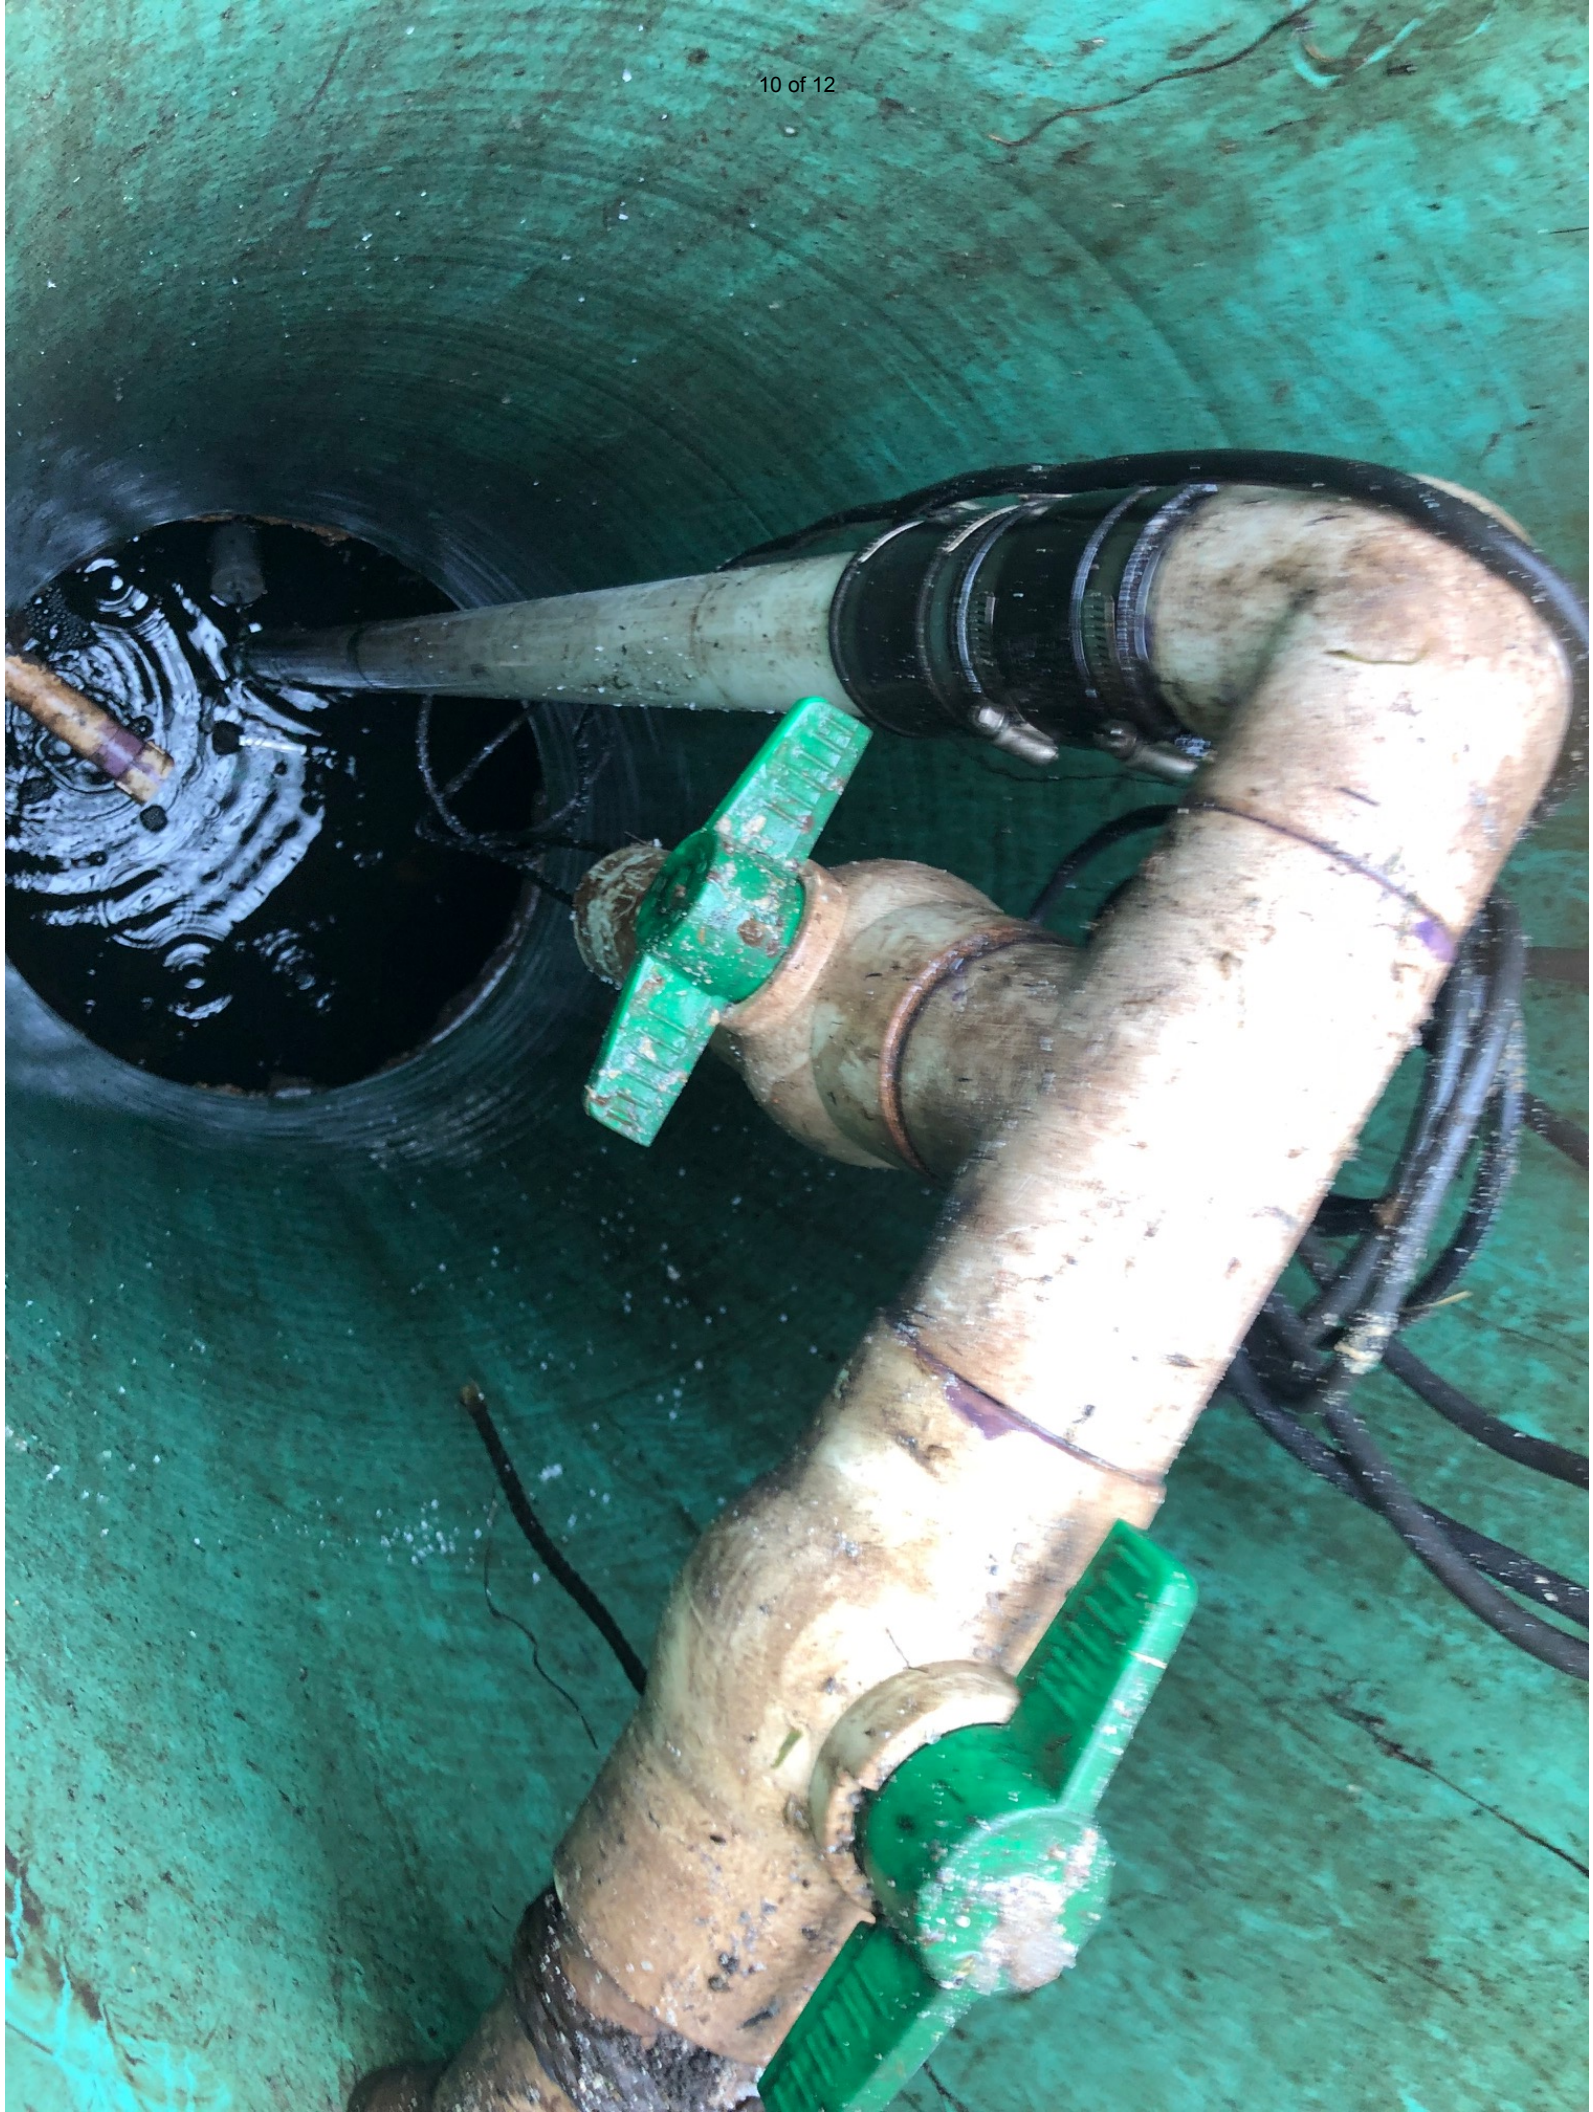
In addition, it should be noted that there was a valve located in the lift tank, which would allow effluent to be pumped into an old drainfield. This drainfield has been permanently disconnected from the main system.

Disconnected
