#### **Inspect Minnesota & Midwest Soil Testing**

#### SUBSURFACE SEWAGE TREATMENT SYSTEM (SSTS) COMPLIANCE REPORT

Inspection Address: 20941 Meadowbrook Ave N, Scandia, MN 55073

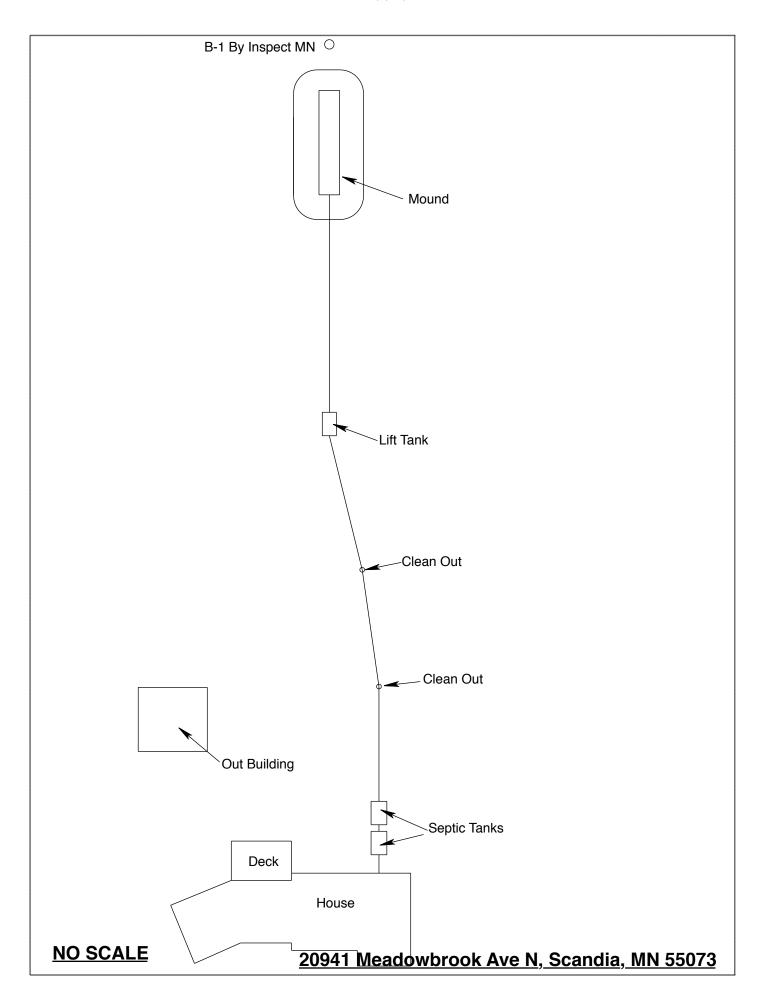
#### **Log Of Soil Borings**

Location of Project: 20941 Meadowbrook Ave N, Scandia, MN 55073					
Borings Made By: Inspect Minnesota		Date:		5/13/19	
Auger Used: Hand/Bu		Hand/Bucket	Classification System:		USDA
Boring Number: 1		1		Boring Number:	
Surface Elevation of Boring  51" below top of mound on original contour		-	Surface Elevation ( Boring	of	
Depth In Inches	Soils E	ncountered	Depth In Inches	Soils En	countered
0-8 8-17 17-21	10YR 4/4 Fine 10YR 4/4 Fine Sa	/2 Silt Loam Sandy Loam (Moist) Indy Loam (Saturated) S & 10YR 6/2 Redox			
17"	Depth To End Of B	oring Or Redox		Depth To End Of Bo	oring Or Redox
+51"	Elevation Of Boring	g Below Top Of Mound	E	Elevation Of Boring	Relative To System
-22" Depth To Bottom Of Distribution Media				f Distribution Media	
=46" Of Separation			Of Separation		
	E J Of D - 1 At	24"		End Of Delta At 1	
End Of Boring At: 21"			End Of Boring At:		
Redox Present At: 17"		Redox Present At:			
Standing Water Present At: None		ivone	Standing	Water Present At:
