Midwest Sewer Services

SUBSURFACE SEWAGE TREATMENT SYSTEM (SSTS) COMPLIANCE REPORT

Date: April 1, 2020

Inspection Address: 3363 Oasis Ave N, Baytown Twp, MN 55082

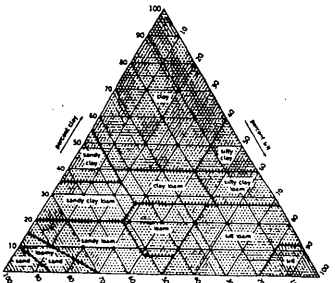
End of boring at 4-11 feet.
Standing water table: NO
Present at _____ feet of depth,
_____ hours after boring.
Not present in boring hole _____.

Mottled Soil: NO
Observed at _____ feet of depth.
Not observed in boring hole _____.
Observations and comments: _____

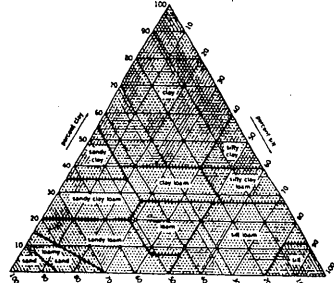
End of boring at 57 feet.
Standing water table: NO
Present at _____ feet of depth,
_____ hours after boring.
Not present in boring hole _____.

Mottled Soil: NO
Observed at _____ feet of depth.
Not observed in boring hole _____.
Observations and comments: _____

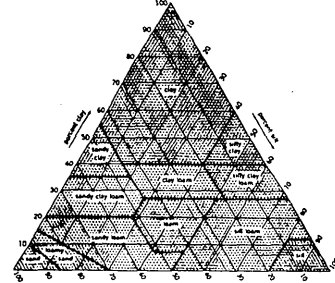
End of boring at 5 feet.
Standing water table: NO
Present at _____ feet of depth,
_____ hours after boring.
Not present in boring hole _____.

Mottled Soil: NO
Observed at _____ feet of depth.
Not observed in boring hole _____.
Observations and comments: _____

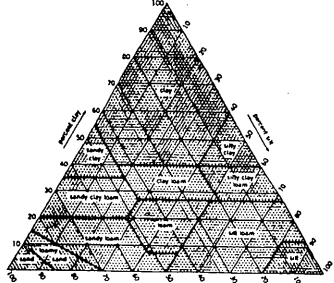
End of boring at 5 feet.
Standing water table: NO
Present at _____ feet of depth,
_____ hours after boring.
Not present in boring hole _____.

Mottled Soil: NO
Observed at _____ feet of depth.
Not observed in boring hole _____.
Observations and comments: _____
