Midwest Sewer Services

SUBSURFACE SEWAGE TREATMENT SYSTEM (SSTS) COMPLIANCE REPORT

Date: August 13, 2020

Inspection Address: 7959 Quadrant Ave S, Denmark Twp, MN 55033

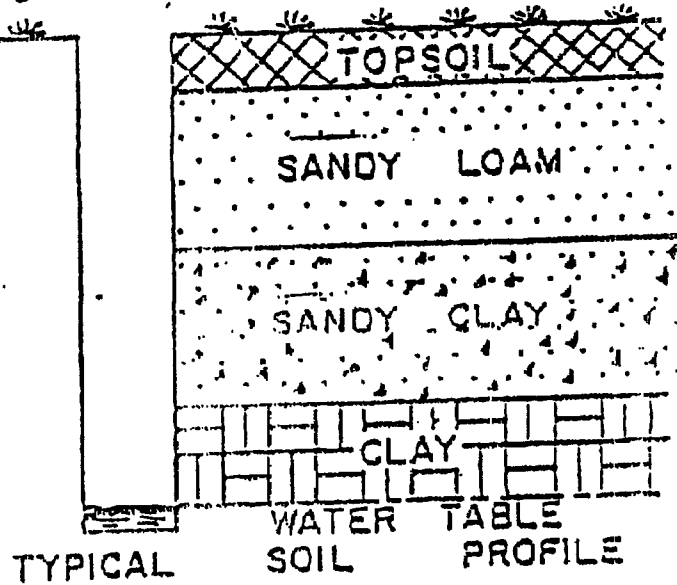
LOG OF SOIL BORINGS

Soil Borings done by J. Bush, MPCA Certification
Number 389, on 10-16-07
(date)

End of boring at 73"
 Standing water table:
 Present at feet of depth,
 hours after boring.
 Not present in boring hole X.
 Mottled soil:
 Observed at 60" of depth.
 Not present in boring hole .
 Observations and comments:

End of boring at 60"
 Standing water table:
 Present at feet of depth,
 hours after boring.
 Not present in boring hole X.
 Mottled soil:
 Observed at 60" of depth.
 Not present in boring hole .
 Observations and comments:

End of boring at 50" ~~feet~~.
 Standing water table:
 Present at feet of depth,
 hours after boring.
 Not present in boring hole X.
 Mottled soil: BEDROCK
 Observed at 50" ~~feet~~ of depth.
 Not present in boring hole .
 Observations and comments:

End of boring at 6 feet.
 Standing water table:
 Present at feet of depth,
 hours after boring.
 Not present in boring hole X.
 Mottled soil:
 Observed at 58" ~~feet~~ of depth.
 Not present in boring hole .
 Observations and comments:
