Compliance Inspection Form

Existing Subsurface Sewage Treatment Systems (SSTS)

Pro	perty	address: 9920 190th St N Forest	Lake, MN 55025	Inspector initials/Date: TT 8/14/2017
				(mm/dd/yyyy)
1.	lm	pact on Public Health – C	Compliance comp	onent #1 of 5
		empliance criteria:	· · · · · · · · · · · · · · · · · · ·	
				Verification method(s):
		stem discharges sewage to the ound surface.	☐ Yes ☒ No	Searched for surface outlet
			DV- DN-	Searched for seeping in yard/backup in home
		stem discharges sewage to drain or surface waters.	☐ Yes ⊠ No	
				☐ Homeowner testimony (See Comments/Explanation)
	dw	stem causes sewage backup into elling or establishment.	☐ Yes ⊠ No	☐ "Black soil" above soil dispersal system
	7075	Cost 1 and 1	22422462	System requires "emergency" pumping
		ny "yes" answer above indi stem is an imminent threat		Performed dye test
		alth and safety.	to public	☐ Unable to verify (See Comments/Explanation)

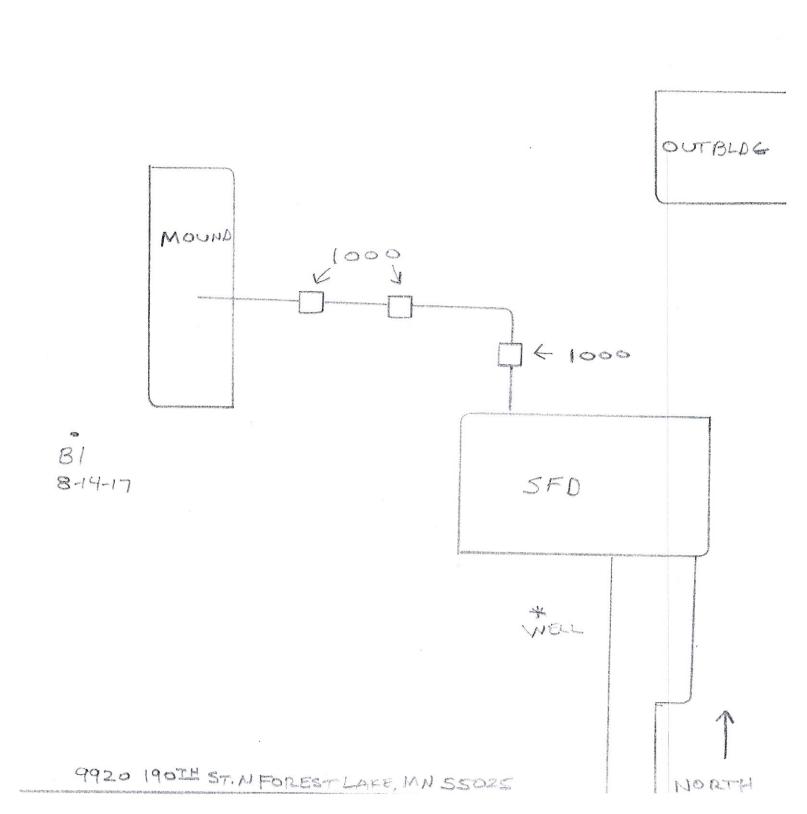
LOGS OF SOIL BORINGS

6-6 SLUEMAN 10/1/2 3/43 648 Loan 104R 4/4 12-30 Louis + Rodes 10 4/2 4/6 30+ Claylon 1042 5/4
Andry De 18"

Depth, In Feet	Boring Number 1
()-6"	Dark-brown sandy loam(10YR-3/3)
5-18"	Dark yellowish-brown loam(10YR-4/4)
18-30"	Dark yellowish-brown gravelly loam(10 YR-4/6)
30-42"	Yellowish-brown clay form(10YR-5/4), iron-stains, light-gray untiles

Standing water table:
Present at feet of depth, hours after boring.
Standing water not present in hole ...
Motified Soil:
Observed at 2.5 feet of depth.
Mottled soil not present in bore hole ...
