SSTS MAINTENANCE REPORT

System Location		
Address <u>19900 Maxwell Ave N.</u>	Telephone Number <u>651-338-5231</u>	
City <u>Maric on St. Croix</u>	State <u>ZIP 55047</u>	Property ID No./GEO Code
Owner <u>Thomas Owczarzak</u>	Pumping Date	
Contractor <u>Northside Septic Service</u>		
Maintainer <u>Kyle Carpenter</u>	MPCA License No. <u>930</u>	Telephone Number <u>763-444-7898</u>

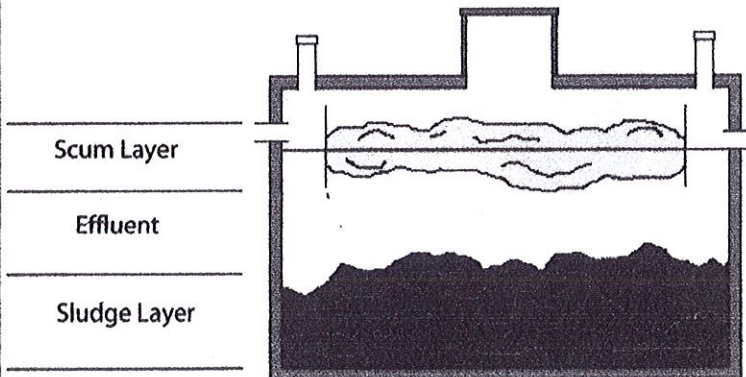
Liquid Level of Tank (Distance from invert of outlet pipe to bottom of tank) 43 in. 1st septic

Sludge Level 13 in. + Scum Level 6 in. = Total Sludge and Scum Level 19

Total Sludge and Scum Level _____ / Liquid Level _____ = Percent Sludge and Scum in Tank 44 %

*Tanks must be pumped if either of the following conditions exist:
 1. The top of the sludge layer is less than 12 inches from the bottom of the outlet baffle; or
 2. Total sludge and scum volume is greater than 25 percent of the tank's liquid capacity.

Liquid Level measured from invert of outlet pipe to bottom of tank
