# Inspect Minnesota & Midwest Soil Testing

## SUBSURFACE SEWAGE TREATMENT SYSTEM (SSTS) COMPLIANCE REPORT

**Inspection Address:** 5376 Osgood Ave S, Afton, MN 55001

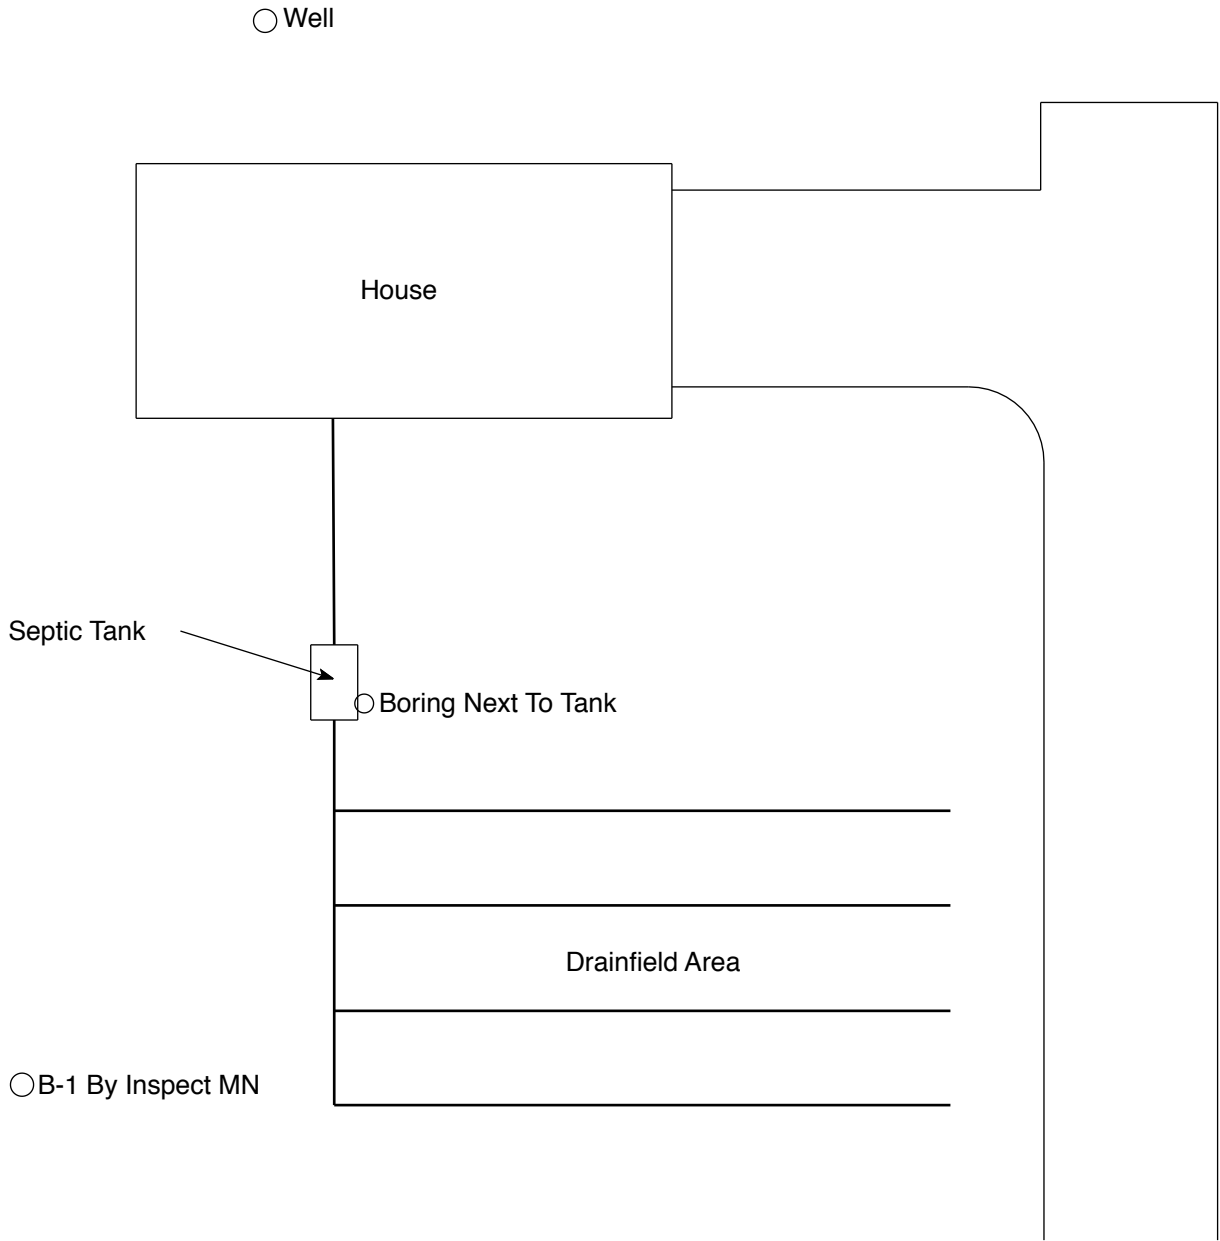
**5376 Osgood Ave S, Afton, MN 55001**

N →  
**NO SCALE**

I have performed an “MPCA Compliance Inspection” on this system and have reviewed the original design/permit records on file at Washington County. This very old system (installed in 1976) consists of a fiberglass septic tank and a rock trench drainfield. It should be noted that the average life expectancy of a septic system is approximately 30 years.
