Inspect Minnesota & Midwest Soil Testing

SUBSURFACE SEWAGE TREATMENT SYSTEM (SSTS) COMPLIANCE REPORT

Inspection Address: 21311 Hoakstra Ave, Forest Lake, MN 55025

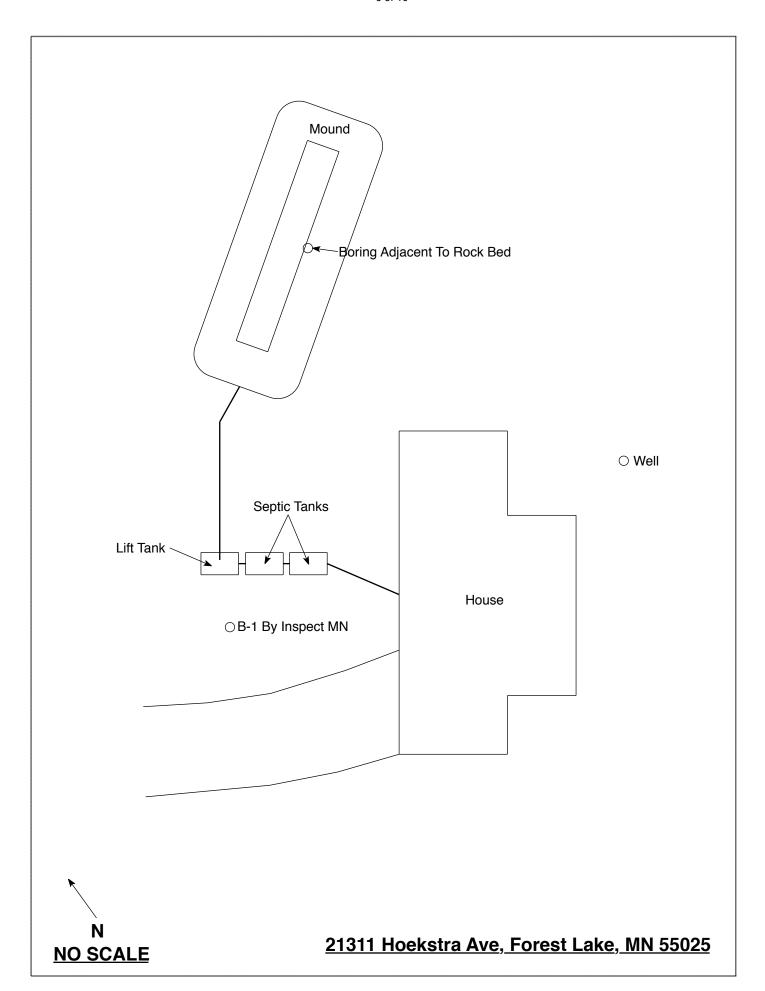
Log Of Soil Borings

Loc	Location of Project: 21311 Hoekstra Ave, Forest Lake, MN 55025				
Е	Borings Made By: Inspect Minnesota			Date:	6/13/19
	Auger Used: Hand/Bucket		Class	ification System:	USDA
	Boring Number:	1	Boring Number		
Surface			Surface		
Elevation	of		Elevation	of	
Boring			Boring		
Depth In	Soils E	ncountered	Depth In	Soils End	countered
Inches 0-19	10VR 3/3	3 Sandy Loam	Inches		
19-24		andy Loam With			
		5/8 Redox			
	Boring Adjacon	t To Mound Rock Bed			
0-14	Borning Adjacem	Fill			
14-38		d Sand/Fill			
38-40	Origi	nal Topsoil			
	38"-26" (Botton	n Of Rock Bed) = 12"			
		Below Rock Bed			
19"	Depth To End Of B	oring Or Redox		Depth To End Of Bo	ring Or Redox
+12"	Amount Of Sand B	elow Rock Bed		Elevation Of Boring	•
=31"	Of Seperation		Depth To Bottom Of Distribu		Distribution Media
				Of Separation	
	End Of Boring At:	12"		End Of Boring At:	
	Redox Present At:	19"		Redox Present At:	
Standing	Water Present At:	resent At: None Standing Water Present At:

Hand bucket auger used for borings; USDA - SCS Soil Classification used.				
Depth, in feet	Boring Number 1	Depth, in Boring Number 2			
06"	Dark-brown sandy loam	6" Dark-brown sandy loam			
1	Brown sandy loam	l Brown loamy sand			
3	Yellowish-brown clay loam, iron-stained, mottled obstruction	230"_ 3 — Yellowish-brown clay loam, iron-stained, mottled			
5		5			
6		6			
7 —		7			
8 —		8—			
Standin Present Standing Mottled Observe	d at feet of depth. soil not present in bore hole	End of boring at4feet. Standing water table: Present atfeet of depth,hours after boring. Standing water not present in holex Mottled Soil: Observed at2½feet of depth. Mottled soil not present in bore hole Comments:			
Depth, in feet	Boring Number 3	Depth, in Boring Number 4			
		feet			
0	Dark-brown sandy loam Brown loam	04" Dark-brown sandy loam 10" Brown sandy loam			
0 8" 1 18" 2 — 3 —		Dark-brown sandy loam 10" Brown sandy loam Yellowish-brown clay loam, iron-stained & mottled below 3
