#### **Inspect Minnesota & Midwest Soil Testing**

#### SUBSURFACE SEWAGE TREATMENT SYSTEM (SSTS) COMPLIANCE REPORT

**Inspection Address:** 23545 Jensen Ave N, Forest Lake, MN 55025

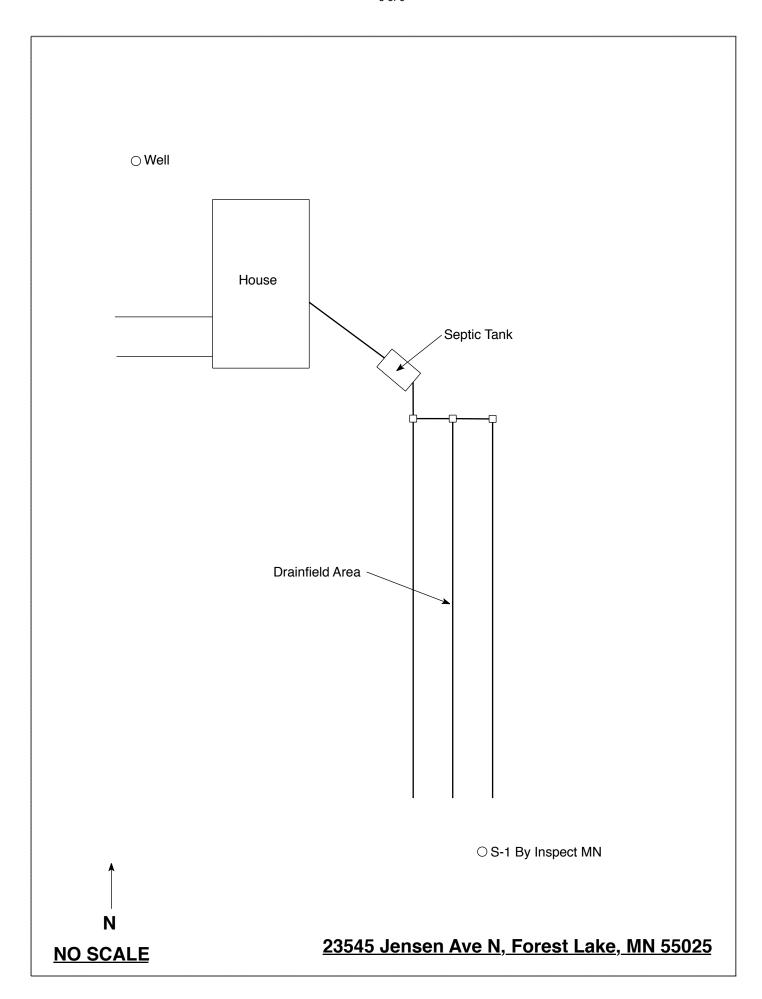
#### **Soil Observations Log**

Location of Project: 23545 Jensen Ave N, Fo				N, Fore	st Lake,	MN 55025	
Observations Made By: Inspect Minnesota					Date:	7/22/19	
Classification System: USDA			USDA				
	Soil	Observation:	1		Soil O	bservation:	
		_	nd surface as last field trench	Surface Elevation of Observation			
Depth In Inches	Rock %	Soils E	ncountered	Depth In Rock %		Soils Encountered	
0-12 12-17 17-46		10YR 4/3 L 5YR 3/4 ( Trace C	Loamy Fine Sand Loamy Fine Sand Clay Loam With Of Gravel And ron Nodules				
46"	Depth T	o End Of Soil O	bservation Or Redox		Depth T	o End Of Soil	Observation Or Redox
Same				Elevatio	n Of Observat	tion Relative To System	
-22" Depth To Bottom Of Distribution Media				Depth T	o Bottom Of I	Distribution Media	
≥24" Of Separation			Of Sepa				
		E 163		,, ,, ,			
End		Observation At:	46"	End Of		servation At:	
Redox Present At: None			C1 ''		x Present At:		
Standing Water Present At: None		Standi	ng Wate	r Present At:
