Midwest Sewer Services

SUBSURFACE SEWAGE TREATMENT SYSTEM (SSTS) COMPLIANCE REPORT

Inspection Address: 10077 Julep Trl N, Forest Lake, MN 55073

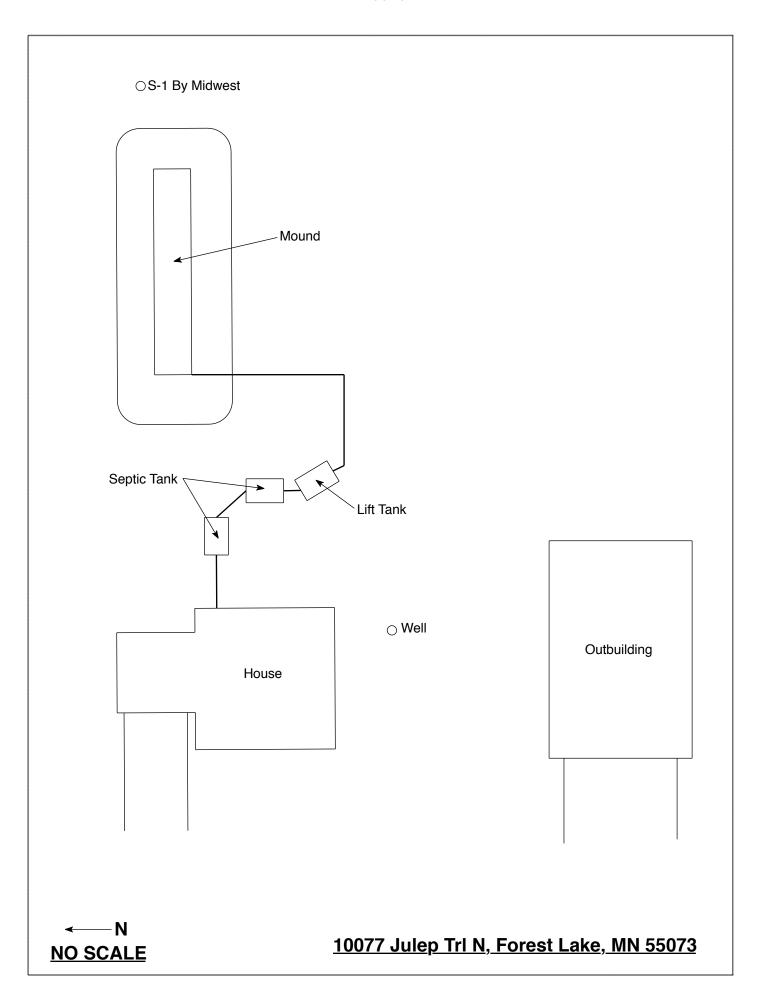
Soil Observations Log

Location of Project: 10077 Julep Trl N, Forest Lake, MN 55073						
Observations Made By: Midwest Sewer Ser				,	Date:	12/10/19
Classifi	cation System:	USDA				
So	il Observation:	1		Soil O	bservation:	
Surface Elevation of Observation S3" below top of mound on original contour			face tion of vation			
Depth In Inches Rock %	Soils E	ncountered	Depth In Inches	Rock %	Soils	Encountered
0-12 12-18	10YR 4/4	Fine Sandy Loam Clay Loam With & 10YR 6/2 Redox				
12" Depth To End Of Soil Observation Or Redox			Depth T	o End Of Soil	Observation Or Redox	
+53" Elevation Of Observation Below Top Of Mound					tion Relative To System	
-28" Depth To Bottom Of Distribution Media					Distribution Media	
=37" Of Separation				Of Sepa	ration	
Fnd Of Soil	Observation At:	18"	Fnd Of	Soil Oh	servation At:	
	edox Present At:	12"	2.10 01		x Present At:	
	ater Present At:	None	Standi		r Present At:	
Tanana
