Midwest Sewer Services

SUBSURFACE SEWAGE TREATMENT SYSTEM (SSTS) COMPLIANCE REPORT

Inspection Address: 20360 Enfield Ct N, Forest Lake, MN Site Conditions: 12" Snow 6" Frost

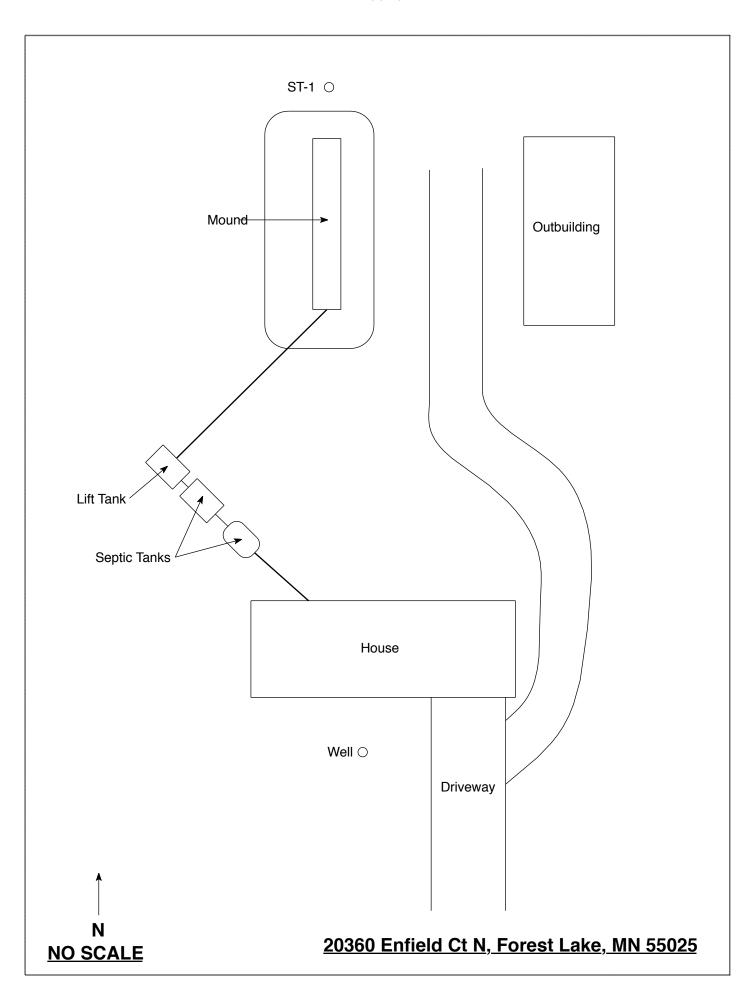
Soil Observations Log

Location of Project: 20360 Enfield Ct N, Forest Lake, MN 55025						
Observations Made By: Midwest Sewer Ser				Date:	1/23/2020	
Classification System: USDA						
	Soil Observation:	ST-1		Soil C	bservation:	
Surface Elevation of Observation Observation 49" below top of moun original contour		-		face ion of vation		
Depth In Inches Rock	k % Soils E	ncountered	Depth In Inches	Rock %	Soils	<u>Encountered</u>
0-15 15-24	10YR 7/1 L	2 Loamy Sand oamy Sand With & 5YR 5/8 Redox				
15" Dep	oth To End Of Soil O	bservation Or Redox		Depth T	o End Of Soil	Observation Or Redox
+49" Elev	ation Of Observation	n Below Top Of Mound				tion Relative To System
-28" Dep	oth To Bottom Of Dis	stribution Media				Distribution Media
=36" Of S	Separation			Of Sepa	ration	
Fnd Of S	Soil Observation At:	24"	Fnd Of	Soil Oh	servation At:	
Lilu Oi 3	Redox Present At:	15"	Liid Oi		x Present At:	
Standing	Water Present At:	None	Standi		r Present At:
