Compliance inspection report form

Existing Subsurface Sewage Treatment System (SSTS)

Property address: 18330 IVYWOOD AVENUE N FOREST LAKE

Brief system description: 1200 AND 1000 SEPTIC TANKS, 1000 LIFT TANK AND PRESSURIZED MOUND

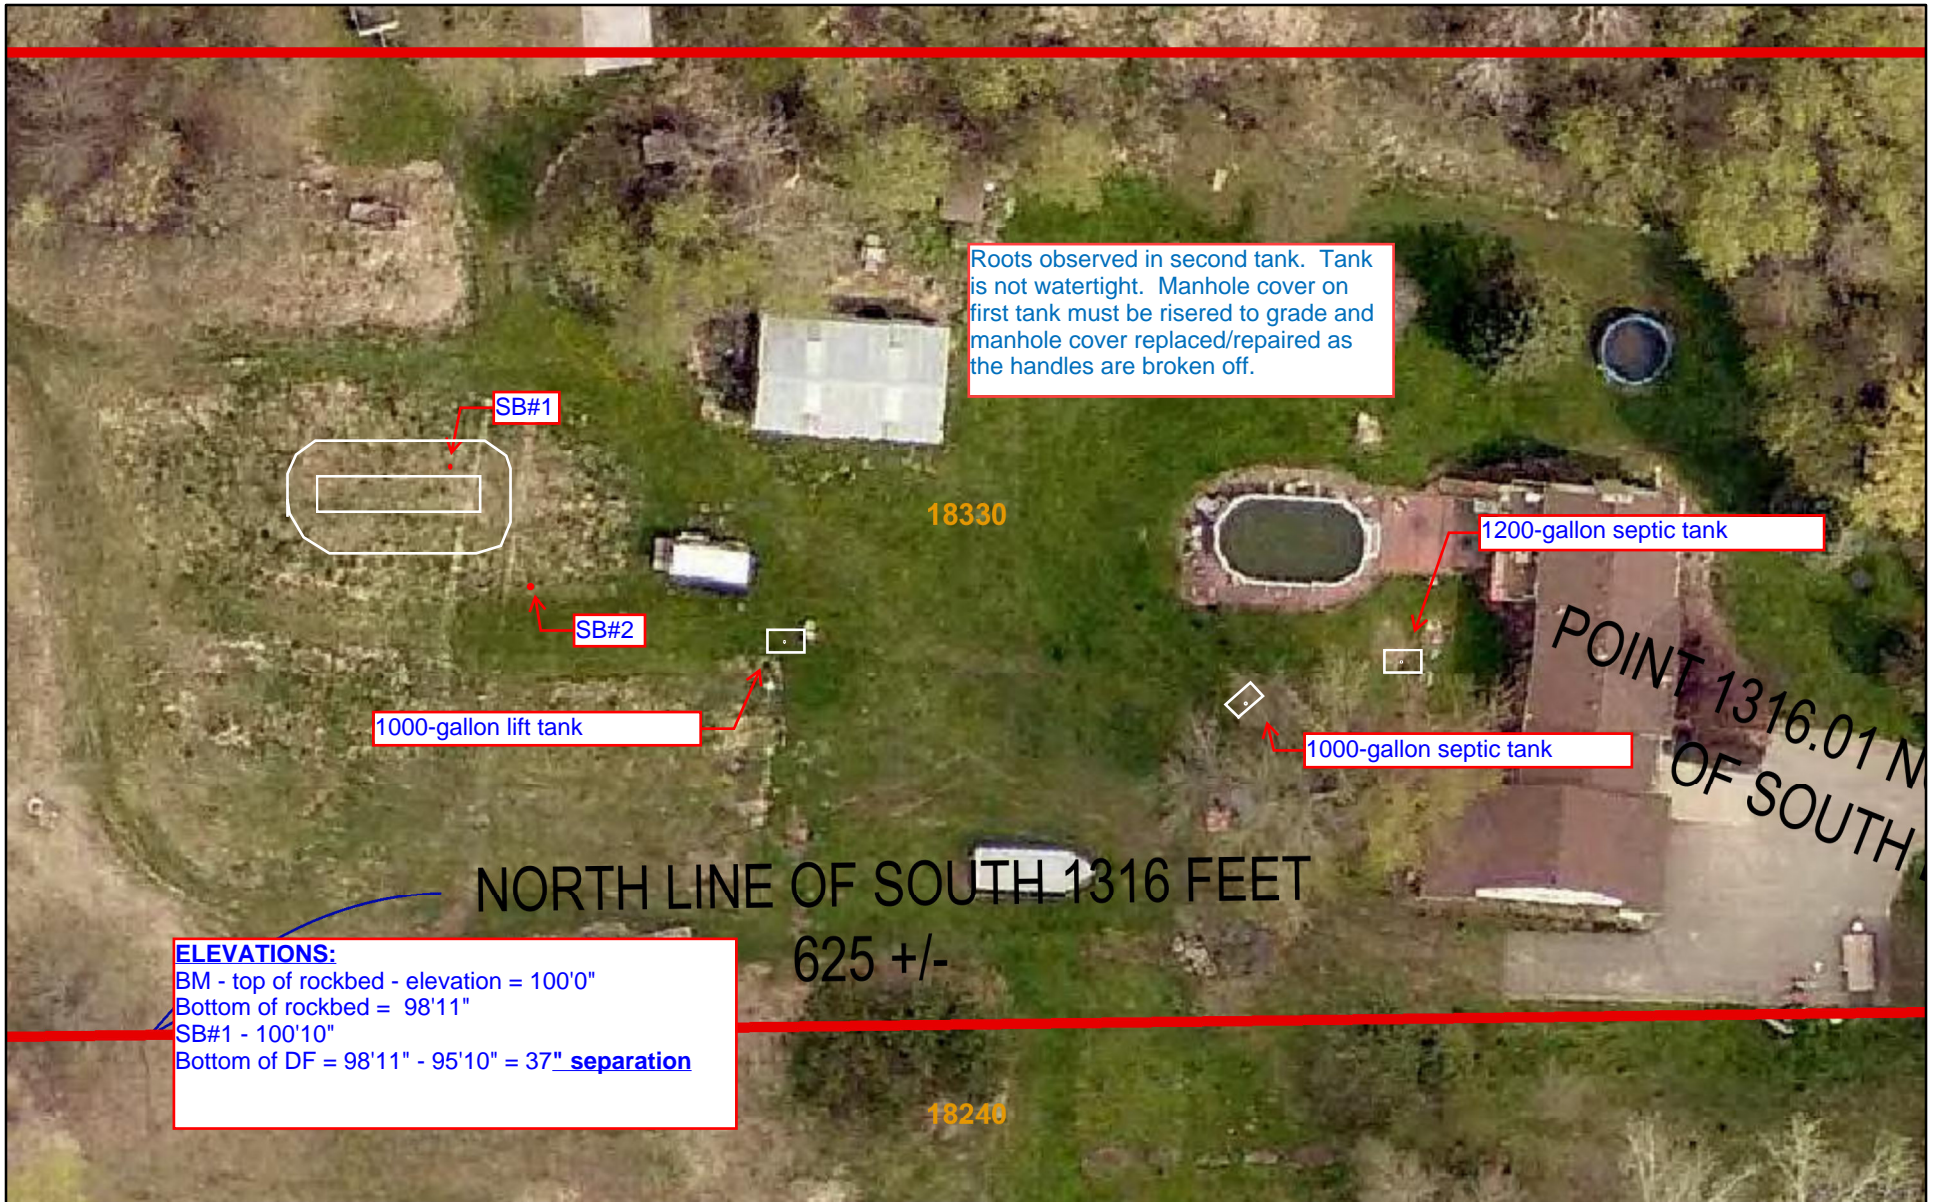
Washington County, MN

deep well

Tank

1200 1600

Comments: Benchmark = Top of rockbed in mound. Assumed elevation = 100'0". Soil boring #1 taken directly through the sand layer of the mound and along the upslope of the mound, indicate that the system does meet the required 36" vertical separation from seasonally saturated soils. The system consists of a 1250 and 1000--gallon septic tank, a 1000-gallon lift tank with a 450 sq. ft, pressurized mound system with 24" sand lift. The tanks were pumped and inspected. Roots were observed in the second tank and is not watertight. This tank must be replaced/repared. The manhole cover on the first tank needs to be risered to grade for access. Probe samples taken in the mound indicated no signs of excess ponding in the rockbed or sand layers of the mound. The pump and floats were manually run and operable at time of inspection. This system is classified as noncompliant. This inspection is not a warranty or guarantee, either written or implied, of future or long-term hydraulic functionality/performance, but rather a determination if the systems use is/may cause pollution and/or adverse harm to the environment, groundwater or public health and safety at the time of this inspection. No guarantee can be made on future hydraulic performance, or the performance of system components (pumps, controls, etc.). Changes in use can cause any system, failing or compliant, to become hydraulically overloaded and ultimately fail. Owner/buyer assumes full responsibility for the long-term performance of this system as well as any future upgrade, repairs or replacement costs. Liability is limited to the cost of this inspection.
