ZIERKE SOIL TESTING

At your request, I have conducted a septic inspection to determine the compliance status of your septic system pursuant to Minnesota Rules Chapter 7080.1500.

Compliance inspection report form

Existing Subsurface Sewage Treatment System (SSTS)

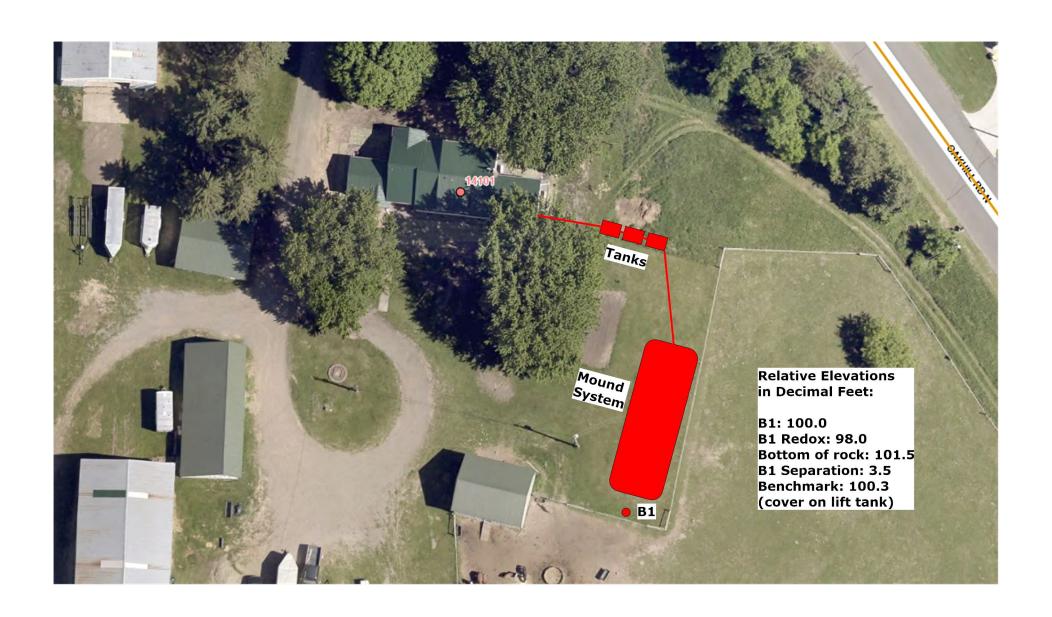
Logs of Soil Borings

Location of Project: 14101 Oakhill Rd N Scandia, MN 55073 Borings Made by Ben Zierke 6/6/2022 Date: Hand bucket auger used for borings; USDA - SCS Soil Classification used. Depth, in Depth, in **Boring Number 1 Boring Number 2** Inches Inches 0-13" Sandy loam fill soil 13-19" 10YR 2/2 fine sandy loam 19-24" 10YR 5/3 fine sandy loam 24-30" 10YR 6/3 fine sandy loam, 7.5YR 5/6 and 10YR 6/1 redox End of boring at End of boring at Standing water table: Standing water table: feet of depth Hours after boring feet of depth Hours after boring Present at Present at Standing water not present in hole Standing water not present in hole Mottled Soil: Mottled Soil: feet of depth Observed at Observed at Mottled soil not present in bore hole Mottled soil not present in bore hole Comments: Comments: Depth, in Depth, in **Boring Number 3 Boring Number 4** Inches Inches End of boring at End of boring at Standing water table: Standing water table:
