ZIERKE SOIL TESTING

At your request, I have conducted a septic inspection to determine the compliance status of your septic system pursuant to Minnesota Rules Chapter 7080.1500.

Compliance inspection report form

Existing Subsurface Sewage Treatment System (SSTS)

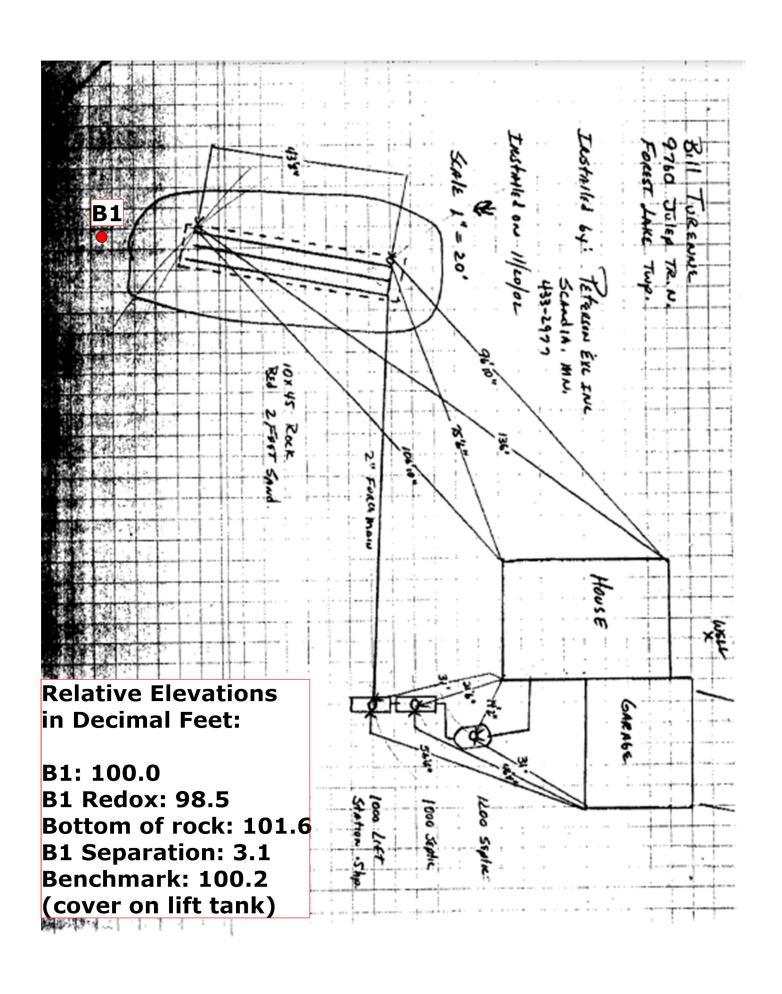
Logs of Soil Borings

Location of Project: 9760 Julep Trl N Scandia, MN 55073 Borings Made by Ben Zierke 6/27/2022 Date: Hand bucket auger used for borings; USDA - SCS Soil Classification used. Depth, in Depth, in **Boring Number 1 Boring Number 2** Inches Inches 0-7" 10YR 2/1 loam 7-10" 10YR 3/2 loam 10-18" 10YR 4/3 loam 18-22" 10YR 4/3 clay loam, 7.5YR 5/6 concentrations and 5/1 depletions End of boring at End of boring at Standing water table: Standing water table: feet of depth Hours after boring feet of depth Hours after boring Present at Present at Standing water not present in hole Standing water not present in hole Mottled Soil: Mottled Soil: 1.5 feet of depth Observed at Observed at Mottled soil not present in bore hole Mottled soil not present in bore hole Comments: Comments: Depth, in Depth, in **Boring Number 3 Boring Number 4** Inches Inches End of boring at End of boring at Standing water table: Standing water table: Hours after boring Hours after boring Present at Present at Standing water not present in hole Standing water not present in hole Mottled Soil: Mottled Soil:
