ZIERKE SOIL TESTING

Compliance inspection report form

Existing Subsurface Sewage Treatment System (SSTS)

Logs of Soil Borings

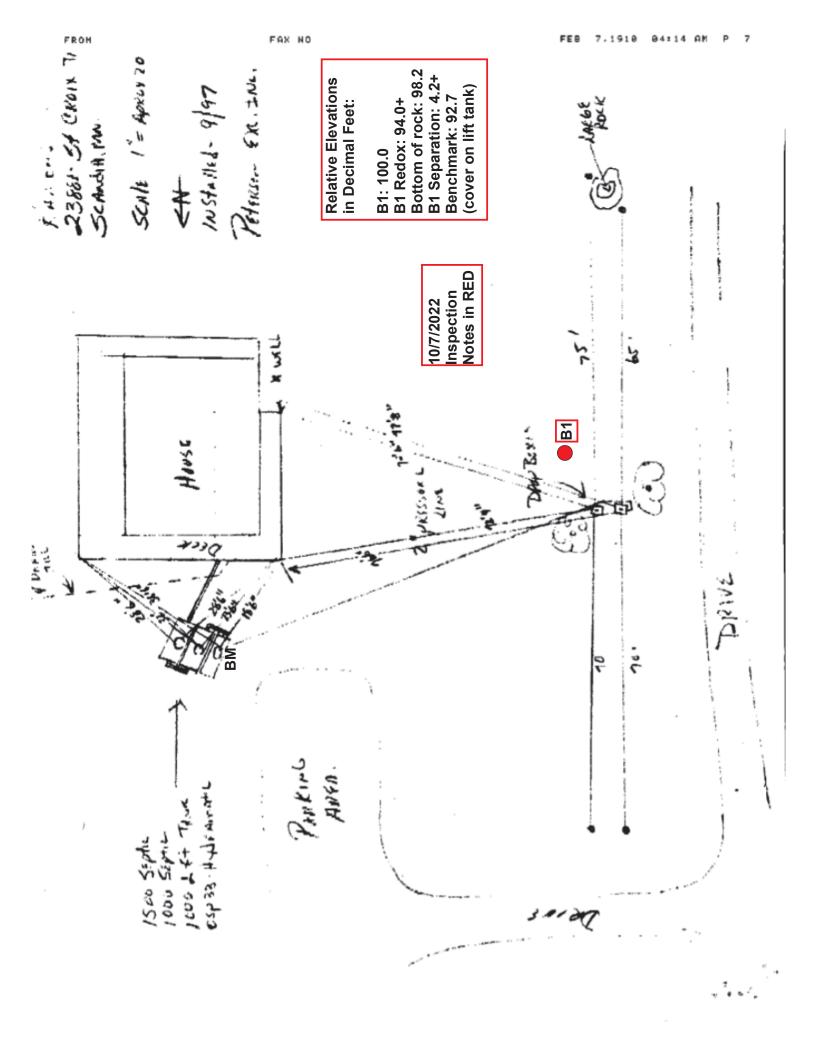
Depth, in Inches	Boring Number 1	Depth, in Inches	Boring Number 2
0-19"	10YR 3/2 loamy sand 5% rock	0	
19-38"	10YR 4/4 medium sand 5% rock		
38-42"	10YR 3/2 sandy loam		
42-68"	10YR 4/3 fine sand <5% rock		
68-72"	10YR 6/4 fine sand <5% rock		
End of boring at Standing water tab Present at Standing water not p Mottled Soil: Observed at Mottled soil not pres Comments:	feet of depth Hours after boring feet of depth feet of depth	End of boring at Standing water tal Present at Standing water not Mottled Soil: Observed at Mottled soil not pre Comments:	feet of depth Hours after boring present in hole feet of depth
Depth, in Inches	Boring Number 3	Depth, in Inches	Boring Number 4
0		0	
End of boring at	feet	End of boring at	feet
