P.O. Box 383 Hugo, MN	55038	Brian Humpal		
651-492-7550/Brian@midwes	tsoiltesting.com M	MPCA Licensed Advanced Inspector		
SUBSURFACE SEWAGE TR	EATMENT SYSTEM	(SSTS) COMPLIANCE REPORT		
Date: September 26, 2016	Time: 11:30 AM	Owner: Wheelock Whitney III		
Inspection Address: 2767 Itasca	Ave S, St. Mary's Point,	, MN 55043

REPORT SUMMARY

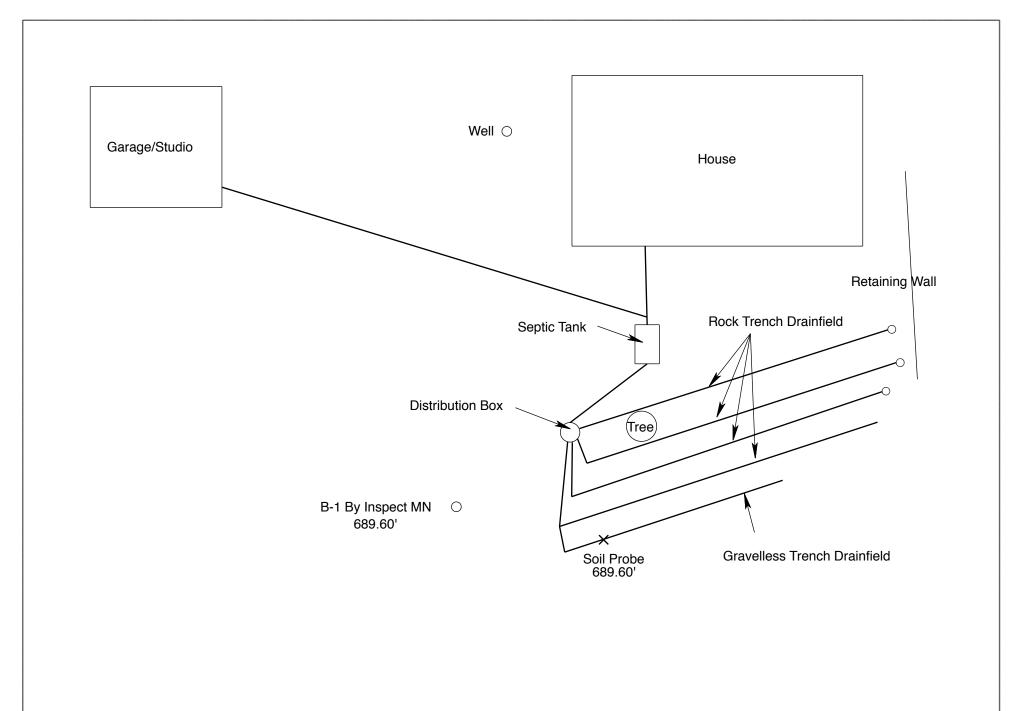
2767 Itasca Ave S, St. Mary's Point, MN 55043

NO SCALE

I have performed an "MPCA Compliance Inspection" on this system and have reviewed the original design/permit records on file at Washington County. This older system consists of a pre-cast septic tank and a rock trench drainfield, which was installed in 1992. One gravelless trench was added in 1993 when the garage/studio was connected to the septic system.

It should be noted that the line serving the 4th and 5th drainfield trenches is currently blocked and should be repaired as soon as possible.
