ZIERKE SOIL TESTING

Compliance inspection report form

Existing Subsurface Sewage Treatment System (SSTS) 520 Lafayette Road North St. Paul, MN 55155-4194

Location of Project: 9637 Stonebridge Trl N Stillwater, MN 55082 Borings Made by Ben Zierke 5/6/2024 Date: Hand bucket auger used for borings; USDA - SCS Soil Classification used. Depth, in Depth, in **Boring Number 1 Boring Number 2** Inches Inches 0----sandy topsoil fill 0-8" 8-19" 10YR 3/2 loamy sand 19-45" 10YR 4/4 medium sand, 5% rock 45-62" 10YR 6/4 medium sand, few 10YR 4/6 lamellae bands 62-84" 10YR 6/3 fine sand, few 10YR 4/6 bands, no restriction observed End of boring at End of boring at Standing water table: Standing water table: feet of depth Hours after boring feet of depth Hours after boring Present at Present at Standing water not present in hole Standing water not present in hole Mottled Soil: Mottled Soil: feet of depth Observed at Observed at Mottled soil not present in bore hole Mottled soil not present in bore hole Comments: Comments: Depth, in Depth, in **Boring Number 3 Boring Number 4** Inches Inches End of boring at End of boring at Standing water table: Standing water table: Hours after boring feet of

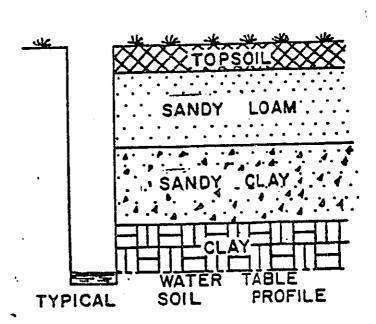
LOG OF SOIL BORINGS

Soils encountered at various depths should be listed as to appearance, texture and composition.

Depth at which water, bedrock or heavy clay layer is encountered should be recorded.

BORING NO. 1 BORING NO. 2 BORING NO. 3 BORING NO. 4								
BOR	ING NO. I	שטא	און טאו	,	10 110. 0				
DEPTH IN FEET	SOIL DESCRIPTION	DEPTH IN FEET	SOIL DESCRIPTION	DEPTH IN FEET	SOIL DESCRIPTION	DEPTH IN FEET	SOIL DESCRIPTION		
0	GRAYISH BROWN -	0		0		0			
1/2	DARK GRAVISH	1/2	BEZOISH	1/2	,	1/2			
	Browis	ı	≥ Cowos	1		1			
11/2	DAGK BEOWS	11/2	sanda evener	11/2		11/2			
2	SAL	2	DAK Zamo	2		2			
21/2	1	21/2		51/5		21/2			
3	7	3_	SAD	3		3			
31/2] Beowo	31/2		31/2		31/2	·		
4		4	L'Soury	4		4			
41/2	7	41/2	SANS	41/2		41/2			
5	7	5		5	<u> </u>	5			
51/2	ZAMAZ	51/2	(Med a Cooke)	51/2	<u> </u>	51/2			
6	(Medy Care)	6		6]	6			
61/2		61/2]	61/2		61/2			
7		7		7	1	7	1		
71/2		71/2		71/2	_	71/2	4		
8		8		8	_	8	4 .		
81/2	2	81/2		81/2	_	81/2	1		
9		9		9		9

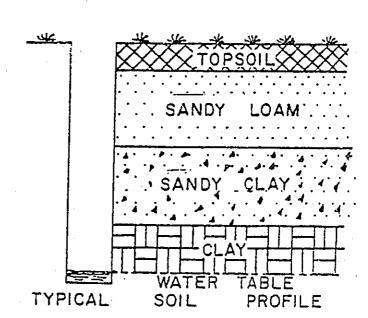
LOG OF SOIL BORINGS

Soils encountered at various depths should be listed as to appearance, texture and composition.

Depth at which water, bedrock or heavy clay layer is encountered should be recorded.

ING NO. I	BOR	ING NO. 2	BORI	NG NO. 3	BORI	NG NO. 4
DEPTH IN FEET	SOIL DESCRIPTION	DEPTH IN FEET	SOIL DESCRIPTION	DEPTH IN FEET	SOIL DESCRIPTION	DEPTH IN FEET	SOIL DESCRIPTION
0	Shirt LOAM -			0		0	
1/2		1/2		1/2		1/2	
		1	1000	1		1	
11/2	DARK	11/2	DARK	11/2		11/2	
2		2	Bus	2		2	
21/2	Estado	21/2		21/2		21/2	
3 -		3	SAUSE	3		3	·
31/2		3 1/2		3 1/2	İ	31/2	
4	SMIZ	4		4	·	4	
41/2		41/2		41/2		41/2	ļ
5.45		5		5		5	
51/2		5 1/2	Cours#	51/2		51/2	
6	40.23	6		6		6	
61/2	DARK BEND	61/2	SAUS	61/2		61/2	
7	SIUT LOAM	7		7		7	:
71/2	Crocast trains	71/2		71/2		71/2	
8		8		8		8	
81/2		81/2		81/2	4 14 1	81/2
