#### **Inspect Minnesota & Midwest Soil Testing**

#### SUBSURFACE SEWAGE TREATMENT SYSTEM COMPLIANCE REPORT

Inspection Address: 157 Ideal Ave N, Mahtomedi, MN Site Conditions: 8" Snow 3" Frost

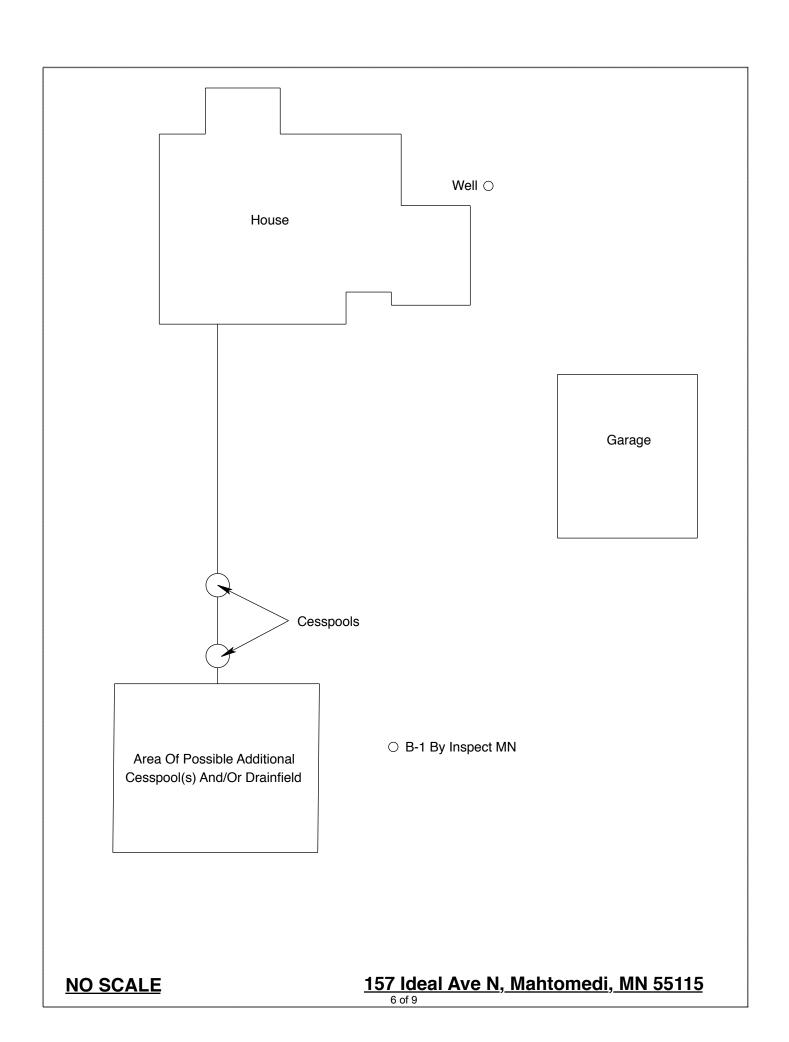
#### **Log Of Soil Borings**

Location of Project: 157 Ideal Ave N, Mahtomedi, MN 55115						
Borings Made By: Inspect Minnesota				Date:	12/21/16	
Auger Used: Hand/Bucket		Classification System:		USDA		
[	Boring Number:	1		Boring Number:		
Surface Same ground surface as last		Surface Elevation Boring	of			
Depth In Inches	Soils E	ncountered	Depth In Inches	Soils En	countered	
0-6 6-25 25-46 46-65	10YR 4, 10YR 5, 10YR 4/4	/3 Fine Sand /3 Fine Sand /4 Fine Sand Fine Sand With 6/2, & 5YR 4/6 Redox				
46" [	" Depth To End Of Boring Or Redox			Depth To End Of Bo	oring Or Redox	
Same Elevation Of Boring Relative To System			Elevation Of Boring	Relative To System		
-54" Depth To Bottom Of Distribution Media				f Distribution Media		
=0" Of Separation			Of Separation			
	End Of Boring At:	65"		End Of Boring At:		
Redox Present At: 46"				Redox Present At:		
	Water Present At:	None		Water Present At:
