SUBSURFACE SEWAGE TREATMENT SYSTEM (SSTS) COMPLIANCE REPORT

Date: January 26, 2017 **Time:** 10:15 AM **Owner:** Bill Beck

Inspection Address: 9880 Dale Rd, Woodbury, MN **Site Conditions:** 3" Snow 13" Frost

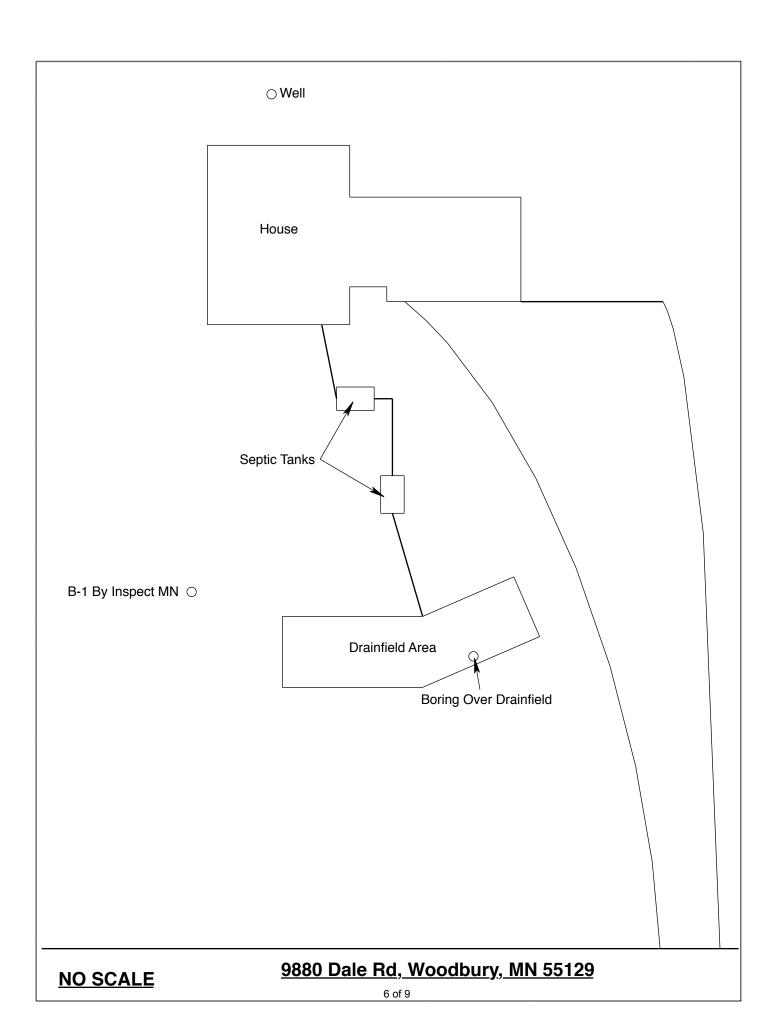
Log Of Soil Borings

Location of Project: 9880 Dale Rd, Woodbury, MN 55129					
Borings Made By: Inspect Minnesota		Date:		1/26/17	
Auger Used: Hand/Bucket				USDA	
	Boring Number:	1		Boring Number:	
Surface Elevation Boring	of Same grou	and surface as last onfield trench	Surface Elevation Boring		
Depth In Inches	Soils E	ncountered	Depth In Inches	Soils Encountered	
0-16 16-32 32-49	≈20% Ro 10YR 4/3 Medium (≈15% Ro	ly Loam With Gravel ock Fragments Coarse Sand With Gravel ock Fragments Coarse Sand With Gravel			
49-62	10YR 4/4 Medium (≈ 20% R	ock Fragments Coarse Sand With Gravel ock Fragments sal At 62"			
62"	62" Depth To End Of Boring Or Redox			Depth To End Of B	oring Or Redox
Same Elevation Of Boring Relative To System				g Relative To System	
-36" Depth To Bottom Of Distribution Media				of Distribution Media	
≥36" Of Separation			Of Separation		
	End Of Boring Att	62"		End Of Boring Att	
	End Of Boring At: Redox Present At:			End Of Boring At: Redox Present At:
