Compliance Inspection Form
Existing Subsurface Sewage Treatment Systems (SSTS)

Property address: 4819 235th Ave N Forest Lake MN 55025

Brief system description: 1500 gallon septic tank, 1000 gallon tank with a lift, mound dispersal system

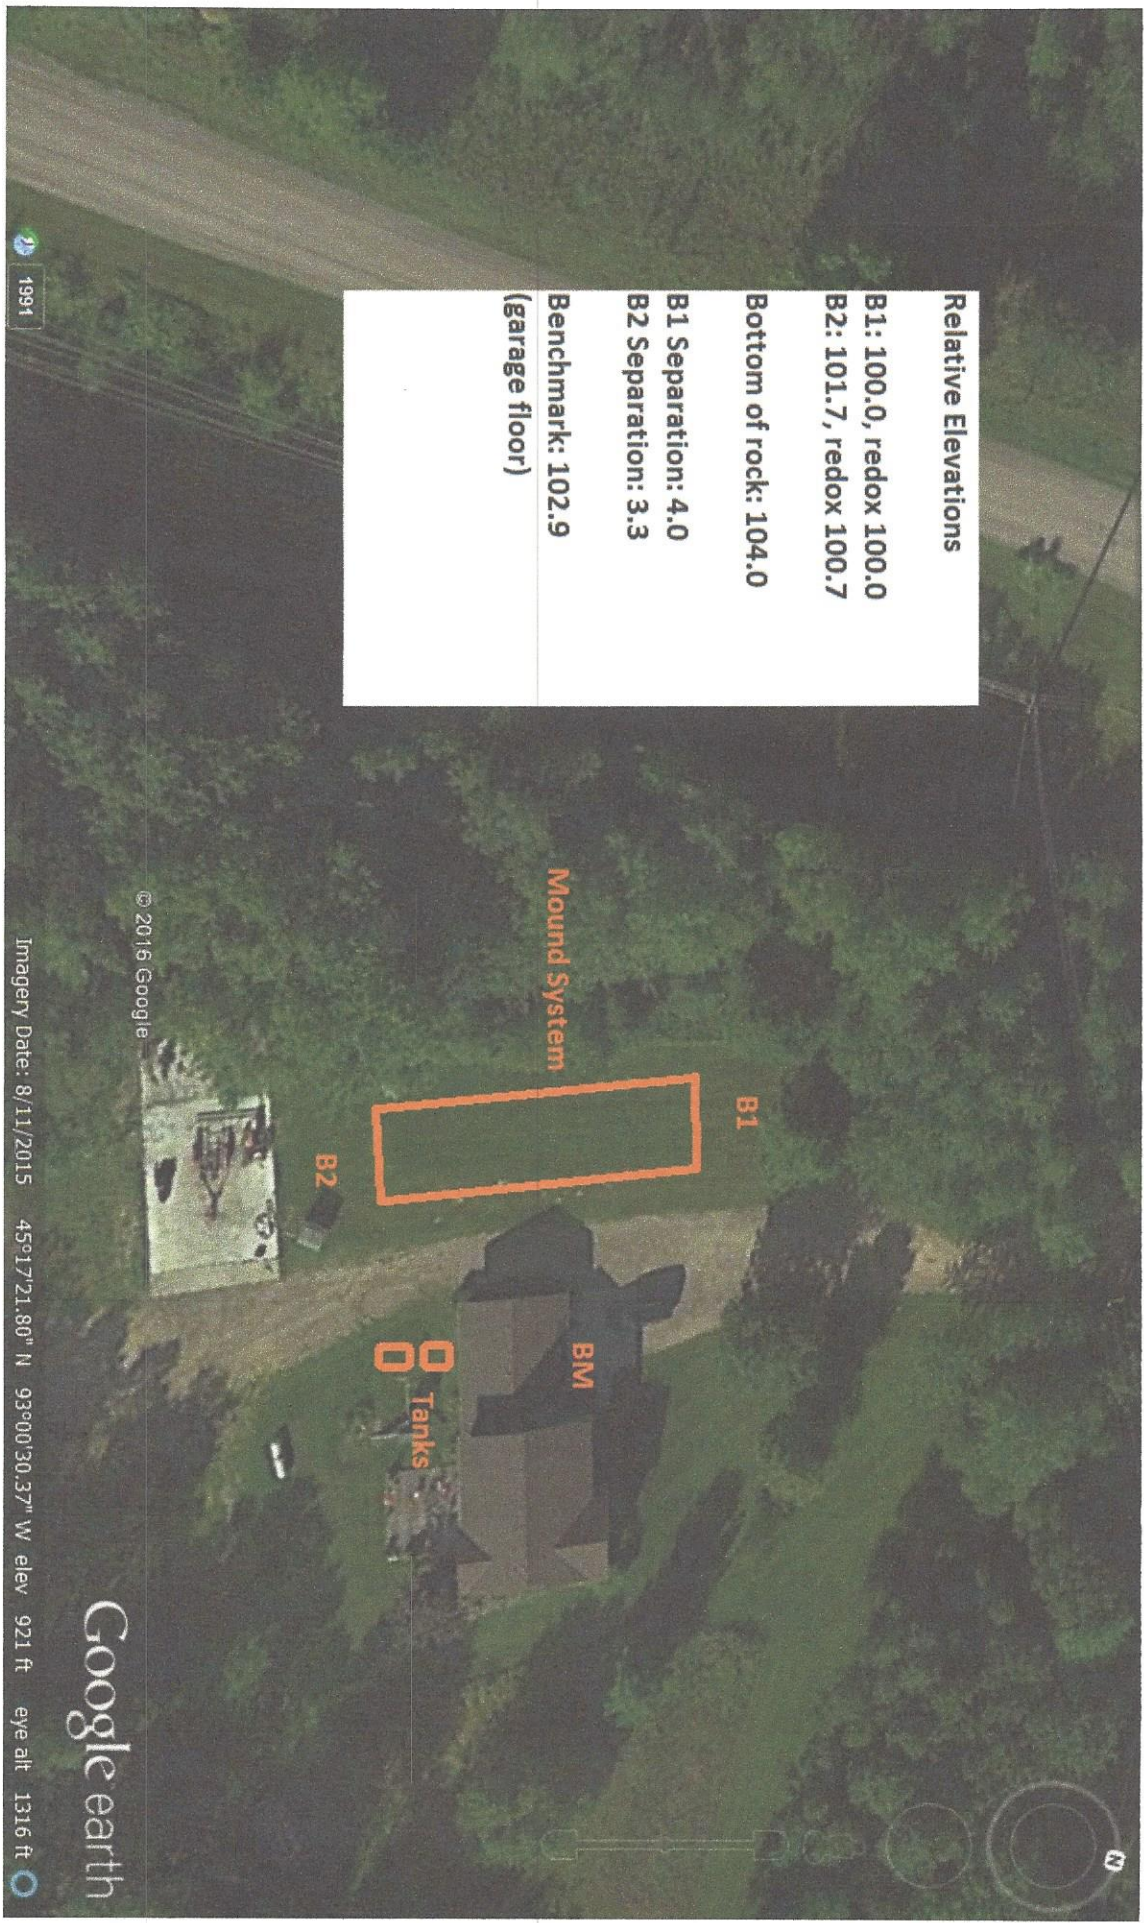
Relative Elevations	
B1:	100.0, redox 100.0
B2:	101.7, redox 100.7
Bottom of rock: 104.0	
B1 Separation: 4.0	
B2 Separation: 3.3	
Benchmark: 102.9 (garage floor)
