# Compliance Inspection Form

## Existing Subsurface Sewage Treatment Systems (SSTS)

Property address: 143/145 ST. CROIX TRAIL SOUTH LAKELAND MN Reason for inspection: PROPERTY TRANSFER

## Compliance Inspection Attachment for Existing Individual Sewage Treatment Systems

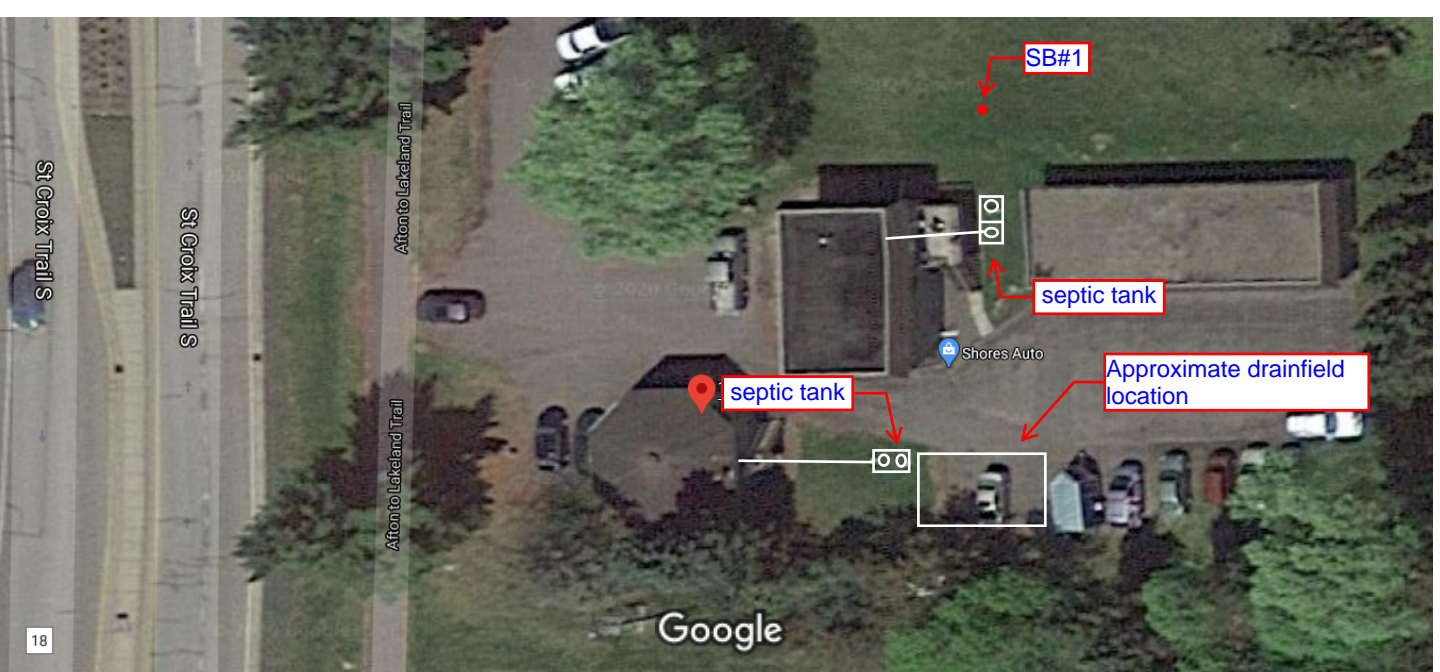
**Sketch:**

**Comments:** Soil boring #1 indicated no redoximorphic mottling to a depth of 96", however no allowable treatment beyond 7' per MPCA Chapter 7080, therefore the drainfield located to the South is noncompliant. The system consists of 2 separate septic tanks with separate drainfields. Unable to locate North drainfield, it may be beneath the detached garage. South drainfield located mostly beneath parking lot/driveway. This inspection is not a warranty or guarantee, either written or implied, of future or long-term hydraulic functionality/performance, but rather a determination if the systems use is/may cause pollution and/or adverse harm to the environment, groundwater or public health and safety at the time of this inspection. No guarantee can be made on future hydraulic performance, or the performance of system components. Changes in use can cause any system, failing or compliant, to become hydraulically overloaded and ultimately fail. Owner/buyer assumes full responsibility for the long-term performance of this system as well as any future upgrade, repairs or replacement costs. Liability is limited to the cost of this inspection.

SB#1

septic tank

Approximate drainfield location
