### Compliance Inspection Form

**Existing Subsurface Sewage Treatment Systems (SSTS)**

Property address: 9611 NEAL AVE N, TOWN OF STILLWATER

# **Compliance Inspection Attachment for Existing Individual Sewage Treatment Systems**

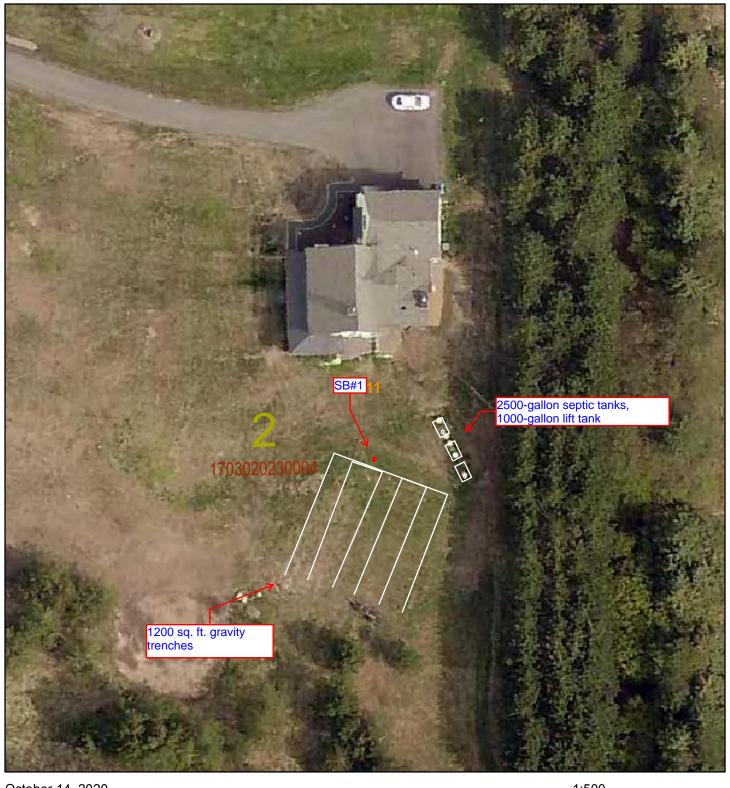
### **Sketch:**

Eenchmark = top of distribution pipe in fourth trench. Assumed elevation = 100'0". Soil boring #1 indicated no redoximorphic mottling at a depth of 72". The system does meet the required 36" vertical separation (31" with the allowable 15% reduction) from seasonally saturated soils. The system consists of a 1500 and 1000-gallon septic tanks, a 1000-gallon lift tank and 1200 sq. ft of gravity trenches w/12" of rock beneath the distribution pipe. The tanks were recently pumped in 2019, the baffles were checked and are o.k. The lift pump was manually tested and operable. The liquid level in all six boxes were below normal operating levels. This inspection is not a warranty or quarantee, either written or implied, of future or long-term hydraulic functionality/performance, but rather a determination if the systems use is/may cause pollution and/or adverse harm to the environment, groundwater or public health and safety at the time of this inspection. No quarantee can be made on future hydraulic performance, or the performance of system components (pumps, controls, etc.). Changes in use can cause any system, failing or compliant, to become hydraulically overloaded and ultimately fail. Owner/buyer assumes full responsibility for the long-term performance of this system as well as any future upgrade, repairs or replacement costs. Liability is limited to the cost of this inspection.
