ZIERKE SOIL TESTING

Brief system description: 1500 gallon septic tank, 1000 gallon lift station, mound dispersal system

System status

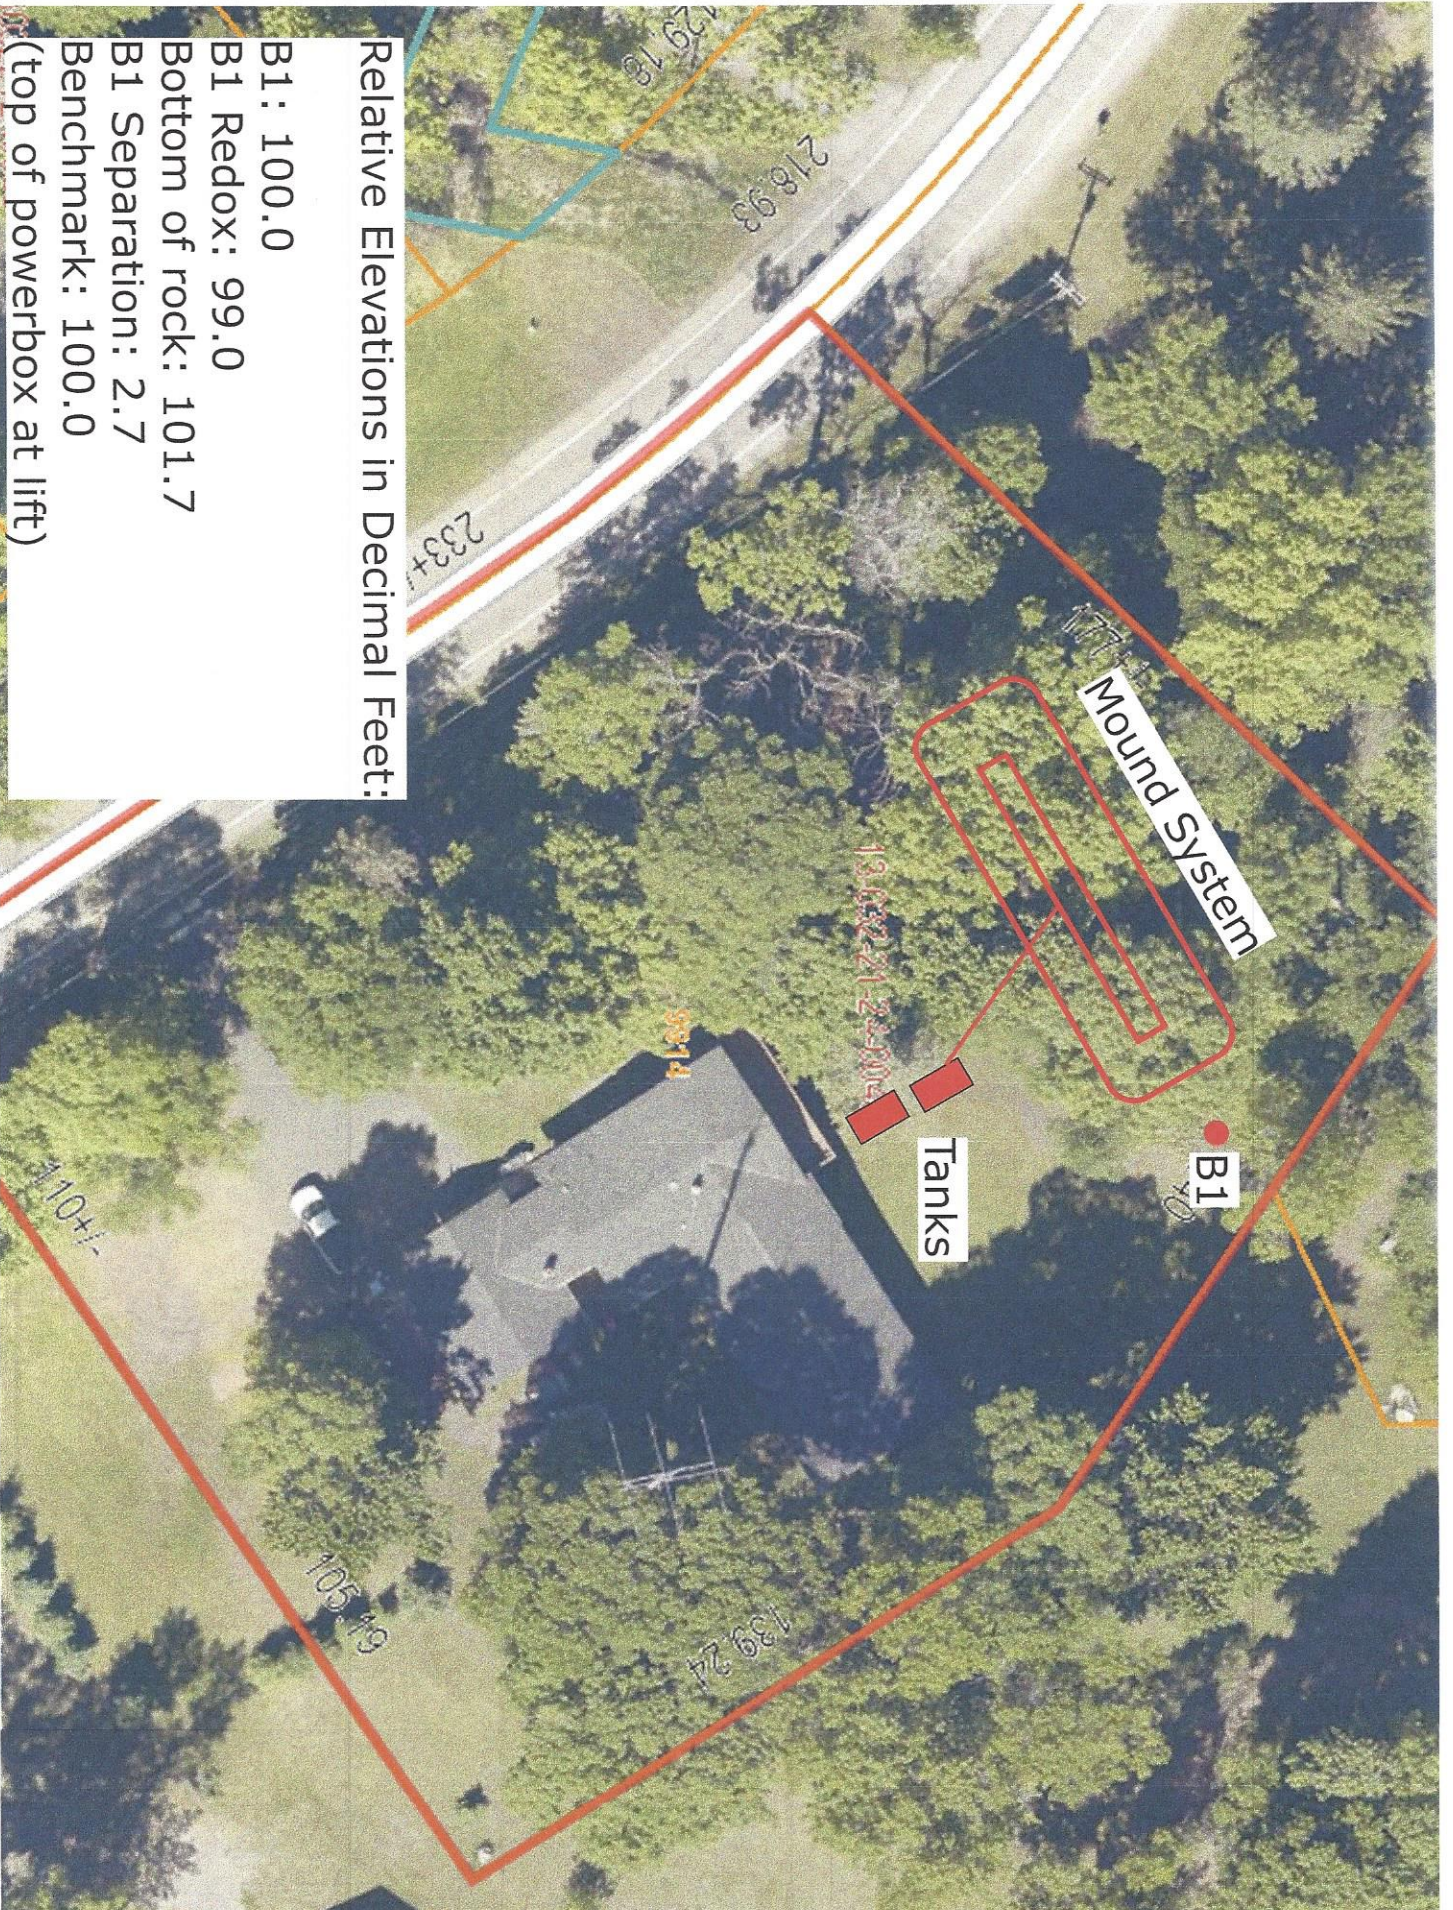
Site sketch

As built shows two septic tanks - only able to locate one septic tank. Pumping records confirm only one septic tank on site.

Relative Elevations in Decimal Feet:

B1: 100.0

B1 Redox: 99.0

Bottom of rock: 101.7

B1 Separation: 2.7

Benchmark: 100.0

(top of powerbox at lift)
