## Compliance inspection report form

**Existing Subsurface Sewage Treatment System (SSTS)**

Property information	Local tracking number:
Parcel ID# or Sec/Twp/Range: 11.028.20.34.0094	Reason for Inspection property sale
Local regulatory authority info: Washington County	
Property address: 16470 20th St S Lake St Croix Beach, MN 5	55043
Owner/representative: Jamie Vinova	Owner's phone: 651-337-1536
Brief system description: Two 1000 gallon precast septic tanks v  System status	with a 1000 gallon pump tank lifting to a gravity, rock trench drainfield
System status on date (mm/dd/yyyy): 8/11/2021	
☑ Compliant – Certificate of compliance*	☐ Noncompliant – Notice of noncompliance
(Valid for 3 years from report date unless evidence of an imminent threat to public health or safety requiring removal and abatement under section 145A.04, subdivision 8 is discovered or a shorter time frame exists in Local Ordinance.)	Systems failing to protect ground water must be upgraded, replaced, or use discontinued within the time required by local ordinance.  An imminent threat to public health and safety (ITPHS) must be

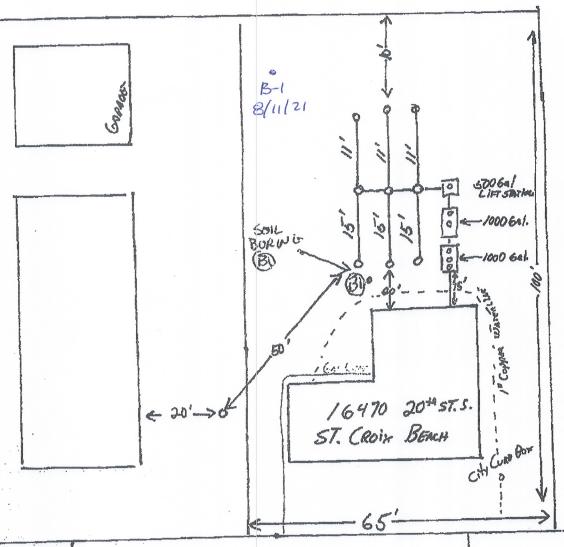
NO SCALE

SOIL BORING LCG.

04-13" = 107R 3/3 MEDIUM SANDY LOAM 13"-58" = 7.57R 3/4 MEDIUM / COAKSE SIND 58"-78" = 7.57R 4/6 MEDIUM SAND
