Property address: 11273 Kingsborough Trail Cottage Grove, Mn. 55016

Brief system description: 2 septic tanks to gravity drainfield

System status on date (mm/dd/yyyy): 9/28/2021

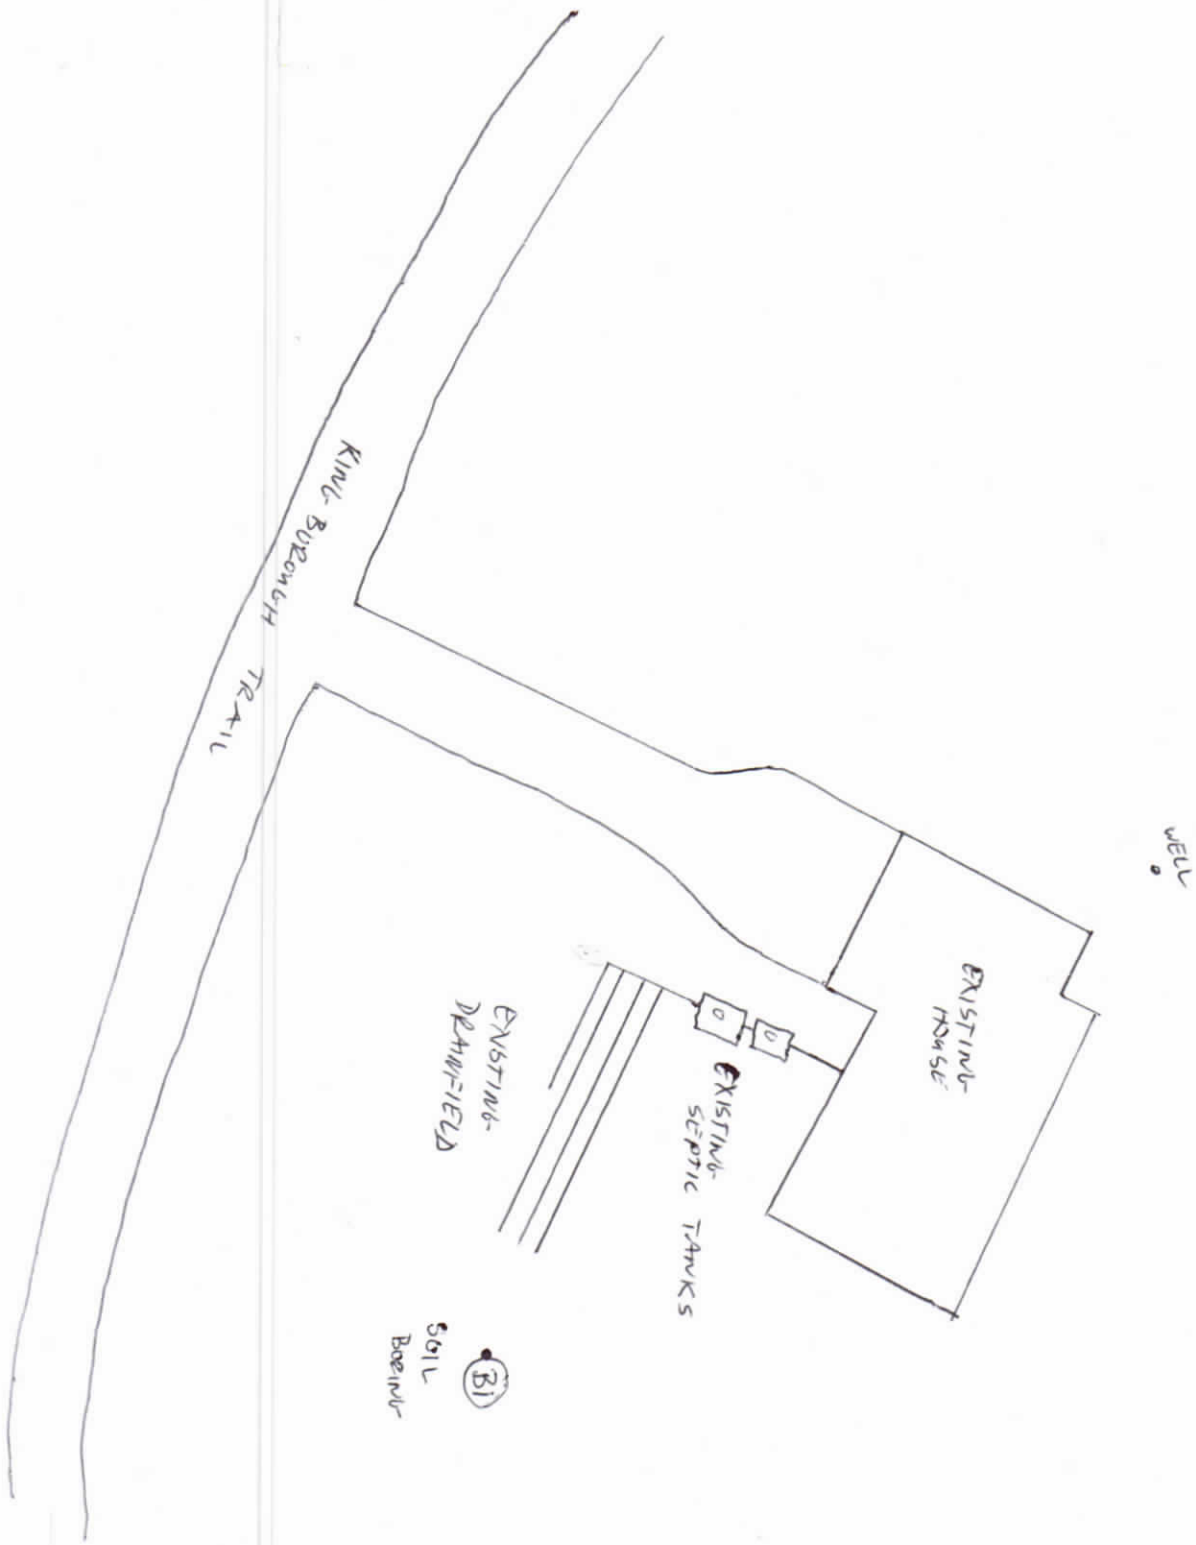
11273 KINGSBOROUGH TRAIL & COTTAGE GROVE, MN SS016

A. Bottom of distribution media	31"
B. Periodically saturated soil/bedrock	70"
C. System separation	39"
D. Required compliance separation*	36"

SOIL BORING LOG (B1)
0" - 56" = 10YR3/3 FINE LOAMY SAND
56" - 70" = 10YR3/6 FINE LOAMY SAND
> 70" = LIMESTONE RESTRICTION

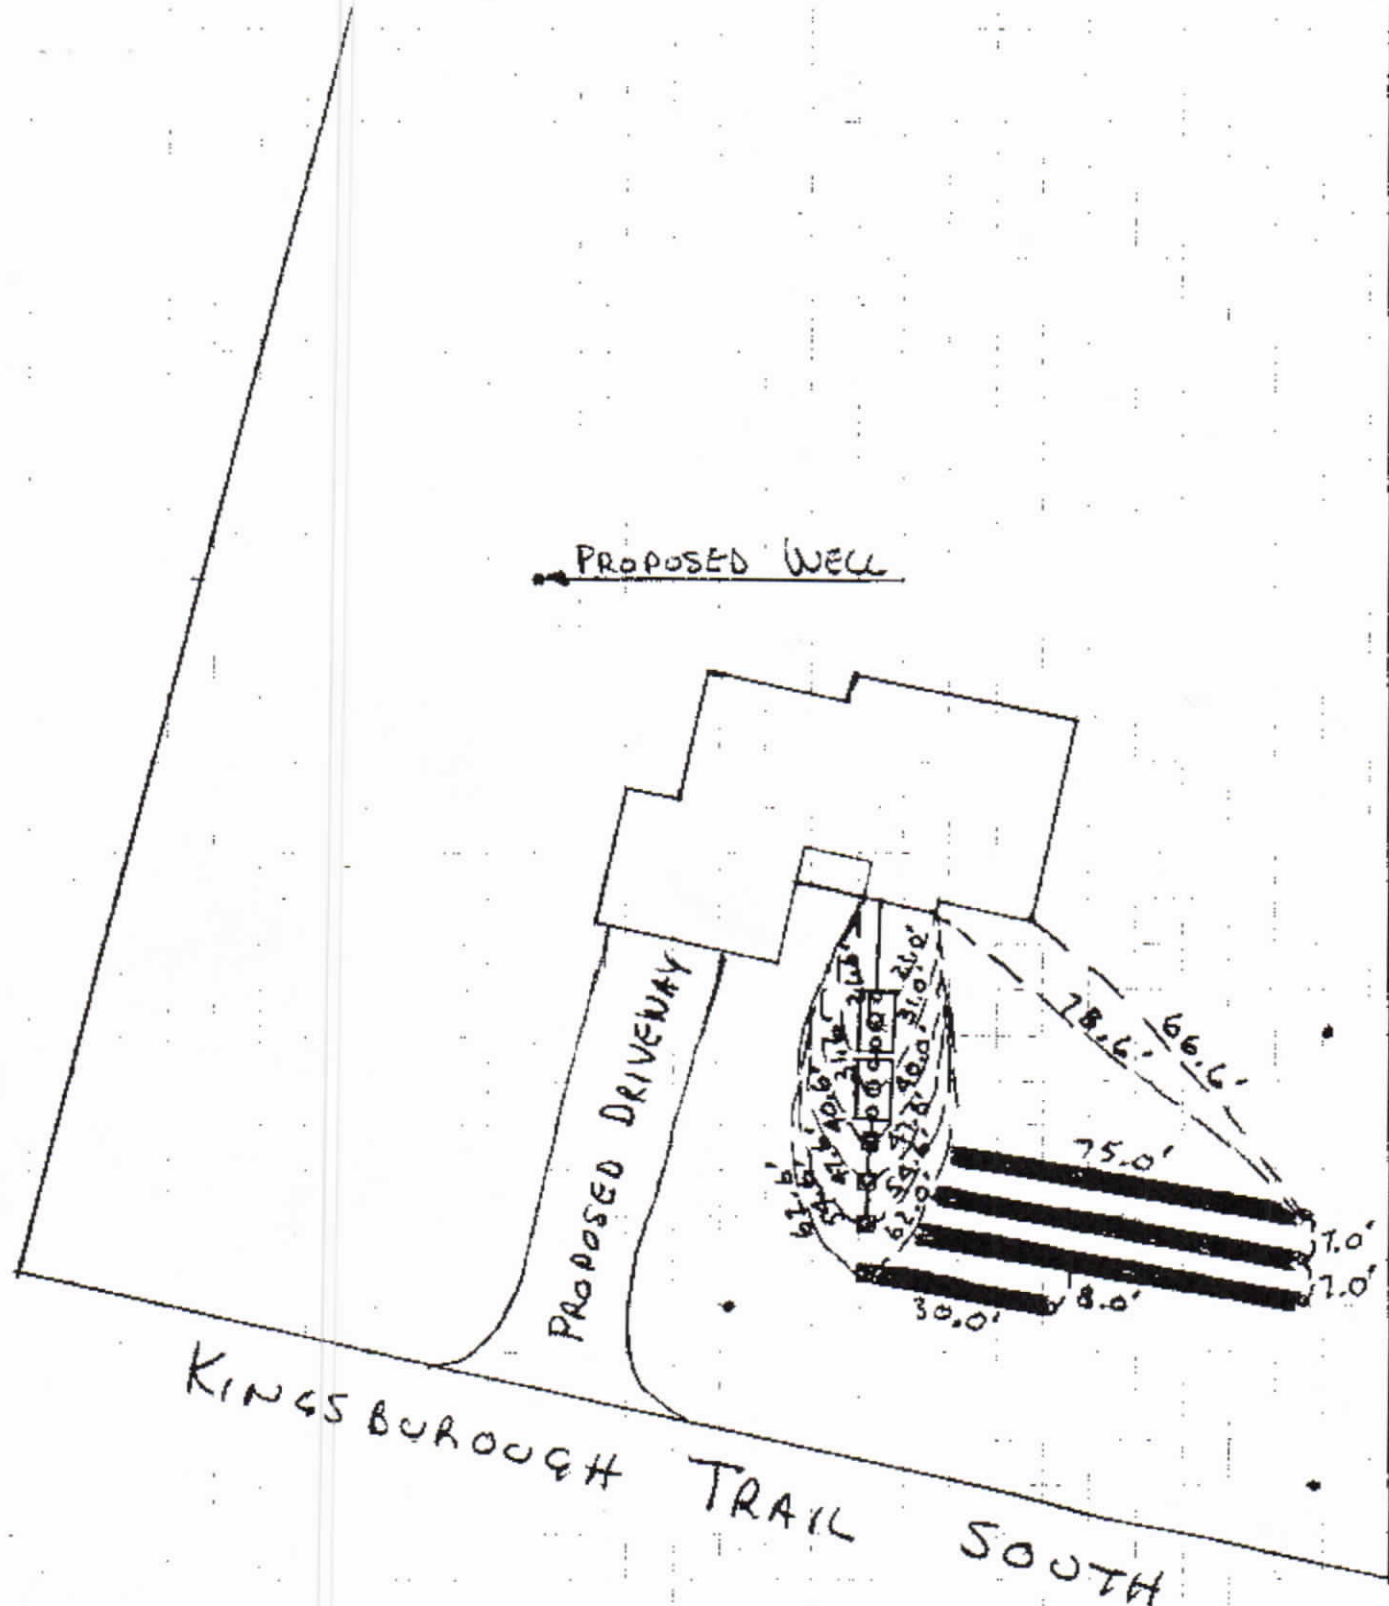
SOIL TESTING FOR THE DESIGN OF ABSORPTION SYSTEMS

Location: LOT 11 BLOCK 4 RIVER OAKS 2ND ADDITION.....

House ..4 bedrooms + garbage disposal

Two 1000 gallon septic tanks will be installed.

Present grade at highest part of the test area is approximately 10 feet lower than top of the block on the house according to owner/builder's benchmark, making a full-gravity system a possibility - see figure D-11. However, suggest doing final elevation checks before setting plumbing stub.

Drop boxes should be used - see figure D-14.

Trenches should be at least 20 feet away from any permanent structure, and at least 10 feet away from property lines.
